Subject: MAZDA CONNECT REBOOTS OR SCREEN TURNS BLACK DURING COLD TEMPERATURES	Bulletin No.: 09-015/20
	Last Issued: 06/03/2020

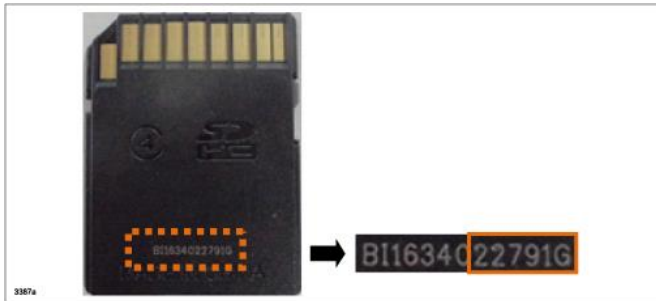
1. Verify customer concern.
2. Remove the SD card and check the last 6 digits of the lot number on the SD card.

- If the SD card has any of the following 6 digit lot numbers, replace it with a new SD card.

50424D	50631D	50635G	50881G	50955G
50428G	50632G	50877D	50913D	50995G

NOTE: The new SD card has a capacity of 16 GB, not 8 GB, like the original.
