<b>Subject:</b> <b>"IN-VEHICLE NETWORK MALFUNCTION" INSTRUMENT CLUSTER WARNING MESSAGE</b>	<b>Service Alert No.:</b> SA-029/20
	<b>Last Issued:</b> 06/23/2020

2019-2020 Mazda3  
2020 CX-30

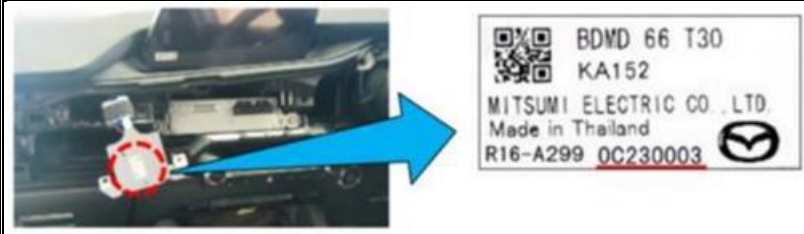
DTC	Action
<p>B119F:01 and one of the following:</p> <ol style="list-style-type: none"> <li>1. B119F:13</li> <li>2. B119F:2B</li> </ol>	<ol style="list-style-type: none"> <li>1. Check GPS antenna lot number. Is the lot number before 0C230003?                     <ol style="list-style-type: none"> <li>1. Yes - Contact Hotline for the latest repair information.</li> <li>2. No - Go to next step.</li> </ol> <p><b>How to read lot number</b> The lot number is in YMDDnnnn format. If it is 0C230003 or later, the part is already modified. No part number change for new modification.</p> <p><b>Example:</b> 0C230003: 0→2020 (year), C → March, 23→ 23th (day), 0003→serial number for the day 9H161360: 9→2019 (year), H → August, 16→ 16th (day), 1360→serial number for the day</p>
