GROUP	NUMBER		
Body	20-BD-016H		
DATE	MODEL(S)		
June, 2020	Santa Fe (TM) Palisade (LX2)

SUBJECT: SECOND ROW SEAT TRACK NOISE REPAIR

Description: Certain Santa Fe (TM) and Palisade (LX2) vehicles may exhibit noise coming from the second row seat track. This bulletin provides information on how to inspect and if necessary repair the condition.

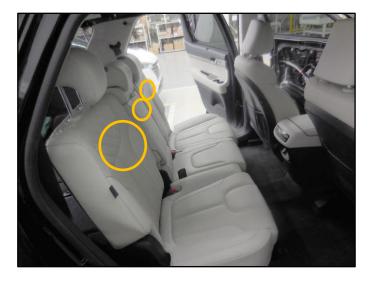
1. Tap the upper portion of the rear seat back 10+ times to inspect for noise.

Perform this inspection on all rear seat backs.
