Technical Service Bulletin

GROUP	NUMBER	
CAMPAIGN	20-01-022H-1	
DATE	MODEL(S)	
JUNE, 2020	NEXO (FE) PALISADE (LX2) SANTA FE (TM)

# SUBJECT: POWER TAILGATE SPINDLE WIRE HARNESS INSPECTION/REVISION (SERVICE CAMPAIGN T4X)

**Description:** Some 2019 - 2020 Nexo (FE), 2020 Palisade (LX2), and 2019 - 2020 Santa Fe (TM) vehicles equipped with the power tailgate may not operate. This bulletin provides the service procedure to inspect and when necessary perform the power tailgate spindle wire harness revision.

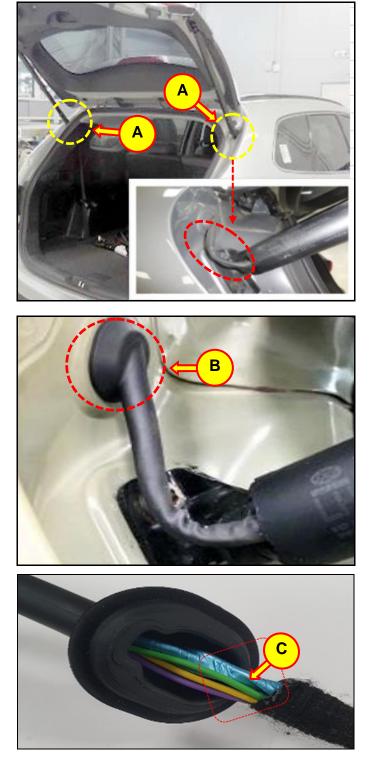
1. Open the tailgate to inspect the LH/RH power tailgate spindle wiring harness (A).

2. Remove the rubber grommet (B) of the tailgate spindle wiring harness and inspect the material.

If the wire harness has a metallic shield (C), <u>no</u> <u>further action is required</u>.

If the wire harness shield does not have the metallic shield, perform the power tailgate spindle wire harness revision on page 4.
