# SERVICE BULLETIN

Classification: EL19-023c	Reference: NTB19-067c	Date: June 25, 2020
------------------------------	--------------------------	------------------------

## SOFTWARE UPDATE FOR INFOTAINMENT ISSUES

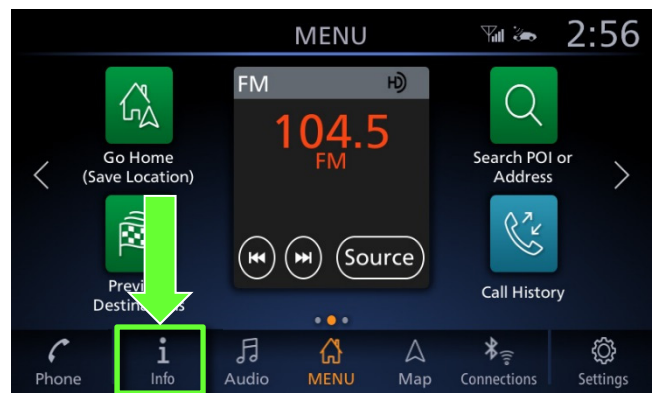
Figure 3

- If the Info icon does not appear as shown in Figure 3, this bulletin does not apply.

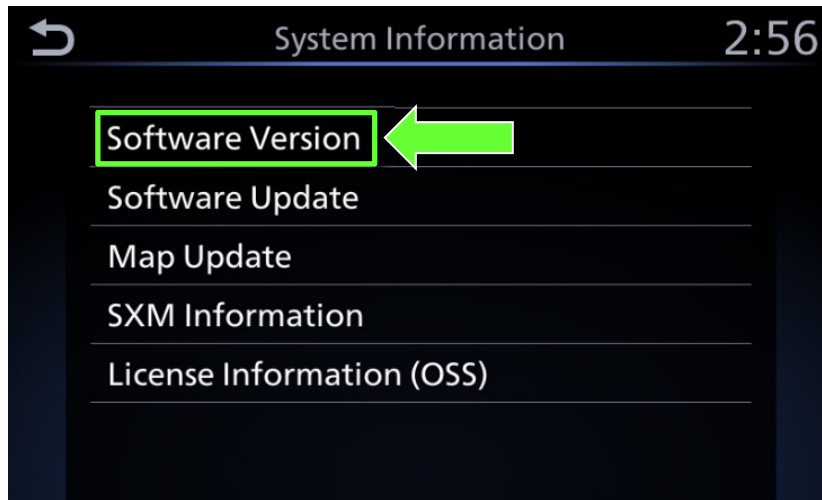
Figure 5

- If the Software version is NOT **0810 or higher**, select the back button and continue to step 5 on the next page.
- If the Software version is **0810 or higher**, select the back button, this bulletin does not apply.

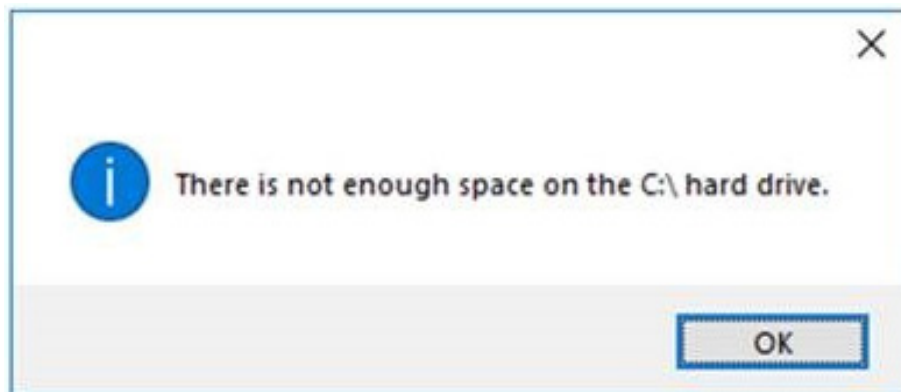
Figure 9

- The update is estimated to take **4 hours** to download to the USB drive.
- If while attempting to download the software to the ASIST Station, you receive the message show in Figure 9:
  - a. First attempt to clear space on the ASIST Station hard drive.
  - b. If space on the hard drive cannot be cleared, email Bosch at **nissan.dealers@us.bosch.com** for additional options.

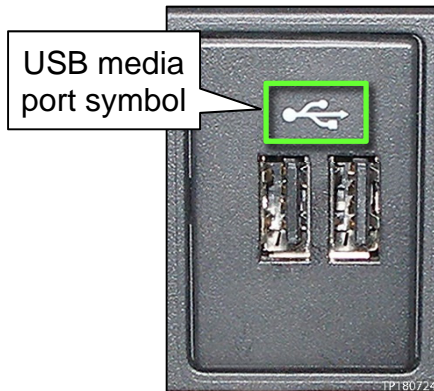
Figure 12

16. Insert the USB drive with infotainment update software into the vehicle's USB media port (see Figure 12).

**NOTICE** Do not insert the USB drive into a charging port. If used, the update software and/or USB drive may become damaged. Only insert the USB drive in a USB media port.

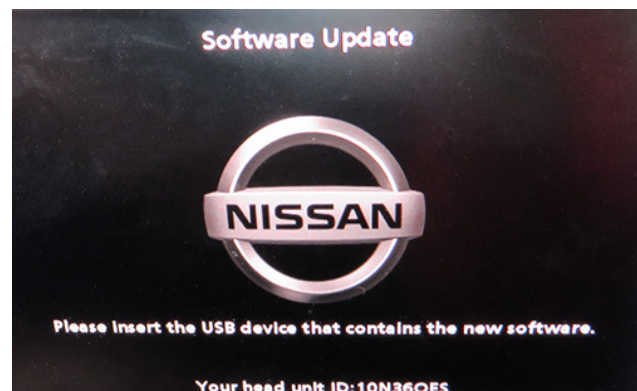
- The screen in Figure 15 may briefly appear. **Do not remove the USB drive.** The audio system will detect the USB drive and continue the update.

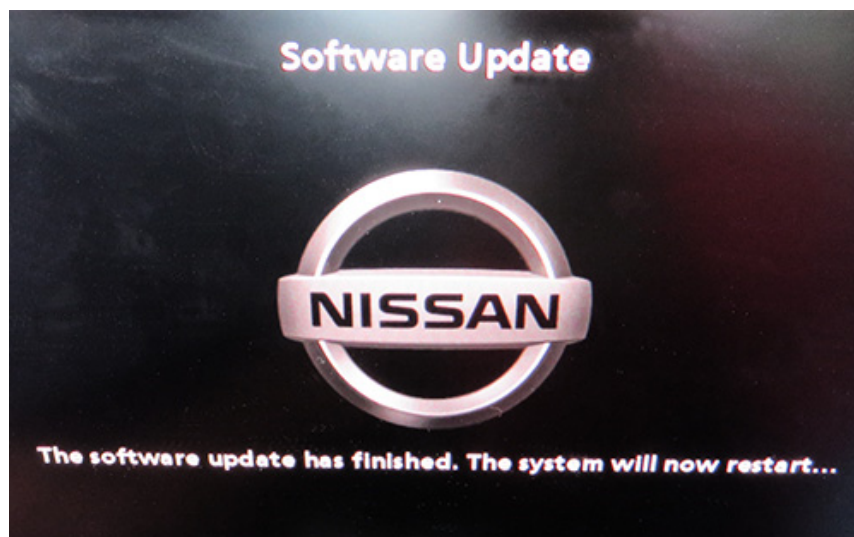
Figure 17

19. Once the update is complete (Figure 17), remove the USB drive; the system will reboot (restart).

**HINT:** The system will not reboot until the USB drive is removed.
