55-18-01TT Rear Lid Does Not Operate or Does Not Operate Correctly

Release date: 07/03/2020

Model(s)	Year	Eng. Code	Trans. Code	VIN Range From	VIN Range To
Atlas, Cross Sport	2018-2020	All	All	All	All

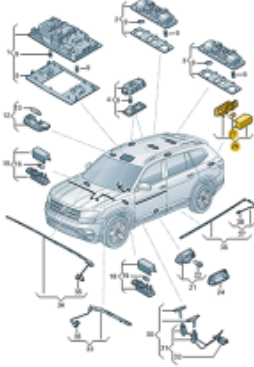
Atlas Luggage Compartment Light

- Check the luggage compartment lamp part number by VIN in ETKA

luggage compartment light					
26	6L0 947 415	light	clear glass		2
27	N 017 753 5	bulb "Longlife"	5W		2

- If the incorrect parts installed, replace with the correct parts for the vehicle.
