GLOBAL SAFETY FIELD INVESTIGATIONS  
DCS5422  
URGENT - DISTRIBUTE IMMEDIATELY

Subject: A202302140-01 - Service Update  
Engine Oil Pressure Sensor Performance Error  
Revised Part, Warranty and Service Procedure sections

Models: 2020 Buick Encore GX  
2021 Chevrolet Trailblazer  
Equipped with 1.2L Turbo Engine (RPO LIH)

## A202302140 Engine Oil Pressure Sensor Performance Error

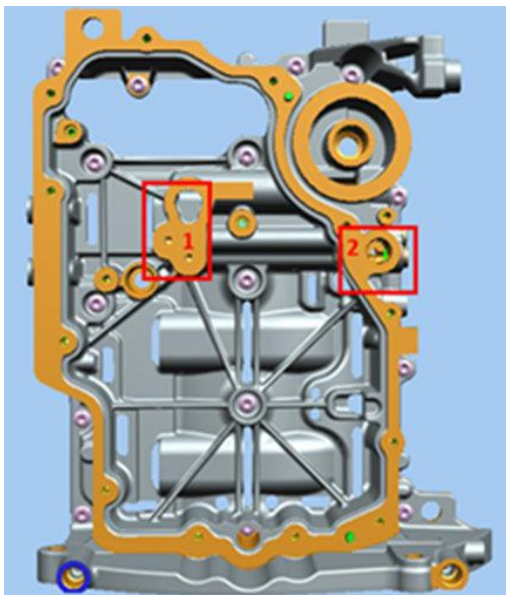
5617448

<b>Condition</b>	On certain vehicles, the engine oil pump may be stuck due to foreign material, and diagnostic trouble codes (DTC) P0521, P06DE, P06DD could be set.
<b>Correction</b>	Dealers are to perform the engine oil pump screening test and if necessary, replace the oil pump.

**Caution: Ensure the three oil pump oil holes (Area 1) and OCV mounting hole (Area 2) are free of debris BEFORE installing the oil pump and OCV. If debris is found, remove with a lint-free cloth or brush that will not scratch the surface.**
