Subject: N202304540 - Emission Recall
Engine Control Module Cannot Detect Catalyst Inefficiency

Models: 2018 Chevrolet City Express

Product Emission Recall

N202304540 Engine Control Module Cannot Detect Catalyst Inefficiency

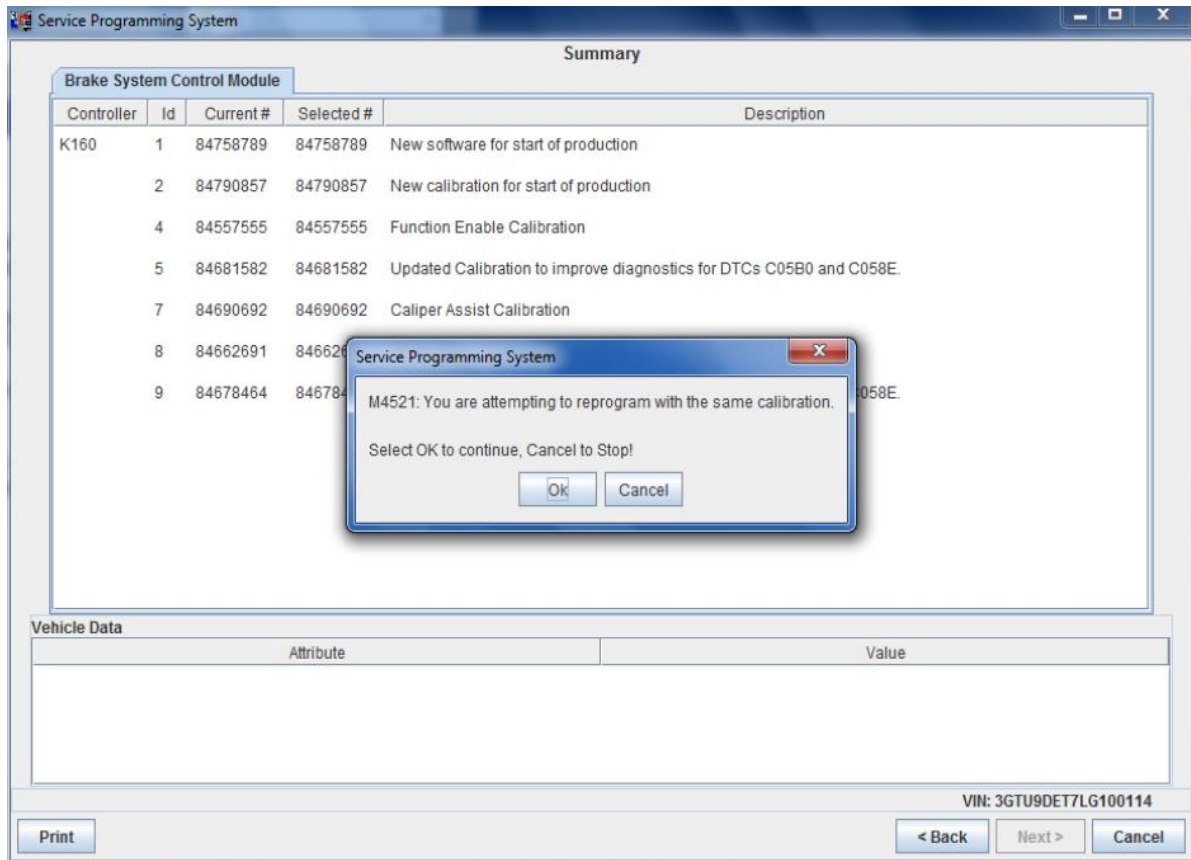
5431207

Important: TIS2WEB screen shown. Techline Connect screen is similar and will be included in the near future.

Important: If the Same Calibration/Software Warning is noted on the SPS screen, select OK and follow screen instructions. After a successful programming event, the WCC is located in the Service Programming System dialogue box of the SPS Summary screen. No further action is required. Refer to the Warranty section of the bulletin.

1. Reprogram the Engine Control Module. Refer to *K20 Engine Control Module: Programming and Setup* in SI. Modify as required.

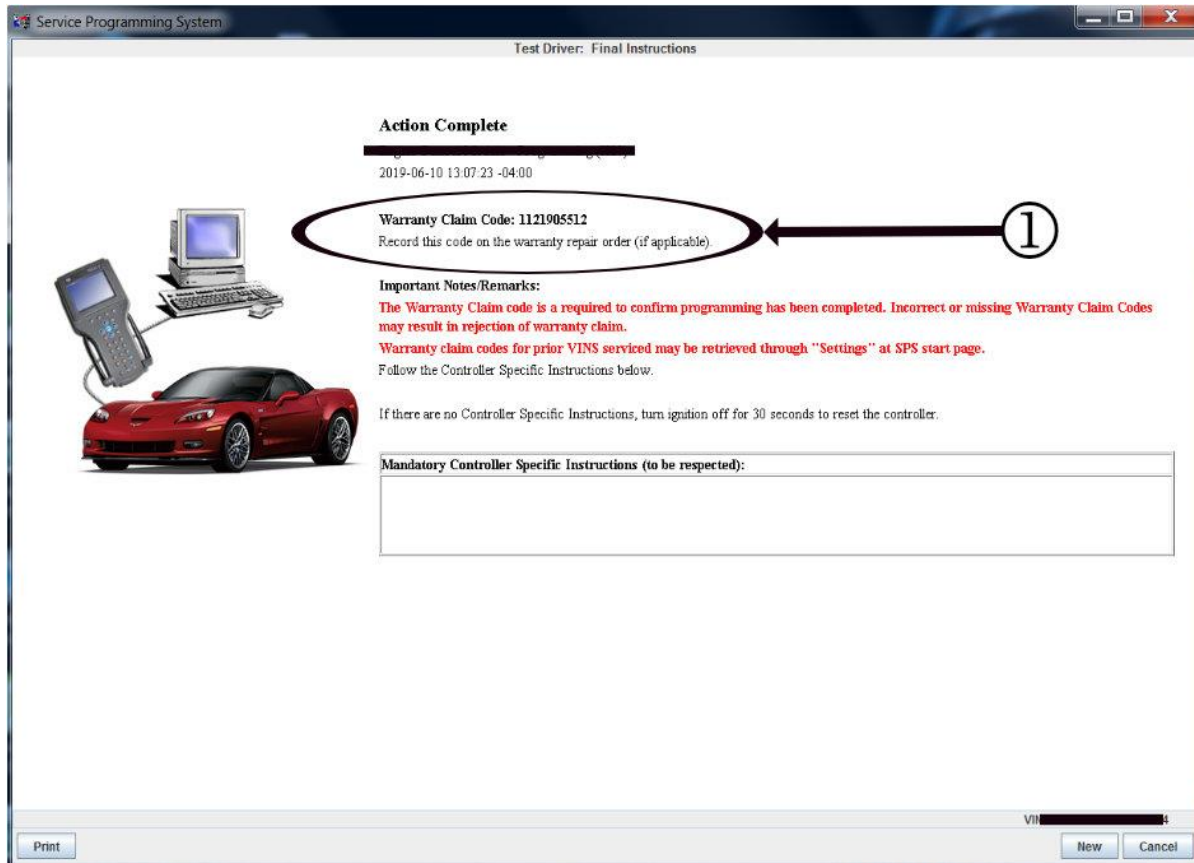
5431209

Important: TIS2WEB screen shown. Techline Connect screen is similar and will be included in the near future.

Important: To avoid warranty transaction rejections, you **MUST** record the warranty claim code provided on the SPS Warranty Claim Code (WCC) screen on the job card. Refer to callout 1 above for the location of the WCC on the SPS screen.

2. Record SPS Warranty Claim Code on job card for warranty transaction submission.
3. CALIFORNIA VEHICLES ONLY: Complete a "Proof of Correction" certificate and provide to the vehicle owner upon recall completion.
