# Service Update

## N202296490 Drive Motor Power Inverter Module

Subject: N202296490 - Service Update  
Drive Motor Power Inverter Module

Models: 2017 – 2018 Cadillac CT6  
Equipped with Hybrid Propulsion – Plug-In Identifier (RPO HP9)

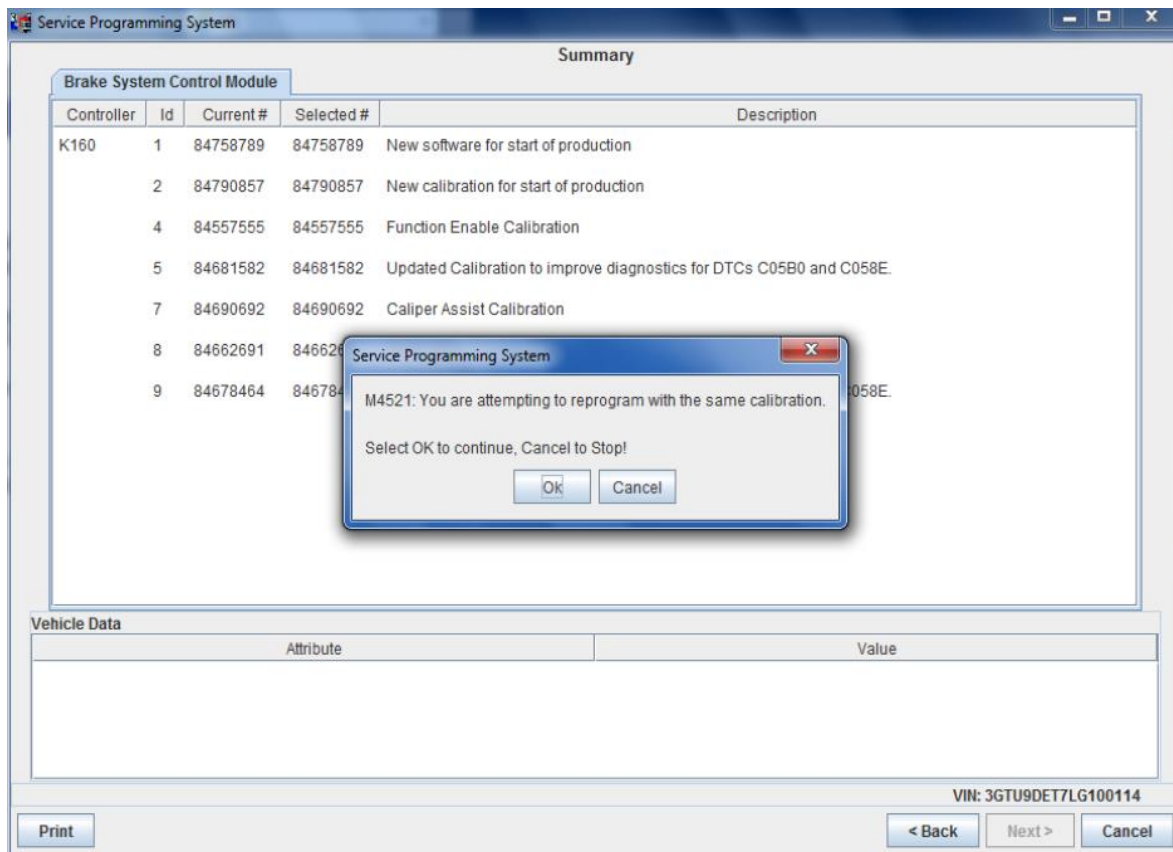
5431207

**Important:** TIS2WEB screen shown. Techline Connect screen is similar and will be included in the near future.

**Important:** If the Same Calibration/Software Warning is noted on the SPS screen, select OK and follow screen instructions. After a successful programming event, the WCC is located in the Service Programming System dialogue box of the SPS Summary screen. No further action is required. Refer to the Warranty section of the bulletin.

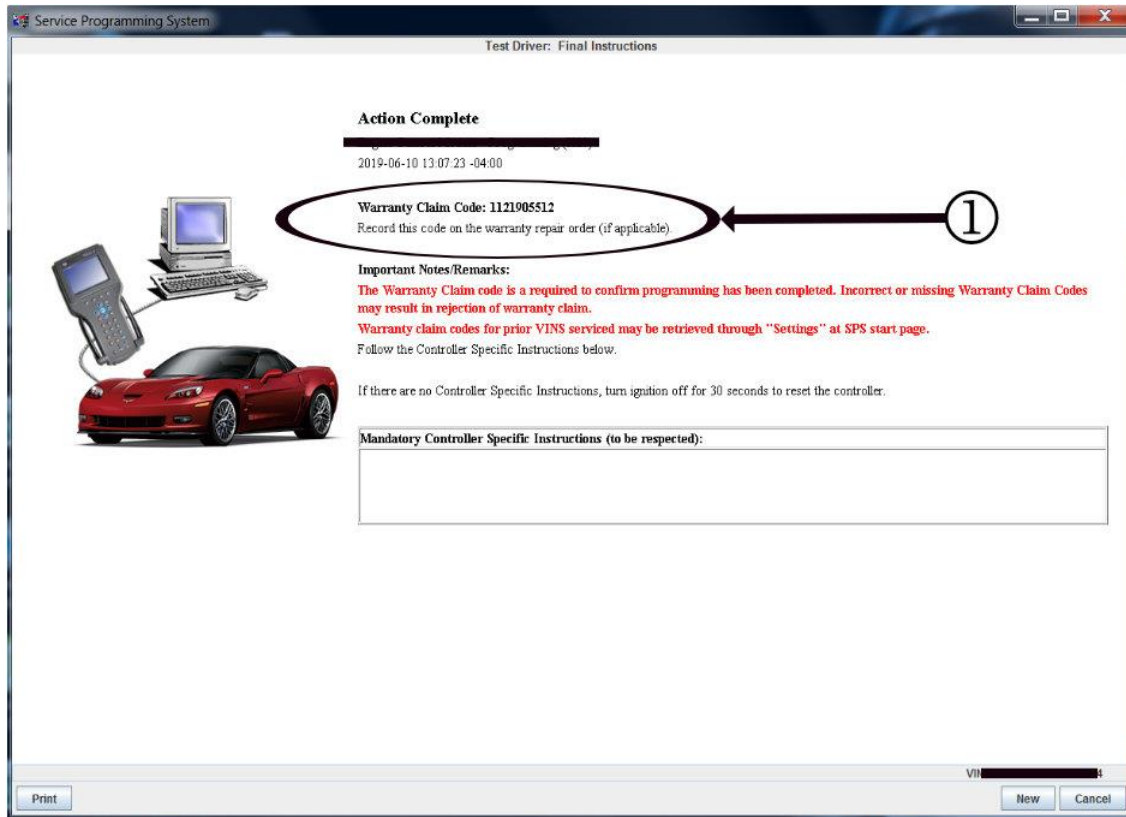
5431209

**Important:** TIS2WEB screen shown. Techline Connect screen is similar and will be included soon.

**Important:** To avoid warranty transaction rejections, you **MUST** record the warranty claim code provided on the SPS Warranty Claim Code (WCC) screen on the job card. Refer to callout 1 above for the location of the WCC on the SPS screen.

- Record SPS Warranty Claim Code on job card for warranty transaction submission.
