Technical Service Bulletin

10 Oil loss from the filler cap

10 20 19 2059446/2 July 14, 2020. Supersedes Technical Service Bulletin Group 10 number 20-18 dated May 12, 2020 for reasons listed below.

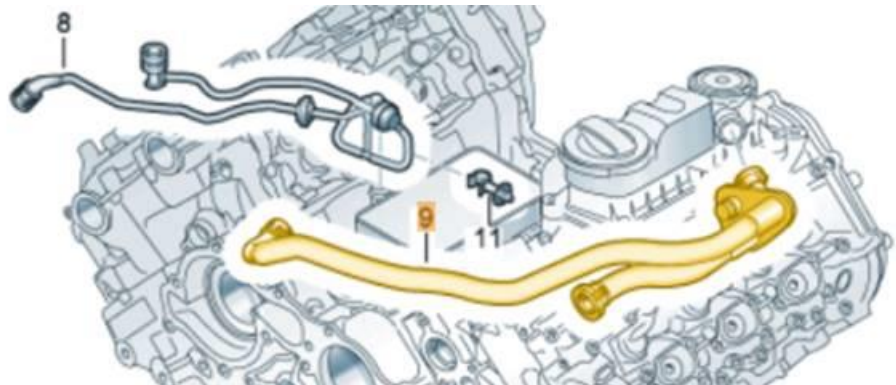
- There are traces of oil around the filler cap.

A faulty membrane in the breather line 06M103210 ** can result in excess pressure in the crankcase and therefore some oil loss through the filler cap.

Figure 1. Breather line that needs to be replaced.

Replace the breather line 06M103210 ** (different variants available, only order by VIN).
