## Engine runs irregularly and shakes. Check engine lamp lights up

Topic number	LI03.10-N-071148
Version	3
Function group	03.10 Connecting rods, pistons
Date	06-04-2020
Validity	Model 906 with engine OM651 Model 906, 907 with engine OM642
Reason for change	Operation Codes Updated
Reason for block

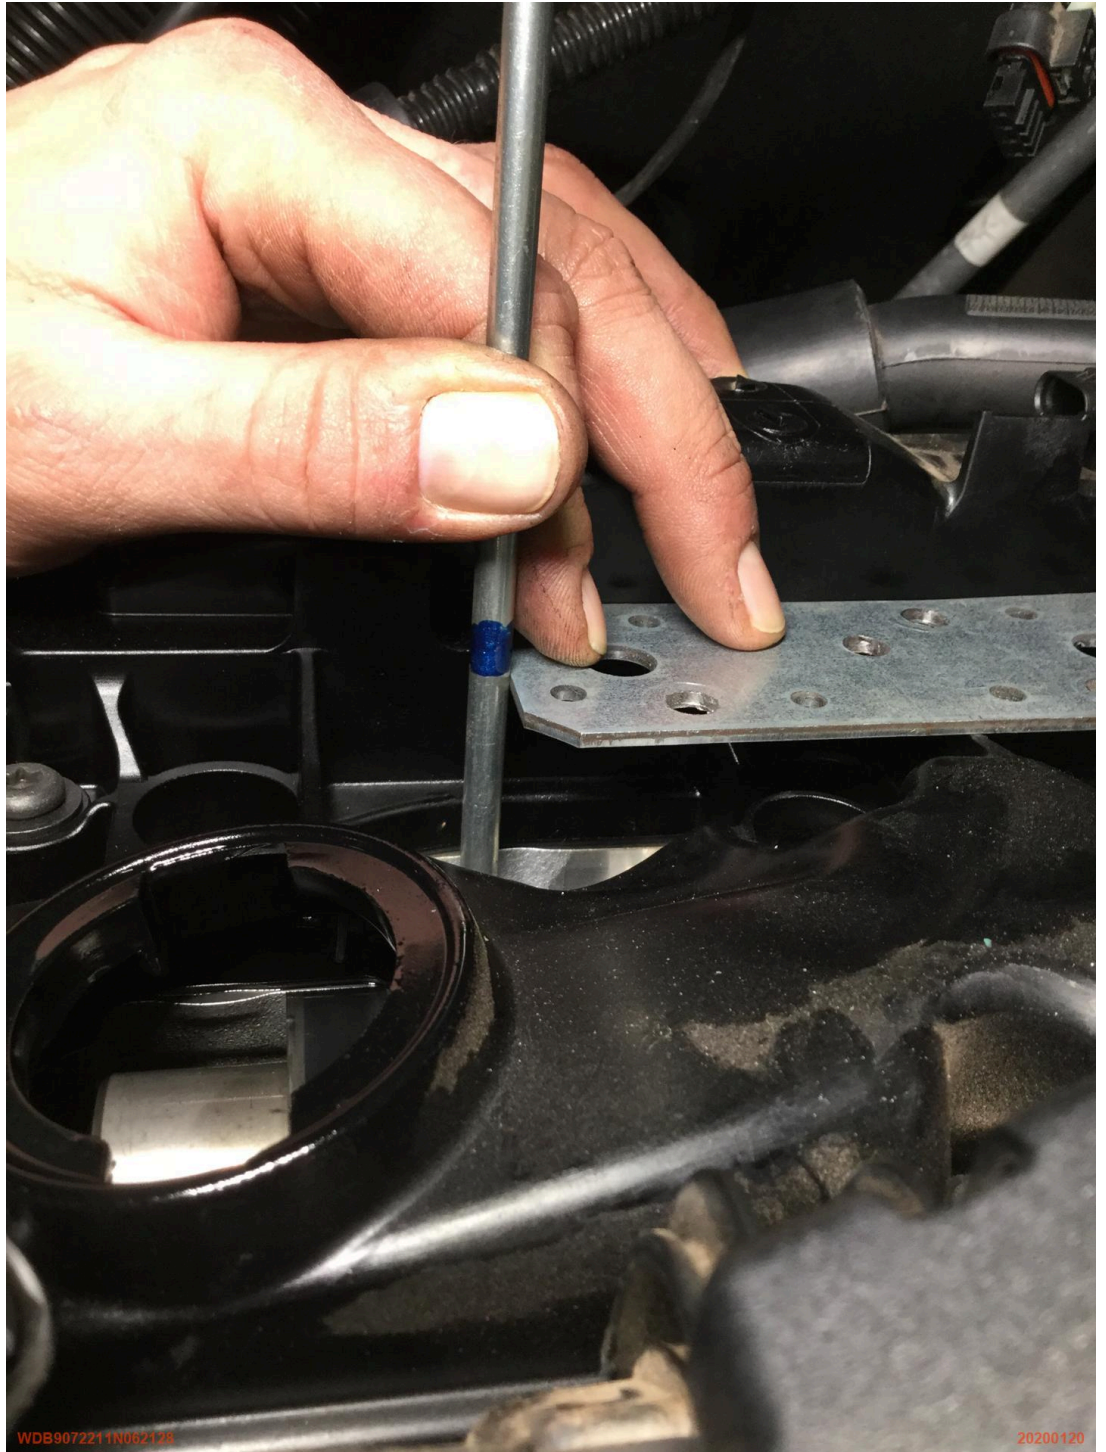
01.jpeg:

Attachments	
File	Description
01.jpeg	Measurement of distance to piston (cylinder 1).
02.jpeg	Measurement of distance to piston (cylinder 2).
03.jpeg	Old as-built configuration of charge air cooler (fitting in center) (A 906 501 02 01). Standard on model 906.
04.jpeg	New as-built configuration of charge air cooler (with lowered fitting on cold side) (A 907 501 16 00). Model 907 with engine 651.
05.jpeg	New as-built configuration of charge air cooler (with lowered fitting on cold side) (A 907 501 17 00). Model 907 with engine 642.

8. Manually turn cylinders, one after the other, to TDC position (see AR01.00-D-0100SF in model 906 with engine 642, AR01.00-D-0100-01TSV in model 907 with engine 642, AR01.10-D-1000-01WE in model 906 with engine 651) and use welding wire or a vernier caliper through the fuel injector slot to measure the distance to the piston (see Picture 01 and 02).

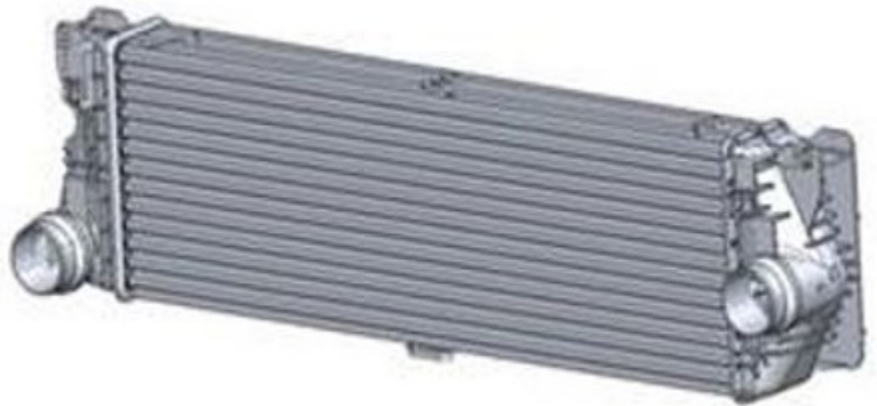
04.jpeg:

Information: For a current as-built configuration (see Pictures 03, 04(OM651) and 05(OM642)), do not undertake any more repair measures.

Information: The new charge air cooler with lowered fitting on the cold side (see AR09.41-D-8619M in model 906 with engine 642, AR09.41-D-8621TSR in model 907 with engine 642 or AR09.41-D-8619WE in model 906 with engine 651) must be installed (see Picture 04 and 05). Cost acceptance to be checked through advance agreement with regard to goodwill (ESKULAB). The modification of the charge air cooler is to be applied for as additional work through an ESKULAB query for engine damage (Note service information bulletin SI01.10-S-0001A hereto).
