Wiper Contacts Hood Trim with Hood Open

Topic number	LI82.30-N-071343
Version	1
Function group	82.30 Windshield wipers
Date	06-15-2020
Validity	447 Metris Equipped with SA code IK8 (Right Hand Steering)
Reason for change	
Reason for block

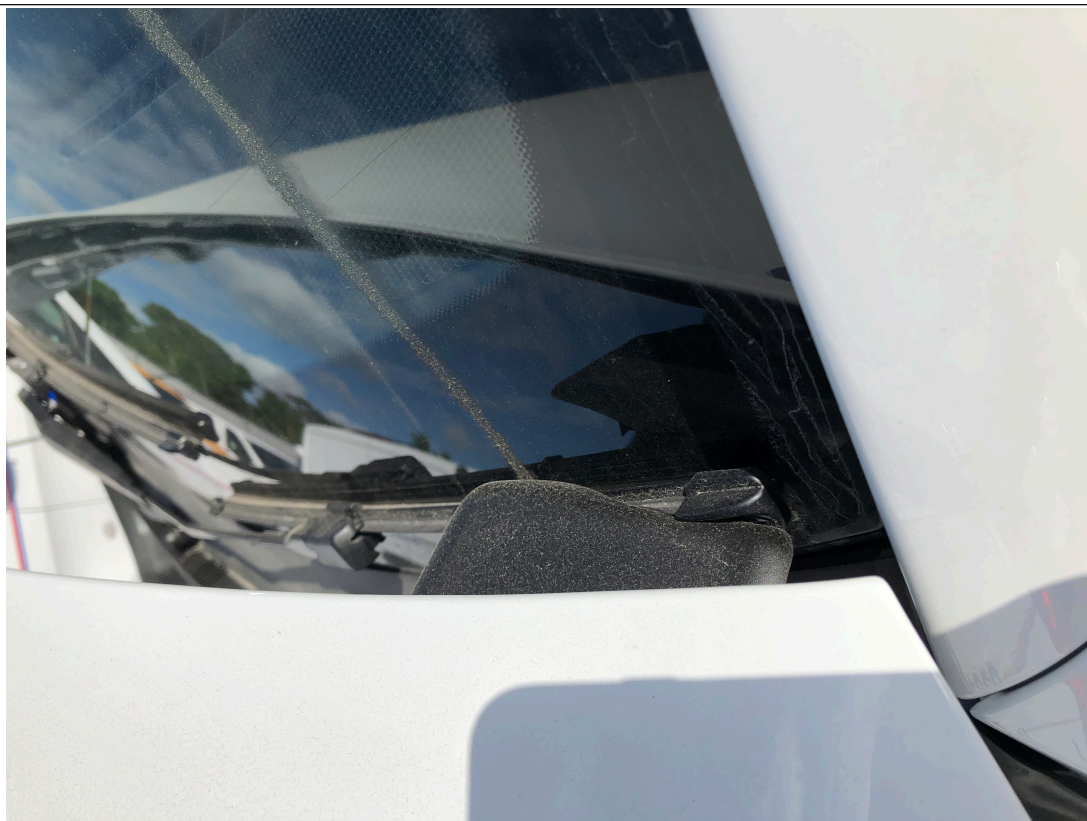
trim contacting wiper top view 2.jpg:

The left windshield wiper contacts the left hood hinge trim when the hood is open (see Image trim contacting wiper top view 2.jpg)

Attachments	
File	Description
trim contacting wiper top view 2.jpg	Example of normal contact of hood trim on wiper blade with hood open

This is a normal characteristic of the right hand drive windshield wiper arm configuration

Do not replace any parts.

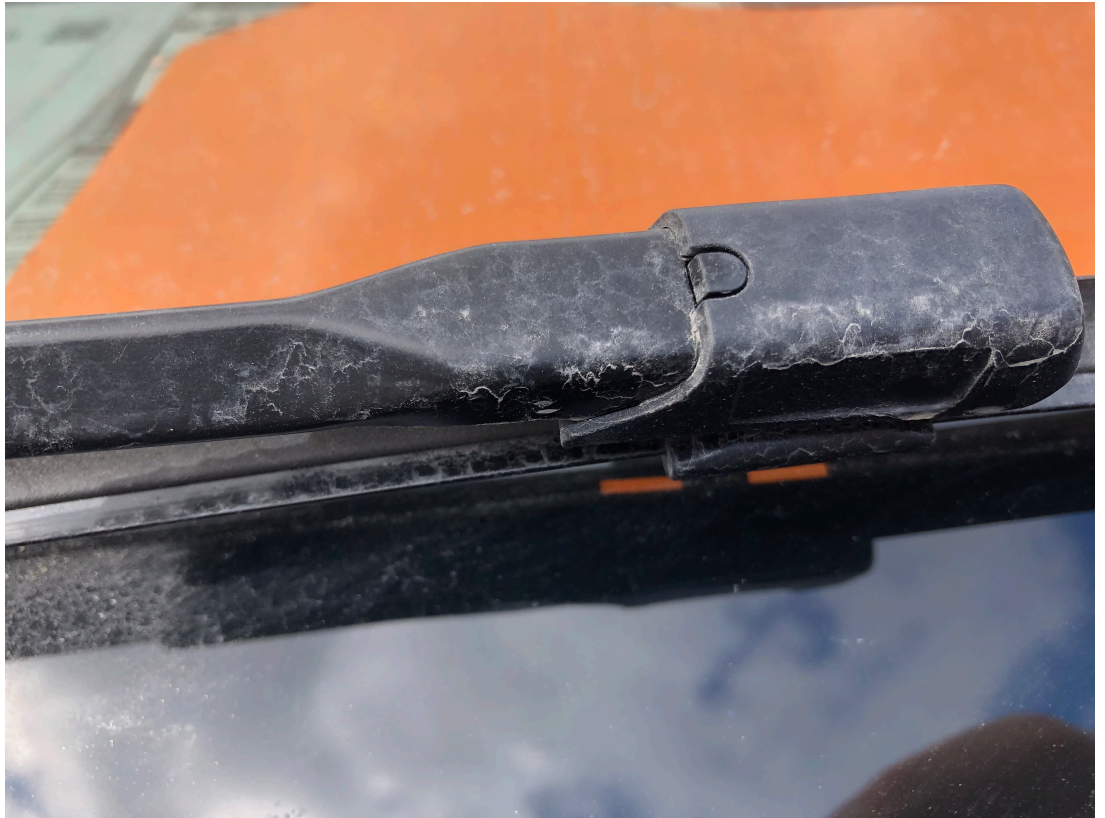
Windshield alignment
mark 2.jpg:

Attachments	
File	Description
Windshield alignment mark 2.jpg	Example of windshield alignment mark

In the park position the wiper arms should be aligned on the markings on the windshield (see image Windshield alignment mark 2.jpg)
