Service Information Letter

May 28, 2020

Units Affected: Certain AT37-G and AT40-G aerial devices built from November 2017 to October 2018 (see attached list)

Torsion Bar Inspection on 60" CA Chassis

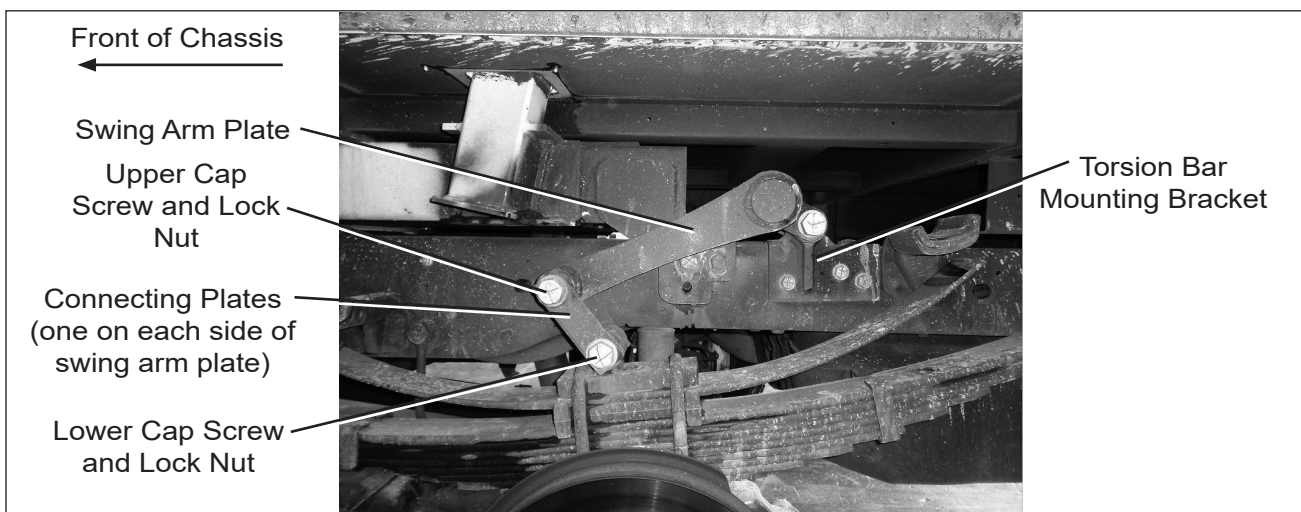
Figure 1 – Street Side Torsion Bar Assembly

6. Using a flashlight and a mirror, inspect both connecting plates, the swing arm plate, and the upper lock nut and cap screw threads from all available angles. Look for any hairline cracks, bending, denting, or metal chipping.

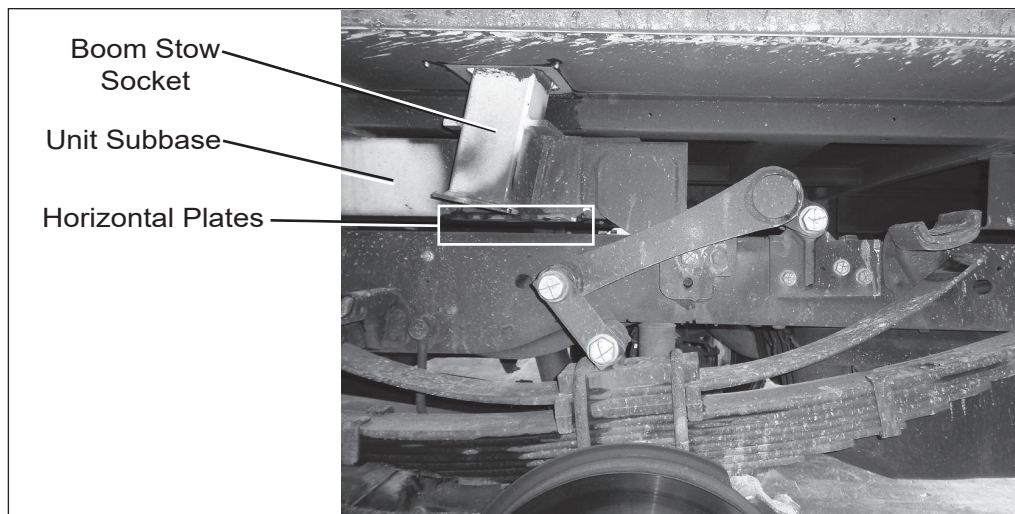
Figure 2 – View of Street Side Wheel Well

11. Locate the boom stow socket on the side of the subbase in the street side rear wheel well. Locate the horizontal plate under the boom stow socket (refer to Figure 2).

12. Using a plasma cutter or cut-off wheel, remove the corner portion of the horizontal plate beyond a distance of $\frac{1}{8}$ " from the edge of the weld beads, as shown in Figures 3 and 4. Do not cut into the weld beads. Do not cut into the horizontal plate any farther on the bottom than on the top if using a cut-off wheel.

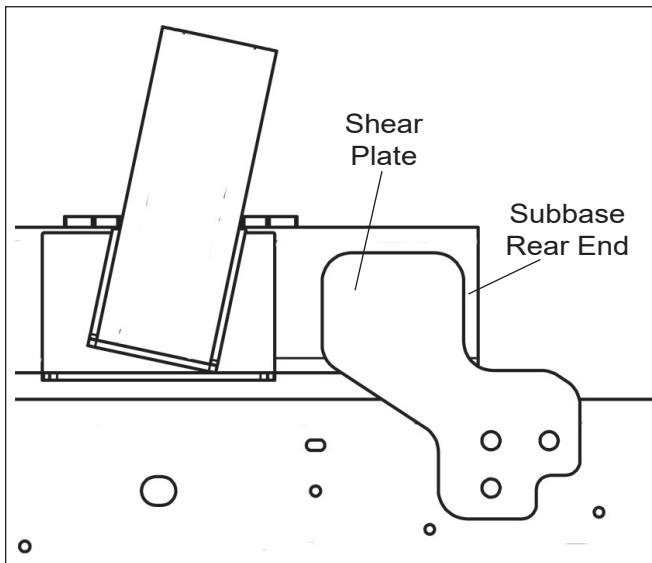
Figure 5 – Shear Plates Located Incorrectly

- If the shear plates are installed with the entire upper portion placed ahead of the rear end of the subbase as shown in Figure 5, modification is required. Proceed to step 14.
- If the shear plates are installed with the upper portion extending about 2" +/- 1" behind the rear end of the subbase as shown in Figure 6, no modification is required. Proceed to step 16.

14. If the shear plates are located incorrectly, a portion of each shear plate toward the front must be removed. Using a cut-off wheel, cut each shear plate vertically 2" from the front edge (refer to Figure 7). Using a grinder, remove the weld along the top and front edges of each shear plate. Do not cut into the side of the subbase tubing with the cut-off wheel or grinder. Complete the removal of this portion of the shear plates.
