SIL 752

# Service Information Letter

Units Affected: Certain AT48S and AT48M aerial devices  
built from January 2017 through August 2019 (see attached list)

## HuckBolt and U-Bolt Inspection

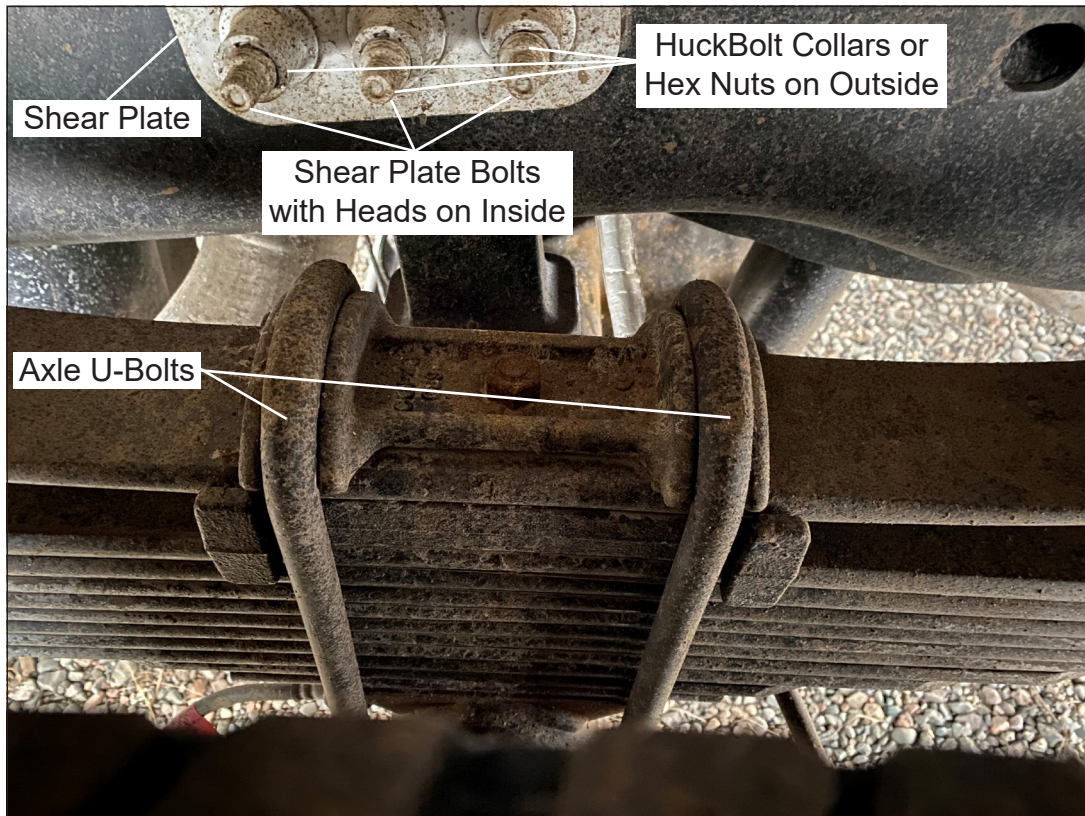
**Figure 1 — Orientation of Shear Plate Bolts**

1. Position the unit on a level surface, apply the parking brake, and chock the wheels. Turn off the engine and remove the key from the ignition.
2. Look at the location and orientation of the bolts in the shear plate above the rear axle on both sides of the chassis (refer to Figure 1).

- If all the shear plate bolts are installed with the heads on the outside, the clearance is adequate. Proceed to step 10.
  - If any of the shear plate bolts are installed with the collar or hex nut located on the outside, inspect for the location of the shear plate bolts vs. the rear axle U-bolts.

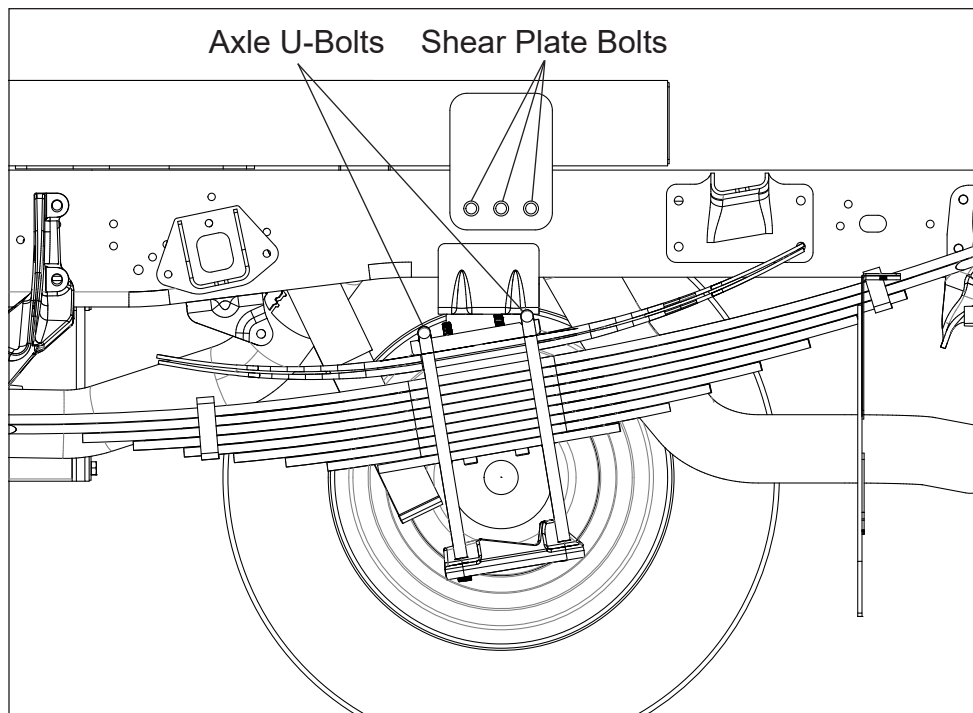
**Figure 2 — Shear Plate Bolts Located Above Axle U-Bolts**

Altec has discovered that the placement of certain HuckBolts or hex head bolts used to attach the unit to the chassis may cause interference with the chassis suspension U-bolts during road travel. This can result in damage to the unit mounting bolts and the chassis U-bolts.

- If any of the shear plate bolts are located in the region directly above the top of either axle U-bolt (refer to Figure 2), proceed to step 3.
    - If the frontmost shear plate bolt is located with a horizontal spacing of 1" or more behind the top of the rearmost axle U-bolt (refer to Figure 3), the clearance is adequate. Proceed to step 10.

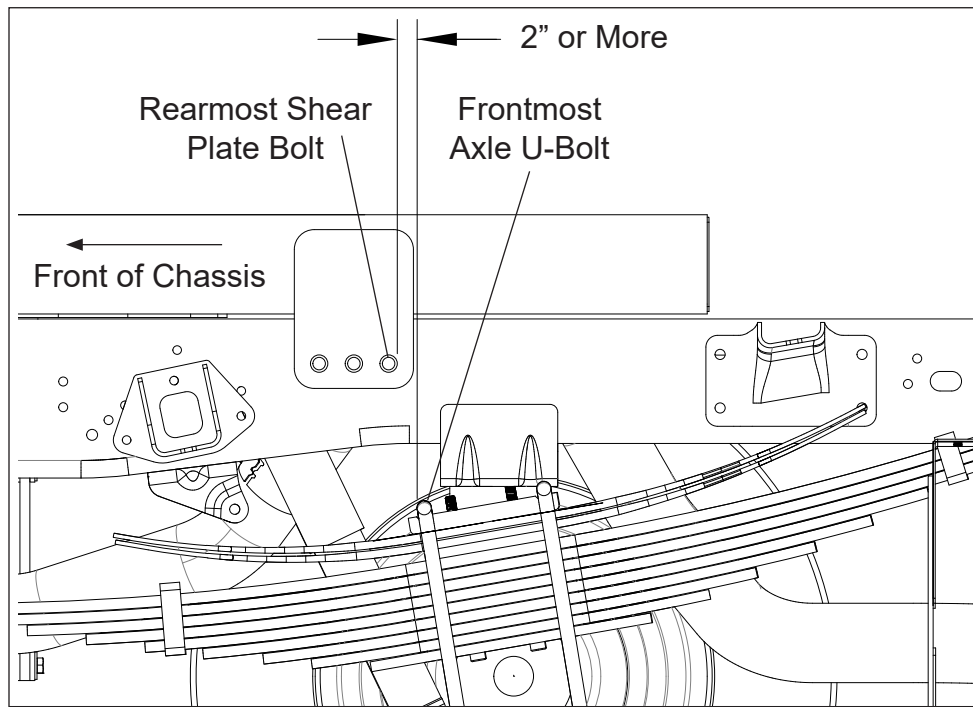
**Figure 4 — Shear Plate Bolts Located in Front of Axle U-Bolts**

- If the rearmost shear plate bolt is located with a horizontal spacing of 2" or more in front of the top of the frontmost axle U-bolt (refer to Figure 4), the clearance is adequate. Proceed to step 10.

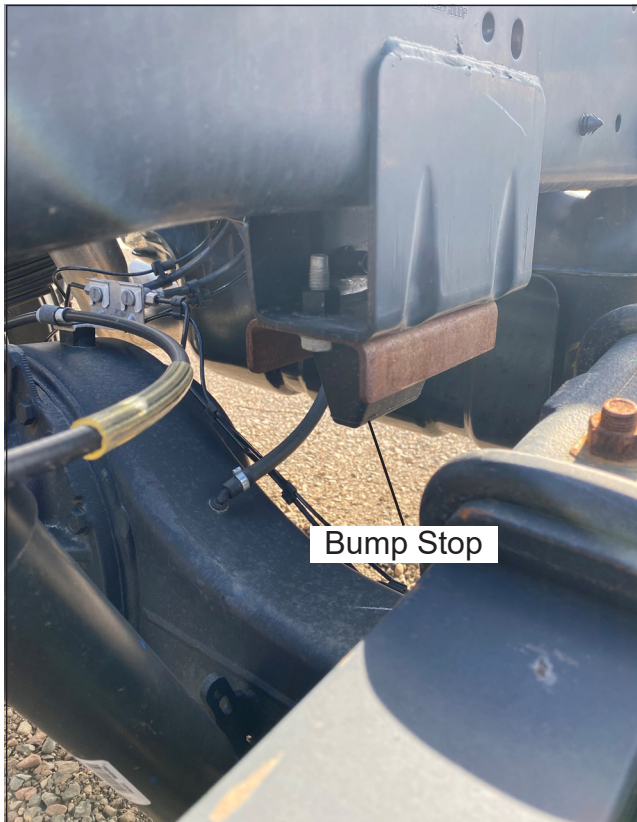
**Figure 5 — Dodge Rear Suspension**

3. Find the rear suspension bump stop located above the rear axle on the street side of the chassis (refer to Figure 5 for a Dodge chassis or Figure 6 for a Ford chassis).

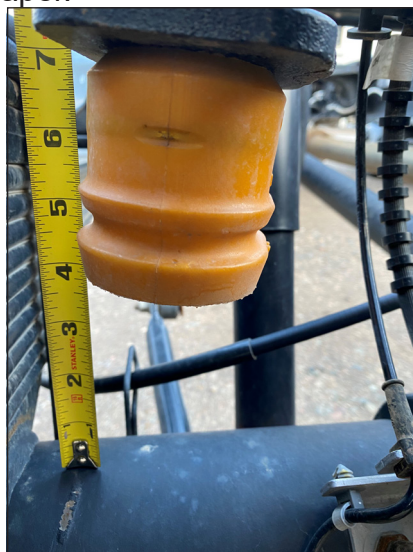
**Figure 7 — Measuring for Suspension Travel Number**

4. Measure the vertical distance from the top of the rear axle to the bottom of the bump stop on the street side of the chassis (refer to Figure 7). This is the suspension travel number. Enter this number in column A of the table in Figure 8 on a printed copy of this SIL or in a similar format on a piece of paper.

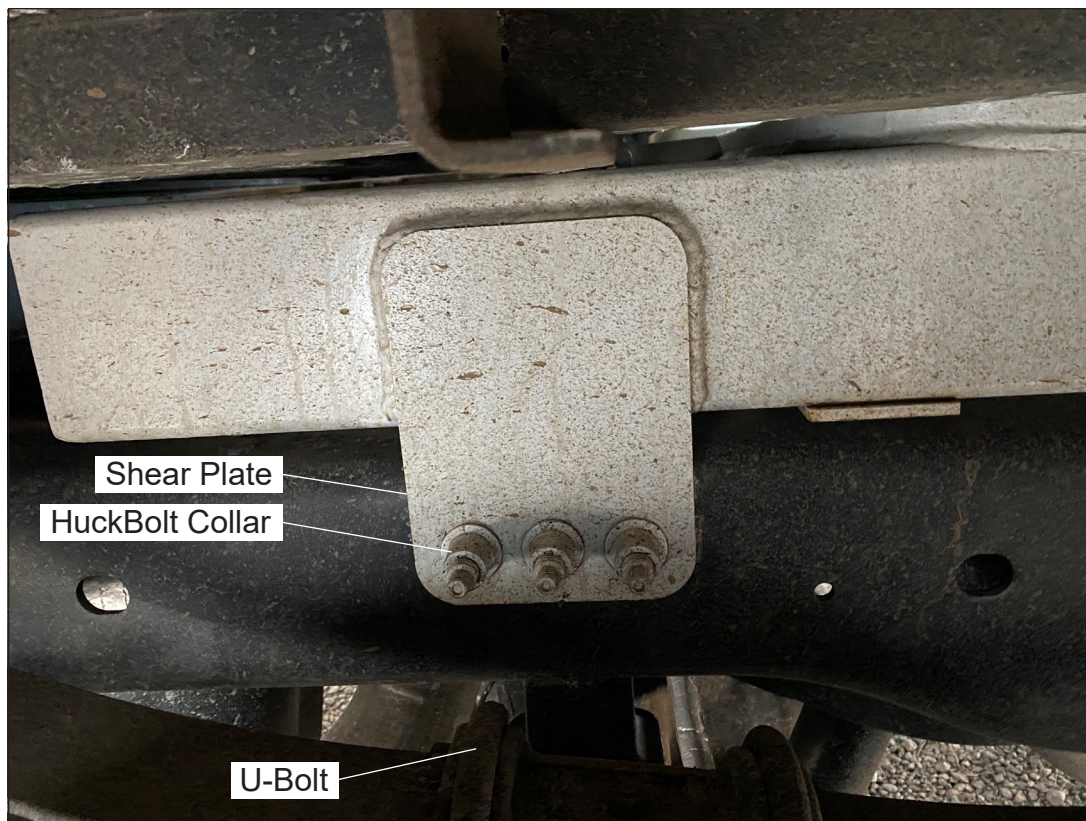
**Figure 9 — Identifying Shear Plate Bolt to Measure for Clearance**

5. Identify a HuckBolt collar or hex nut located above one of the rear suspension U-bolts on the street side of the chassis (refer to Figure 9). Measure the vertical distance from the top of the U-bolt to the bottom of the collar or hex nut (refer to Figure 10). Subtract  $\frac{1}{2}$ " as a safety factor to determine the U-bolt clearance number. Enter this number in column B of the table in Figure 8.
- For example, if the vertical distance measurement is 5", calculate  $5" - \frac{1}{2}" = 4\frac{1}{2}"$  for the U-bolt clearance number.

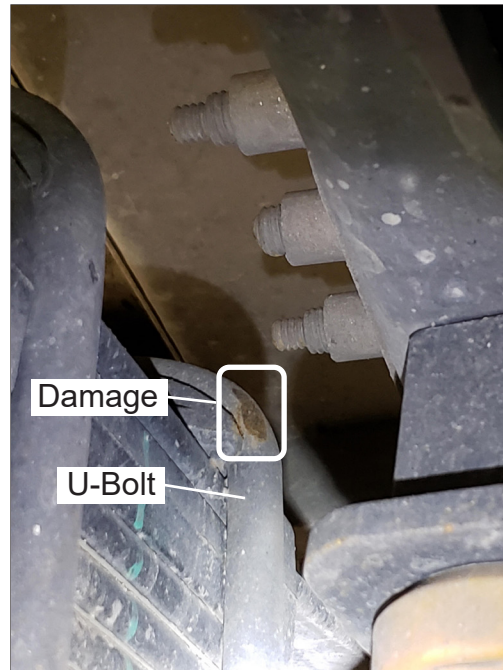
**Figure 11 — Inspecting U-Bolt for Damage**

8. Look at the top portion of a street side U-bolt that can potentially contact a shear plate bolt end, collar, or hex nut. Clean off any dirt or debris on the portion of the U-bolt below the shear plate bolt using an appropriate method, to ensure that any existing damage to the U-bolt will be visible. Using a flashlight, if necessary, inspect the U-bolt for damage due to contact with the shear plate bolt end, collar, or hex nut (refer to Figure 11). Repeat this inspection for the second street side U-bolt if it can also potentially contact a shear plate bolt end, collar, or hex nut.

9. Repeat step 8 for the curb side.
10. Proceed based on the inspection results.
  - If the clearance is adequate, no replacement kit(s) are required. Complete the Inspection Sheet at the end of this SIL and return it to Altec. Return the unit to service.
  - If the clearance is not adequate, take the unit out of service. Order and schedule the installation of the required replacement kit(s) based on the inspection results. Each kit contains parts for one side of the chassis. If parts are needed for both sides, two kits are required. Do not submit the Inspection Sheet at the end of this SIL.

- If no damage is found on any U-bolts, order only the HuckBolt replacement kit(s).
- If U-bolt damage is found on a Dodge chassis, order the HuckBolt replacement kit(s) plus the Dodge chassis U-Bolt replacement kit(s).
- If U-bolt damage is found on a Ford chassis, order the HuckBolt replacement kit(s) plus the Ford chassis U-Bolt replacement kit(s).
