## SIB 01 05 20

### N47T/N57T EGR COOLER: LTD WTY EXTENSION TO 10 YEARS WITHOUT MILEAGE LIMIT

2020-06-11

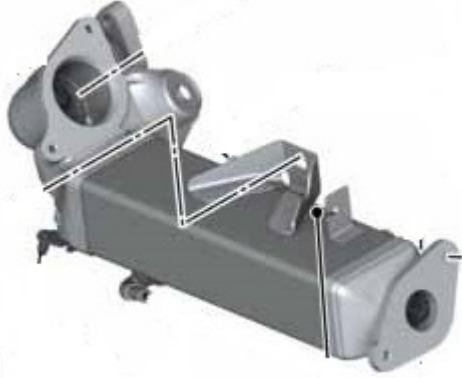
For the eligible vehicles, BMW of North America, LLC (BMW NA) is extending the limited warranty for the vehicle's **Exhaust Gas Recirculation (EGR) Cooler** (shown) to:

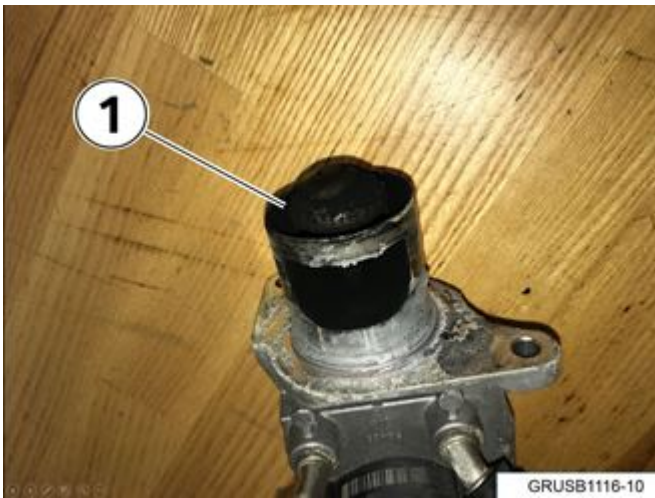
8. Remove the EGR valve and check for jamming (valve is normally sprung closed).  
**Is the EGR valve jammed or stuck open?**  
 YES- continue to step 10.  
 NO – go to Step 9.

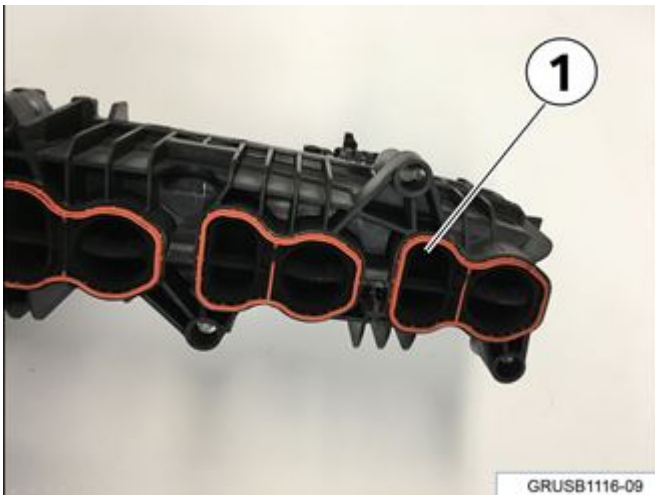
6. Check all swirl flaps for damage or melting/missing parts (1).
