Service Action

Code: 91Y3

Subject	MMI Software – System Privacy Mode															
Release Date	July 21, 2020															
REVISION SUMMARY	Criteria 04 instructions added.															
Affected Vehicles

Subject: Service Action 91Y3 - MMI Software – System Privacy Mode

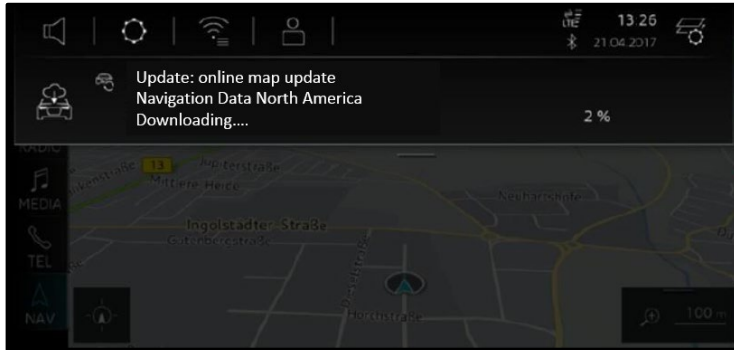
If the infotainment system happens to be in a navigation data download mode (“Downloading...,” as shown), please interrupt this by activating the slider for privacy mode (Home > Settings > Privacy settings > Activate privacy).

Please ensure that you deactivate privacy mode again after the software update is complete.

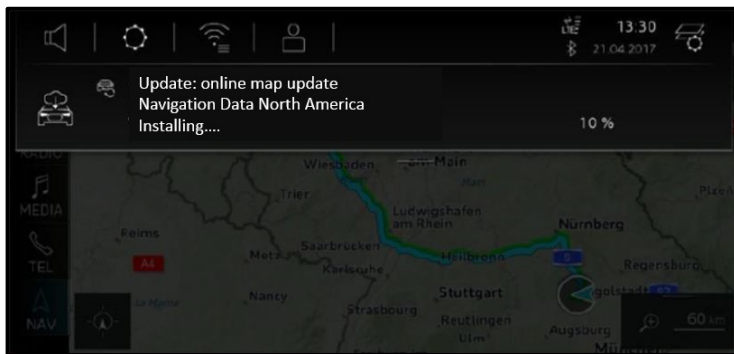
If the navigation database update is already being installed (“Installing...,” as shown), please wait and ensure that the installation is fully complete before continuing with the 91Y3 software update.

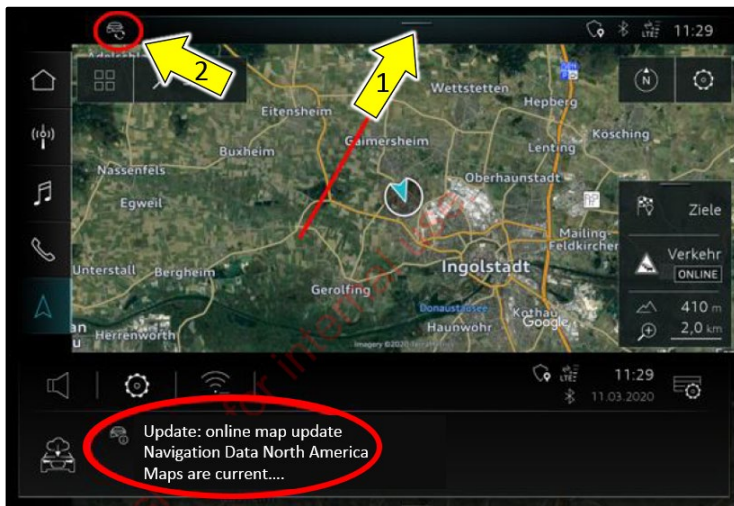
If a navigation database update is already complete, it is very important to confirm this manually in the notifications center of the MMI.

To do so, pull the notification center downwards <arrow 1> and confirm the completion (“Maps are current...,” as shown).

The 91Y3 software update can only be started when the icon at the top left <arrow 2> is no longer visible.
