Technical Service Bulletin

17 MIL on or noises from the crankcase breather, DTC P052E00 is stored in the ECM

17 20 07 2060033/1 July 21, 2020.

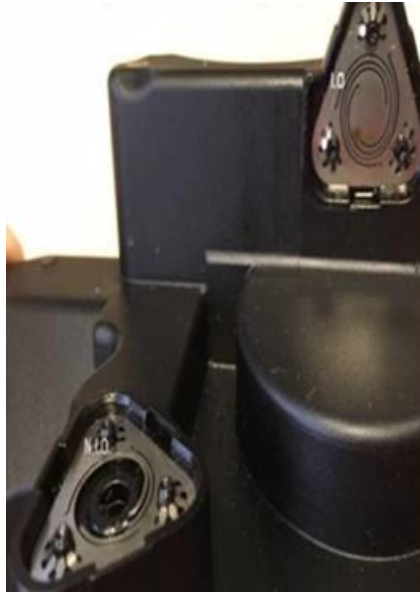
Figure 1. Metal plates.

Fuel additives can cause the membrane to crack.

1. Using the hand vacuum pump VAS 6213 check the membrane of the crankcase breather for leaks; a leak can mean a faulty membrane or elbow piece.
2. Remove the compressor/intake manifold and check the membrane for leaks directly on the crankcase breather. Remove the crankcase breather and check the two metal plates for damage (Figure 1).

If one plate is defective then always replace both (included in the pressure regulating valve repair kit).
