Subject: KNOCKING NOISE FROM REAR SUSPENSION WHILE DRIVING ON ROUGH ROAD	Bulletin No.: 02-005/20
	Last Issued: 07/22/2020

2016-2020 Mazda2 vehicles (Mexico spec) with VINS lower than 3MDDJ*****401991 (produced before Jan. 14, 2020)

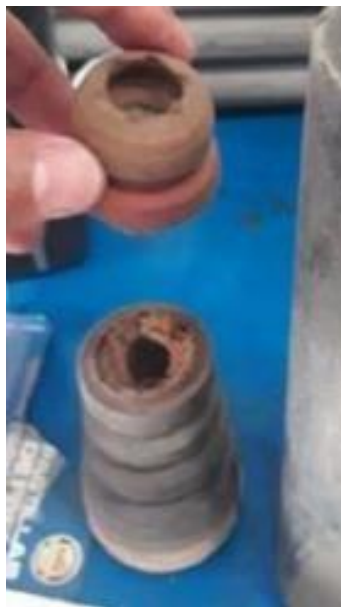
Some customers may complain about a knocking noise heard from the rear suspension while driving on rough road. The noise may be caused by a broken bound (bump) stopper that breaks because of deterioration from environmental factors and bad road conditions.
