<b>Subject:</b>  <b>FRONT DOOR GLASS DOES NOT OPERATE</b>	<b>Bulletin No.:</b> 09-025/20
	<b>Last Issued:</b> 07/28/2020

2014-2018 Mazda3 (Japan built) with VINS starting with JM1

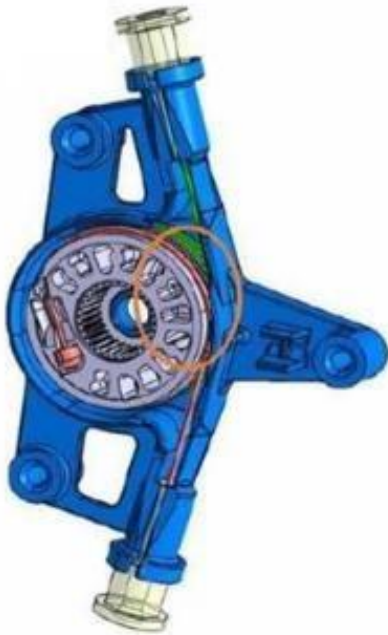
Some customer's may complain that the front power window(s) do not operate after the vehicle has been parked outside during freezing temperatures. This may be caused by water that infiltrates into the power window regulator and freezes in the drum groove for the cable. Then when the power window is operated, the cable slips out from the ice-filled groove and tangles, blocking further window operations.

1. Verify customer concern by checking to see if the cable is tangled inside the power window regulator.

- If the cable is tangled, replace the power window regulator with a modified one according to the instructions on MGSS.
  - 2014-2016 Mazda3 (FRONT POWER WINDOW REGULATOR REMOVAL/INSTALLATION)
  - 2017-2018 Mazda3 (FRONT POWER WINDOW REGULATOR REMOVAL/INSTALLATION)
- If the cable is not tangled, look for other sources of the power window operation failure.
