Subject: ELECTRICAL CONCERN AND/OR MULTIPLE DTC'S DUE TO AFTERMARKET DEVICE	M-Tips No.: MT-001/20
	Last Issued: 07/15/2020

APPLICABLE MODEL(S)/VINS

2011-2014 Mazda2	2007-2020 Mazda6	2007-2012 CX-7	2007-2011 RX-8
2007-2020 Mazda3	2016-2020 CX-3	2007-2020 CX-9	2020 CX-30
2007-2015 Mazda5	2013-2020 CX-5	2007-2020 MX-5

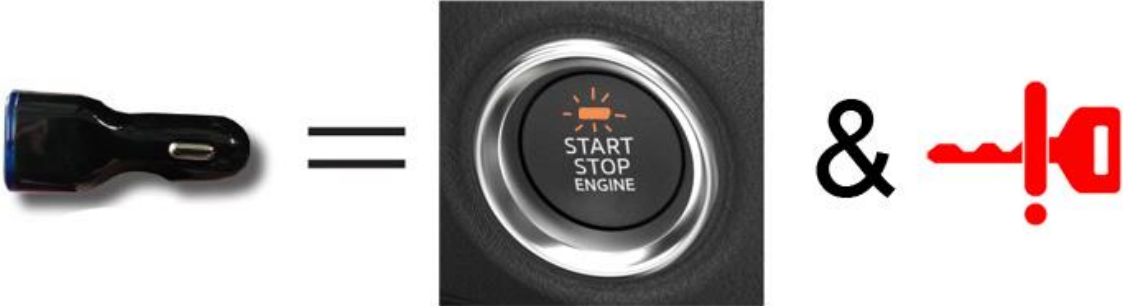
Aftermarket Cell Phone Charger connected to 12V outlet	Engine Start/Stop Button Amber Indicator Light Flashing	Key Warning Light (red)

If you determine that no aftermarket devices have been installed, continue with normal Workshop Manual diagnosis.

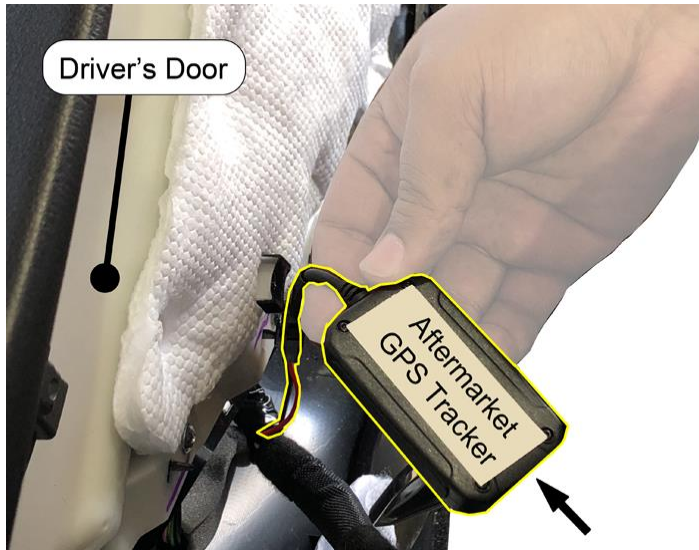
Some aftermarket devices that are wired to the vehicles’s wiring harness may create unusual electrical symptoms and/or store DTCs.

Below are examples of concerns due to an aftermarket GPS tracking device wired to the power window main switch:

- Engine no start
- Battery discharge
- Main relay buzzing

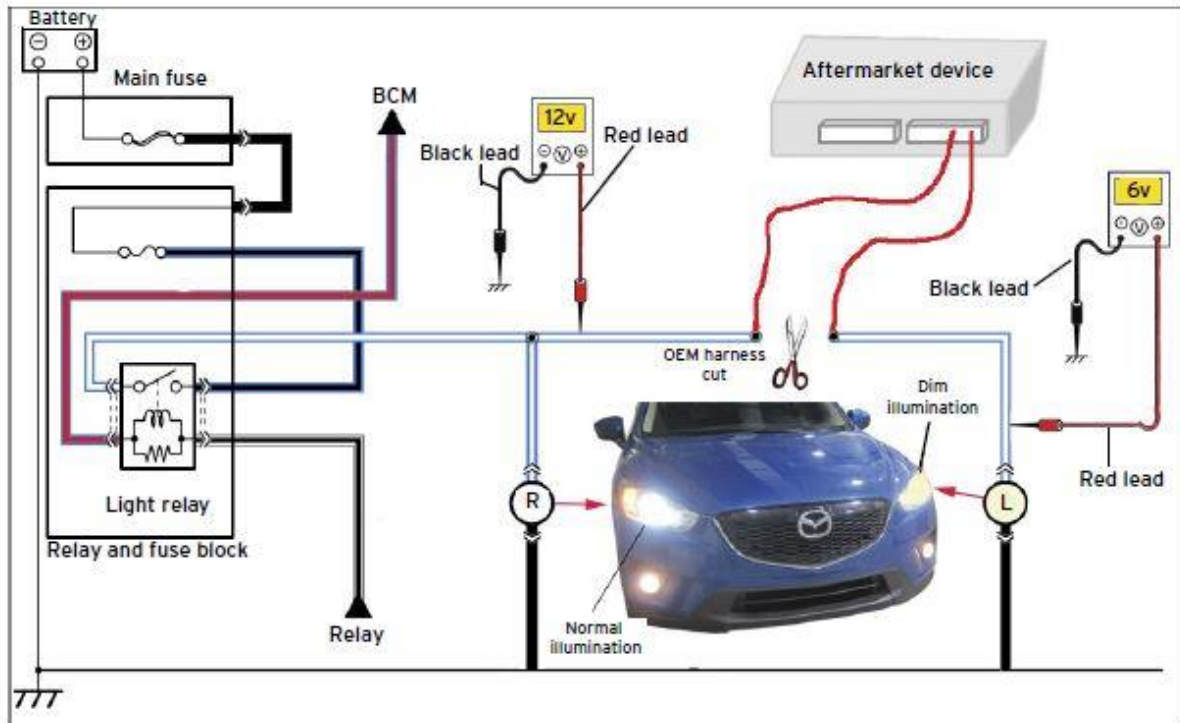
Below is an example of a dim headlight. The aftermarket device changed the headlight circuit resistance, causing a dim headlight.
