Technical Service Bulletin

40 Noises from the front suspension's buffer stops

40 20 13 2059474/2 July 20, 2020. Supersedes Technical Service Bulletin Group 40 number 20-06 dated May 13, 2020 for reasons listed below.

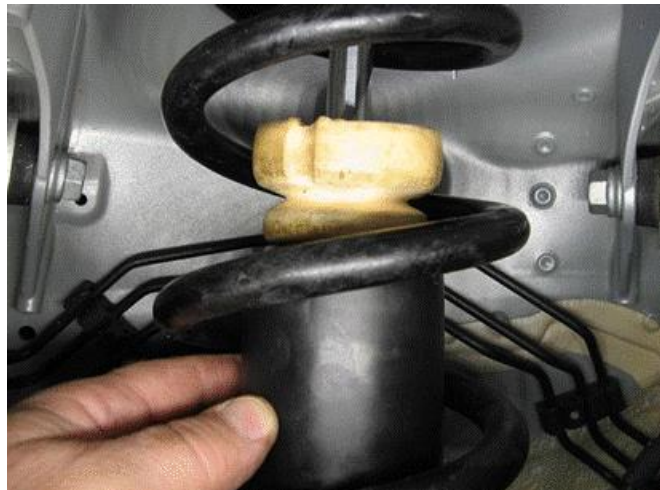
- The buffer stops of the shock absorbers are identified as the source of the noise, because they do not sit correctly in the shock absorber mounting (Figure 1).

Figure 1. The shock absorbers are sitting incorrectly.

With the new improvements in suspension design, the material in the buffer stop changed to increased hardness. As a result, it has become harder to press them into the mountings.

1. Secure the buffer stops correctly. A tire assembly paste can be used as an aid. The buffer stops must be completely pressed in.
2. If the buffer stops were deformed during the vehicle transport, try to shape them correctly by warming them up slightly. If this is not possible, replace the affected components.
