Technical Service Bulletin

91 MIB2 High Navigation Software Update Instructions (PR Code 7UG)

91 20 89 2047576/4 July 24, 2020. Supersedes Technical Service Bulletin Group 91 number 19-98 dated October 4, 2019 for reasons listed below.

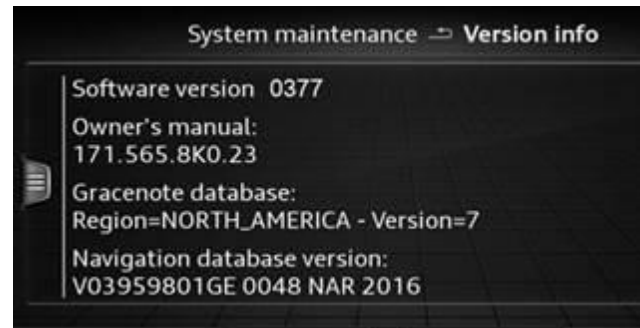
1. To save time, always verify the customer's MMI requires the software update before proceeding. In the MMI, go to *Menu >> Settings >> Left drawer option >> Version Information* (Figure 1). This applies to models using the new MIB2 user interface. The C7 PA uses the old user interface similar to MMI3G+ along with the newer MIB2 hardware. The software version for the older user interface is found under *Menu >> Setup MMI >> Version Information*.

Figure 1. MIB2 Software Version in MMI with a new UI.
