# Technical Service Bulletin

## 97 Corroded splices found under the driver's carpet - Repair Authorization

97 20 77 2060250/1 July 22, 2020.

Model(s)	Year	VIN Range	Vehicle-Specific Equipment
Q7	2017 - 2021	All	Not Applicable
Q8	2019 - 2021	All	Not Applicable
Q5, SQ5	2018 - 2021	All	Not Applicable
SQ7, SQ8	2020 - 2021	All	Not Applicable

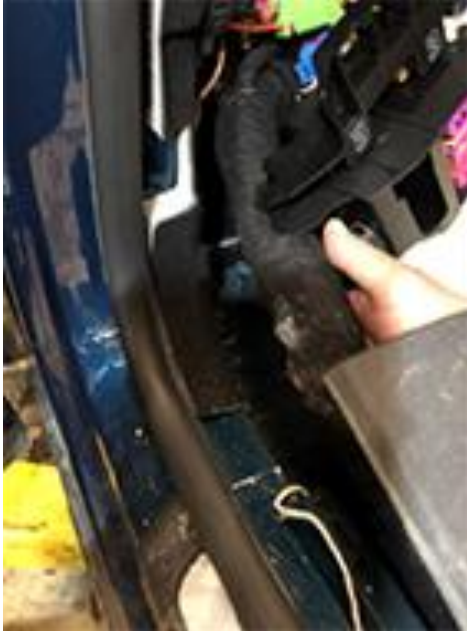
**Figure 1.** Perspective showing the location of the splice.

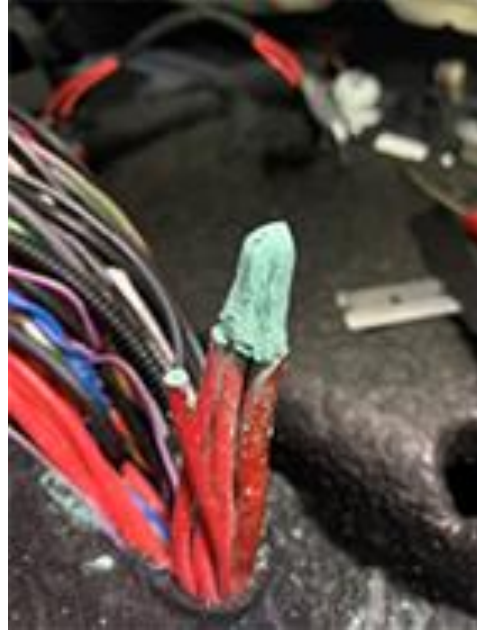
**Figure 2.** Close up of the wire color and damage.
