| REFERENCE: | Nova Bus Manuals |
| SECTION: | 09: Engine cooling system |
| RS N°: | MQR 7621-1960 |

| SUBJECT: | Charge air cooler (CAC) pipings |

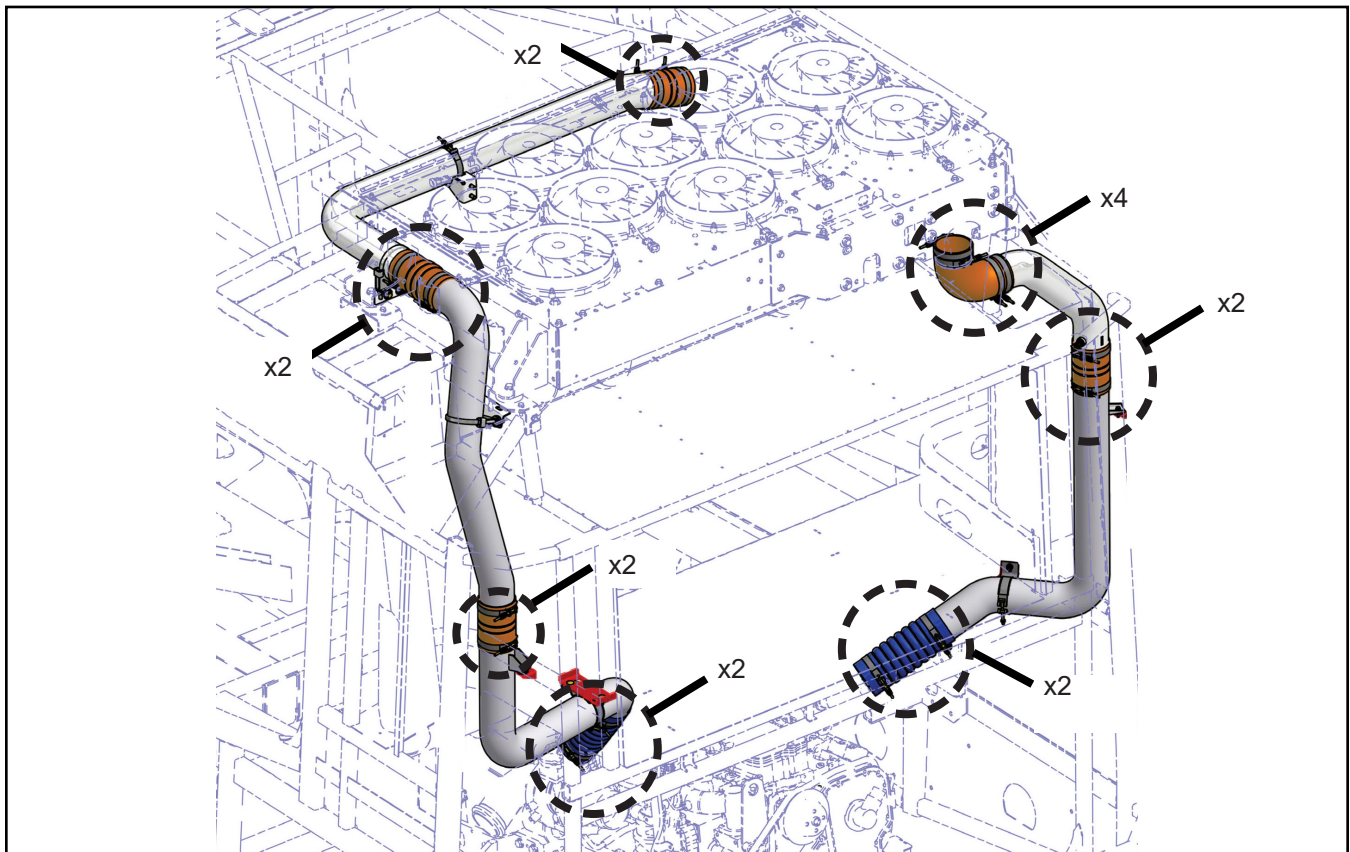
Figure 1 - CAC pipes Clamp Locations

| JUSTIFICATION: | Improved sealing of the joints of the charge air cooler piping. |

- 1.4. Remove a clamp.
- 1.5. Clean the surface of the silicone hose where the new clamp will be installed.
- 1.6. Apply a lubricant such as P-80, N74253, between the new clamp and the pipe. This will prevent the clamp from gripping the hose when tightening and applying the torque properly.

- 1.7. Orient the new clamp to facilitate maintenance and tighten it as close as possible to the raised bead. Apply a torque of $13.5 \pm 2 \text{ N}\cdot\text{m}$ ($10 \pm 1.5 \text{ lb}\cdot\text{ft}$).

- 1.8. Repeat for all clamps shown in Figure 1, for a total of 16 clamps.
- 1.9. Start the vehicle and let it run at fast-idle for 15 minutes.
- 1.10. Apply the tightening torque of $13.5 \pm 2 \text{ N}\cdot\text{m}$ ($10 \pm 1.5 \text{ lb}\cdot\text{ft}$) again.
