Technical product information

Topic	Bullseye air outlets - chrome finisher detached
Market area	Bentley: worldwide (2WBE),Hongkong-Macau (5HK)
Brand	Bentley
Transaction No.	2054084/2
Level	EH
Status	Released for publishing
Release date	02-Jul-2020

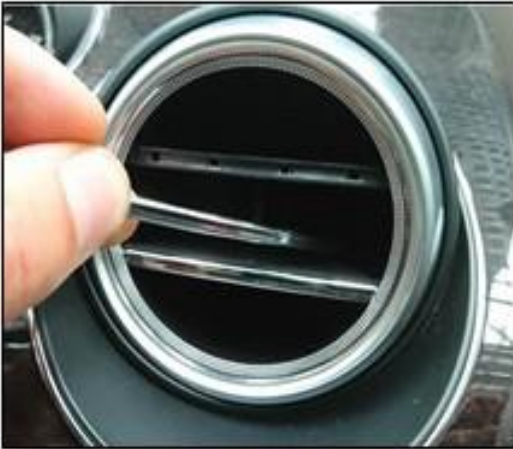
Air vent chrome finisher has detached from vane.

It is possible that using aftermarket clip on devices such as mobile phone holders, air freshener holders or chewing gum dispensers may result in the chrome air vent finisher becoming detached from the vane.
