Technical product information

Topic	Clicking noises from front corner(s)
Market area	Bentley: worldwide (2WBE),Hongkong-Macau (5HK)
Brand	Bentley
Transaction No.	2052853/6
Level	EH
Status	Released for publishing
Release date	02-Jul-2020

Clicking noise from front corner(s)

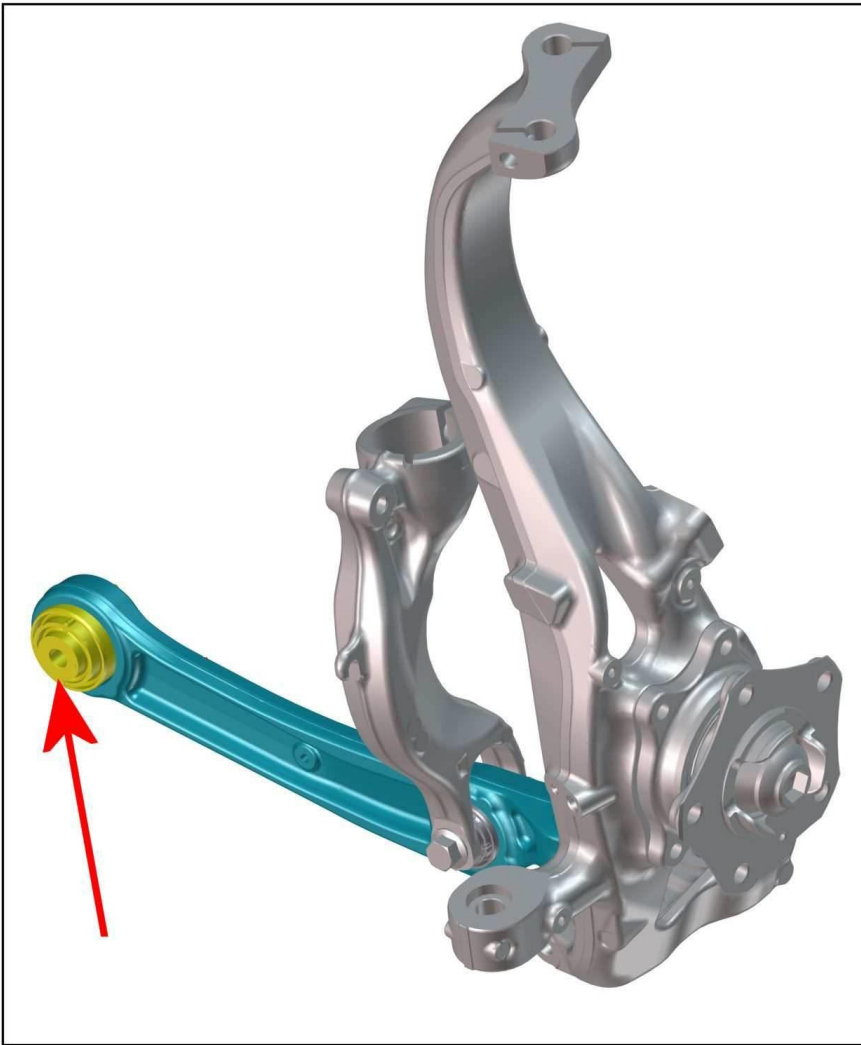
Figure 1

Symptom 1 - Single click from the front wheel corner(s) when the steering is moved from lock to lock whilst stationary

- If so then replace both front lower inner control arm bushes (Figure 1)

IMPORTANT: Please check the vehicle Repair History to confirm the inner bushes have not been previously replaced, if they have been replaced once before, You must then replace the complete arm, Do Not carry out the bush replacement procedure more than once (per lever)

IMPORTANT: Prior to starting this procedure ensure you have assembly lubricant part number G052566A2 this must be used when fitting the new replacement bushes, the lubricant should only be used when the bushes are replaced as per the instructions within TPI 2052853/-

Each bush should have 5ml of lubricant applied prior to fitment within the bush, the grease should remain present throughout the fitting/pressing in procedure as the grease aids the fitting process and is also crucial once fitted to eliminate any further noise issues *Please Note that x1 – 100 ml tube will be sufficient for use on 20 bushes (10 vehicles) – Do not order x1 tube of lubricant per each individual vehicle complaint*
