TSB Number:	TSB 01-004-20B
Product:	Thule® Regal Awning
Date:	June 19, 2020

NOTE: This bulletin supersedes TSB 01-004-20 dated April 17, 2020, which should be removed from your files.

This document outlines the inspection (and correction) of Thule Regal Awnings to determine if there is too much gap between the roll tube and end plates, which could cause the fabric to extend over the edge or the roll tube could shift along the axle plane.

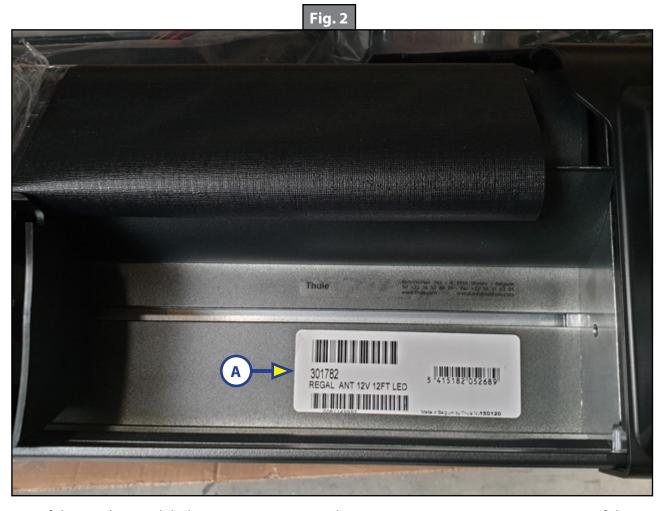
- **1.** Open the awning at least three feet.
- 2. Check for the production label (Fig. 2A) near the left hand end cap, inside the lead rail profile.

NOTE: If the production label is not present, go to the Screw Inspection section on page 4. If the production label is present and dated (DD/MM/YY) prior to February 2020, skip to the Tolerance Inspection on page 5. If the production label is present and dated (DD/MM/YY) February 2020 or later, no further action is needed.

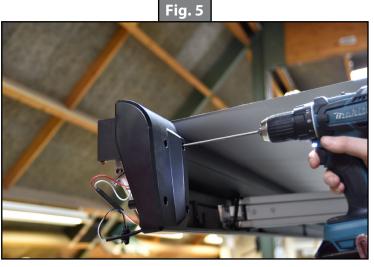
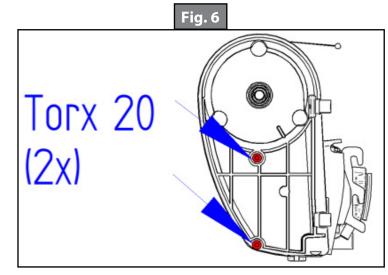
- **5.** Remove the three 3mm hex fasteners (Fig. 5) securing the rear end cap with appropriate bit.
- **6.** Verify the presence of the two 20mm torx fasteners (Fig. 6) on the awning end plate.

7. Repeat steps 2 through 6 for the other end cap. Retain all hardware for re-installation. If the fasteners are present on the awning ends, go to the Tolerance Inspection section on page 5. If the fasteners are not present, install the two 20mm torx fasteners provided.

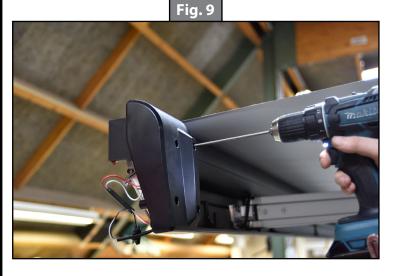
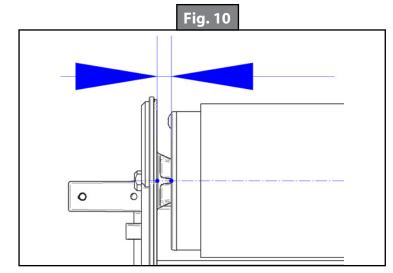
- **4.** Set front end cap (Fig. 8A) aside for re-installation.
- **5.** Repeat steps 1 through 4 for the other end cap. Retain hardware for re-installation.
- **6.** Using a micrometer measure the gap between the awning roll tube and end plates on both the right and left sides (Fig. 10).
- **7.** Add the two measurements and see Tolerance Inspection Table on page 6 for measurement specifics.

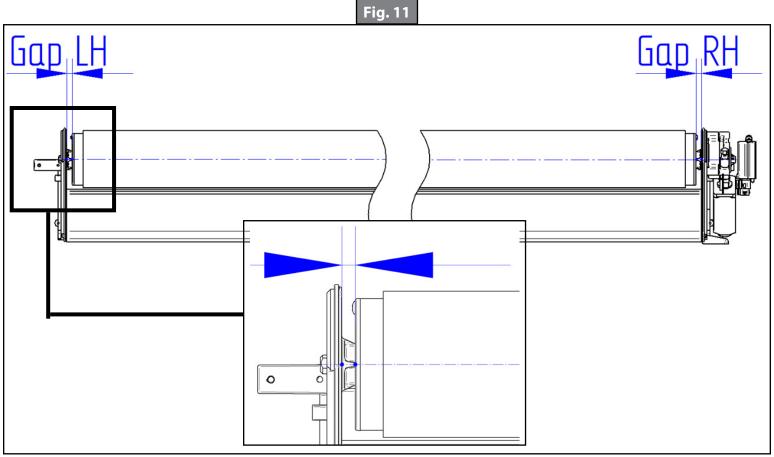
- **1.** Measure the gap on the left and right sides (Fig. 11).
 - Measure at the axle centerline height.
 - The minimum is always 8mm (0.3150")

Gap sum (mm)	Gap sum (")	Action
16mm - 17mm	0.6299" - 0.6693"	No action
17.1mm - 18mm	0.6732" - 0.7087"	Add 1 washer (*)
18.1mm - 19mm	0.7126" - 0.7480"	Add 2 washers (*)
19.1mm - 20mm	0.7520" - 0.7874"	Add 3 washers (*)
20.1mm - 21mm	0.7913" - 0.8268"	Add 4 washers (*)
21.1mm - 22mm	0.8307" - 0.8661"	Add 5 washers (*)
(*) DIN988 A2 (16mm x 22mm x 1mm)
