# Technical product information

<b>Topic</b>	Bentley Dynamic ride system fault within the DIP - DTC C129600 logged
<b>Market area</b>	Bentley: worldwide (2WBE),Hongkong-Macau (5HK)
<b>Brand</b>	Bentley
<b>Transaction No.</b>	2054300/2
<b>Level</b>	EH
<b>Status</b>	Released for publishing
<b>Release date</b>	03-Jul-2020

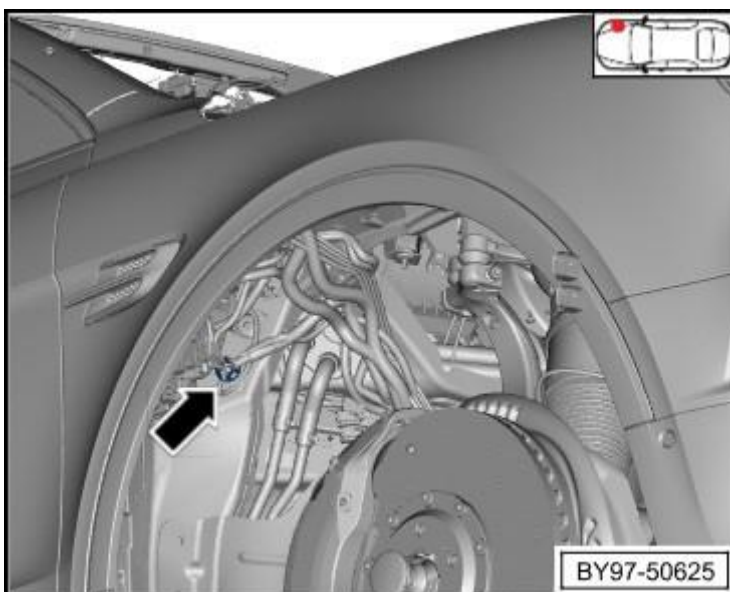
Should the symptoms be evident as described, refer to the Measure section of this TPI, ensure both of the suggested earth points are checked regardless if the DTC is logged in the front or rear anti roll bar control unit

- Remove the right hand front wheel arch liner - Refer to Repair manual Rep. Gr 66
- Referring Figure 2 and Repair manual wiring diagrams locate earth point number 13

3) With care - Remove the earth point fixing - Carry out the following checks

- Check for any paint/dirt residue on the actual earth point - Use suitable abrasive material to remove any paint or dirt

- Check the earth cable terminal to ensure it is free from paint or dirt - Use suitable abrasive material to remove any paint or dirt
- Refit the earth cable terminal and fixing nut
- Torque the earth point fixing nut to 9 Nm

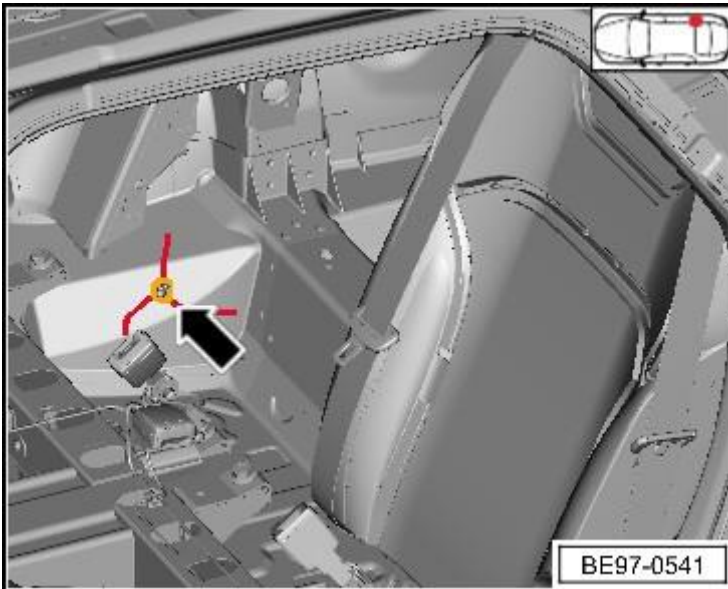
IMPORTANT: Figure 3 shows the earth point (730) on 4/5 seat specification vehicles -Figure 4 shows the earth point location (53) for 7 seat specification vehicles

- **4 and 5 seat variants** - Referring Figure 3 and the Repair manual wiring diagrams locate earth point number 730

5) With care - Remove the earth point fixing - Carry out the following checks

- Check for any paint/dirt residue on the actual earth point - Use suitable abrasive material to remove any paint or dirt
- Check all earth cable terminals to ensure they are free from paint or dirt - Use suitable abrasive material to remove any paint or dirt
- Refit the earth cable terminals and fixing nut
- Torque the earth point fixing nut to 3Nm + 45°
- Erase DTC C129600 using a suitable diagnostic tool
- Carry out a short road test

6) Confirm the DTC is no longer evident NOTE: Raise a DISS query if DTC C129600 is still evident

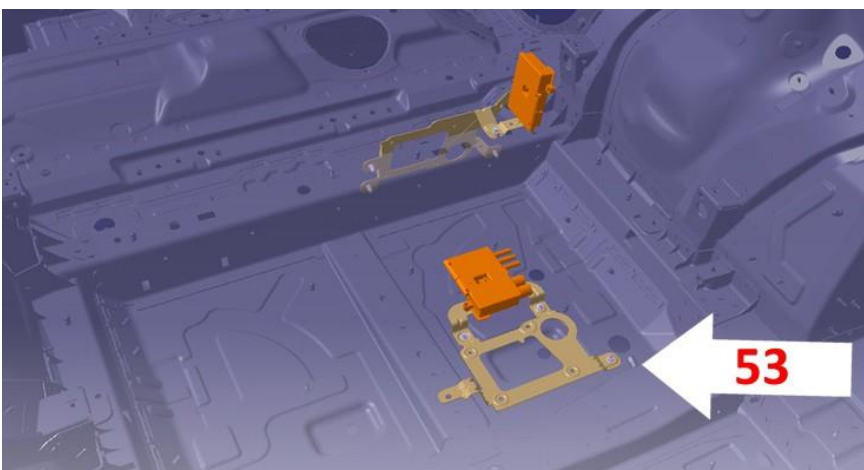
- **7 seat variants** - Referring Figure 4 - Locate earth point number 53 (Situated to the right hand side of the rear floor panel) to gain access remove the rear bench assembly - 3rd row - Refer to Repair manual Rep.Gr 72 Rear bench seat assembly - 3rd row (7 seat) - to remove and fi
