# Technical product information

<b>Topic</b>	Bentayga - Engine Cooling System - DTC P218100
<b>Market area</b>	Bentley: worldwide (2WBE)
<b>Brand</b>	Bentley
<b>Transaction No.</b>	2060205/1
<b>Level</b>	EH
<b>Status</b>	Approval
<b>Release date</b>

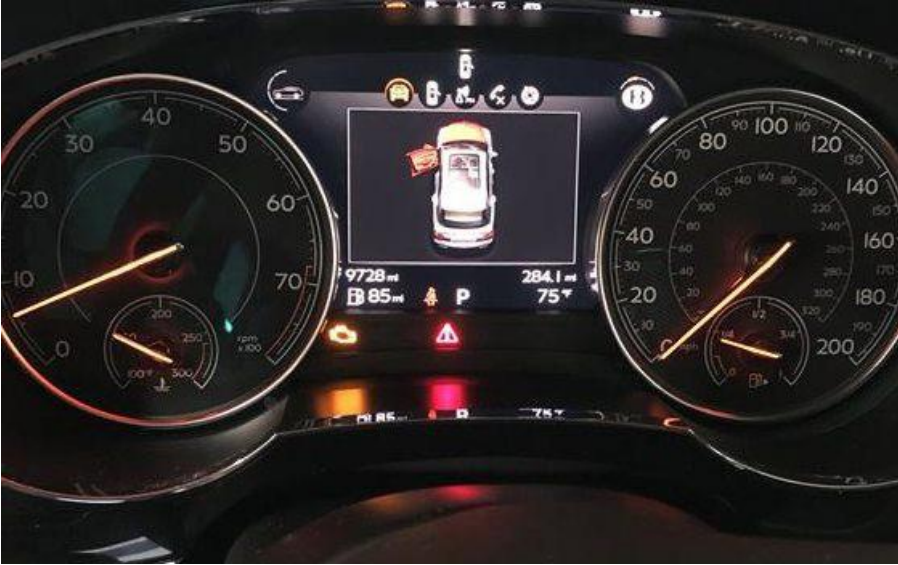
Emission Control Lamp illuminated on Driver Instrument Panel. The time to reach the correct engine coolant operating temperature has increased.

Diagnostic Trouble Code (DTC) 'P218100 - Cooling System Performance' is stored in the Engine Control Module (ECM), the vehicle "warm up" time is longer when compared to other vehicles of the same type.

It is possible for the engine coolant Thermostat to corrode overtime, this corrosion is due to an adverse reaction of the Thermostat material with the engine coolant.

The corrosion and subsequent build-up of debris prevents the correct operation of the thermostat when closing, resulting in over cooling. The ECM triggers a DTC when the target engine temperature is outside of the specified parameter.

With a confirmed Customer complaint of MIL activation, accompanied with DTC 'P218100, Cooling System Performance' proceed to replace the engine coolant thermostat, refer to 19 – Engine cooling – Coolant regulator (Thermostat insert) (V8 biturbo) – To remove and fit. Once completed, retest the vehicle to ensure correct functionality.
