Technical product information

Topic	Unable to run basic settings within the Adaptive suspension control unit (J775)
Market area	Bentley: worldwide (2WBE),Hongkong-Macau (5HK)
Brand	Bentley
Transaction No.	2055693/2
Level	EH
Status	Released for publishing
Release date	03-Jul-2020

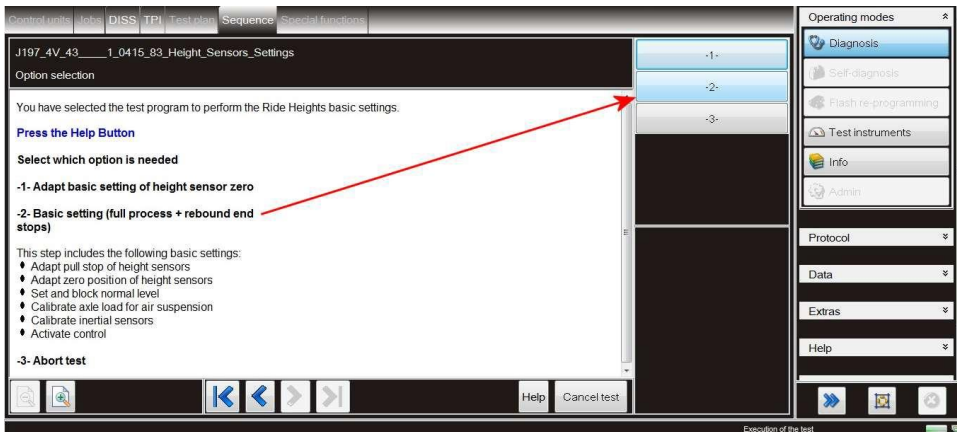
Figure 1

Referring to Figure 1, During the Basic setting (full process + rebound end stops) the routine can stop during the initial part of the procedure, in particular at the stage shown in Figure 2, which is when the vehicle is raised to allow all four wheels to hang down to their full rebound position

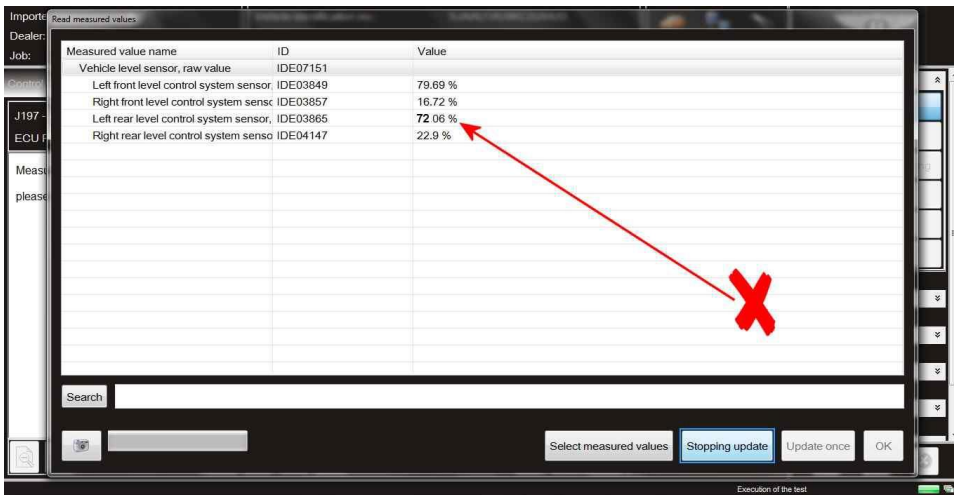
- Compare the sensor measured results in Figure 4 against the correct tolerance bands shown in Figure 5
- Within the example shown, the left hand rear level control sensor is not in tolerance as the value is 72.06%

- 2) When prompted search for IDE 07151 –
- When IDE07151 is located - Select - Starting update
- Monitor the measured value results for each level control sensor (Figure 4)

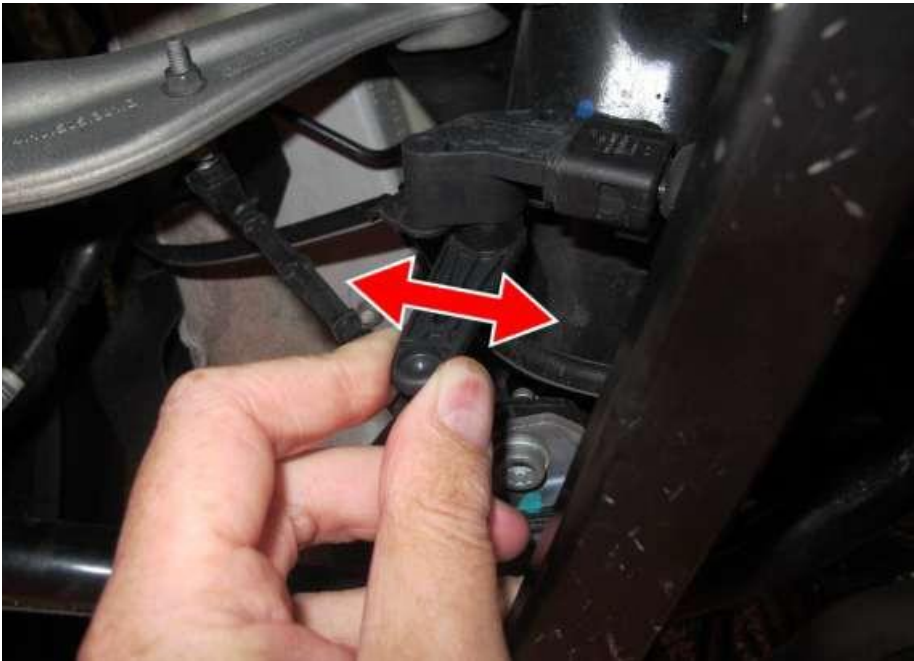
NOTE: For photographic purposes only the left hand rear sensor is shown in Figure 6

- Manually adjust the out of range level sensor by moving the sensor connecting arm whilst monitoring the values until the value falls within the specified tolerance band

Referring to Figure 6, The correct tolerance should be achieved by moving the sensor arm (by hand within the parts natural limits of movement) in the required direction until the tolerance band is within specification NOTE: The tolerance can be achieved by using the recommended method

⚠ DO NOT ATTEMPT TO ADJUST THE TOLERANCE BAND OF THE LEVEL SENSORS BY PRYING, BENDING OR MANIPULATING THE SENSOR RODS BY THE USE OF FORCE
