Technical product information

Topic	Warning lamp for washer fluid level on (for no reason)
Market area	Bentley: worldwide (2WBE),Hongkong-Macau (5HK)
Brand	Bentley
Transaction No.	2057935/2
Level	EH
Status	Released for publishing
Release date	03-Jul-2020

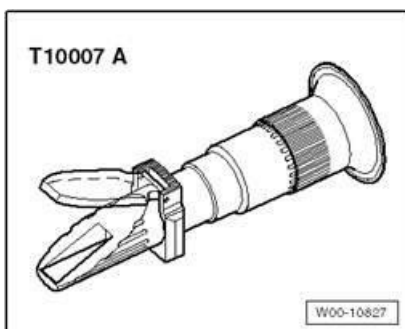
- Refractometer -T10007 A-

If possible, clean the electrodes of the water level switch with the cleaning solution D009401 04

Check the freeze protection of the liquid and the washer fluid level and fill in the liquid:

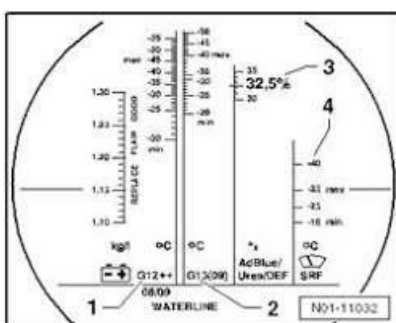
- Put a drop of washer fluid with the pipette on the glass of the refractometer -T10007 A-. With the refractometer a light-dark border can be clearly recognised.
 - Determine the freeze protection of the washer fluid with the scale. To do this read the value on the light-dark border.
 - The scale -4- of the refractometer refers to the concentrated washer fluid percentage

- The freeze protection value of the washer fluid must be adjusted to the expected weather conditions.
