# SERVICE BULLETIN

Classification: AT20-004a	Reference: NTB20-038a	Date: July 28, 2020
------------------------------	--------------------------	------------------------

## 2020 TITAN AND TITAN XD; DTC P288B STORED IN THE TCM

**APPLIED VEHICLES:** 2020 Titan and Titan XD (A61)  
**APPLIED DATE:** Vehicles built before January 28, 2020

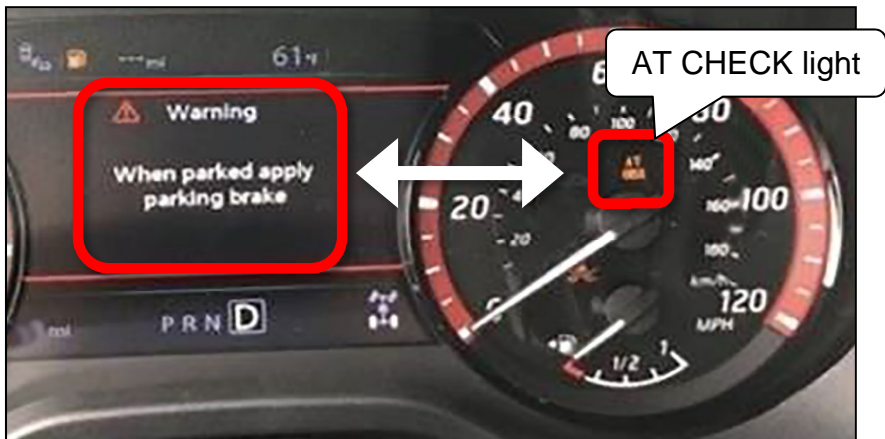
DTC P288B (PARK LOCK SOLENOID) is stored in the transmission control module (TCM).

- The warnings shown in Figure 1 turned ON in the vehicle information display and speedometer.

- Two attempts were required to shift out of Park.

1. Confirm the current TCM part number.
2. Reprogram the TCM, if applicable.
