# SERVICE BULLETIN

Classification: EL20-020a	Reference: NTB20-046a	Date: July 29, 2020
------------------------------	--------------------------	------------------------

## VOLUME KNOB DOES NOT FUNCTION PROPERLY

**APPLIED VEHICLES:** 2019-2020 Altima (L34)  
2019-2020 Murano (Z52)

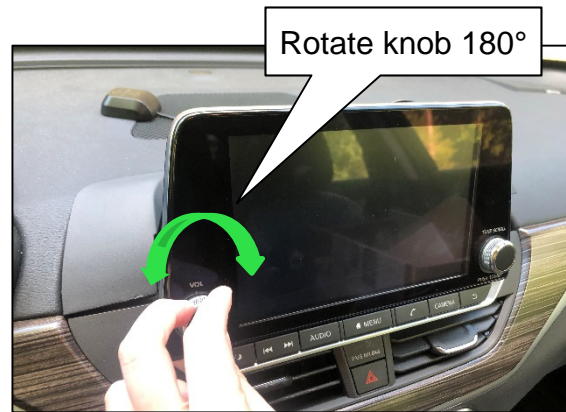
Figure 2  
(Altima shown, Murano is similar)

The customer states the speaker volume does not change or changes erratically when rotating the volume knob.

**NOTE:** To ensure a successful repair, steps 2, 3, and 4 **MUST** be performed to remove contaminate build-up on the full 360° radius of the electrical components internal to the volume knob.

1. Turn the audio and the ignition OFF.
2. Rotate the volume knob clockwise and counterclockwise approximately 180° as rapidly as possible for 30 seconds (Figure 2).
3. Rotate the volume knob 180° from its current position to remove the contaminate from the opposite side of the electrical component internal to the volume knob.
4. Rotate the volume knob clockwise and counterclockwise as rapidly as possible for another 30 seconds.
