CAMPAIGN BULLETIN

Fuel Filler Door Bumper Dealer Inventory

Reference: PM948

PM948 – 2020 SENTRA FUEL FILLER DOOR BUMPER

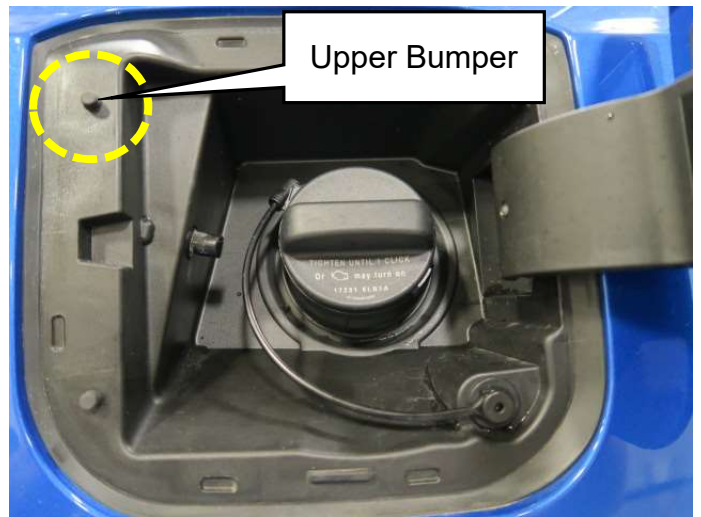
Figure 4

3. Locate the upper fuel door bumper (Figure 4).
