### Fuel Feed Tube Clip Dealer Inventory

Reference: PM957

Date: July 10, 2020

# PM957 2020 SENTRA FUEL FEED TUBE CLIP INSPECTION

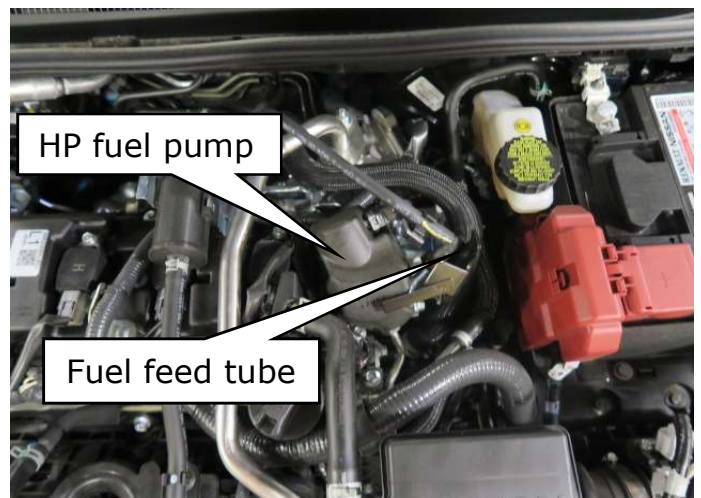
Figure 2

2. Locate the fuel feed tube. (Figure 2)
  - Fuel feed tube connects to the high pressure fuel pump.

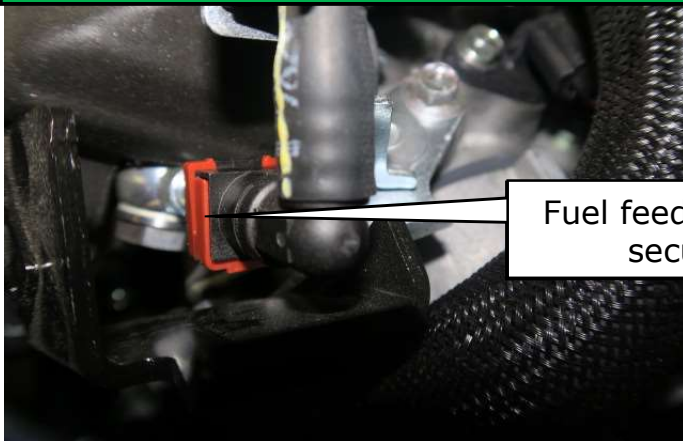
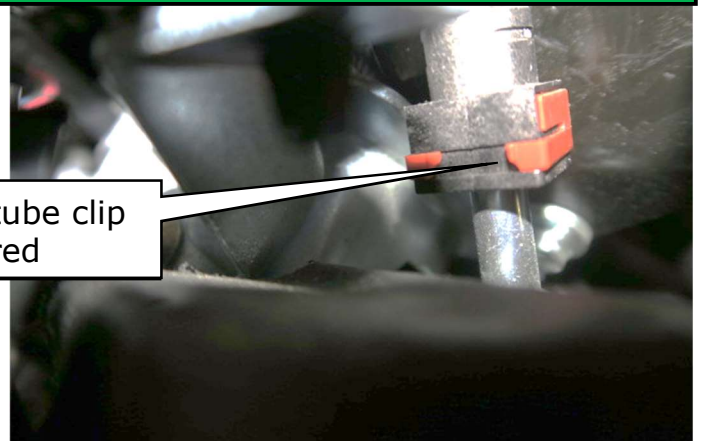
- Verify the fuel feed tube clip is properly secured as shown in Figure 3 and Figure 4

Fuel feed tube clip secured

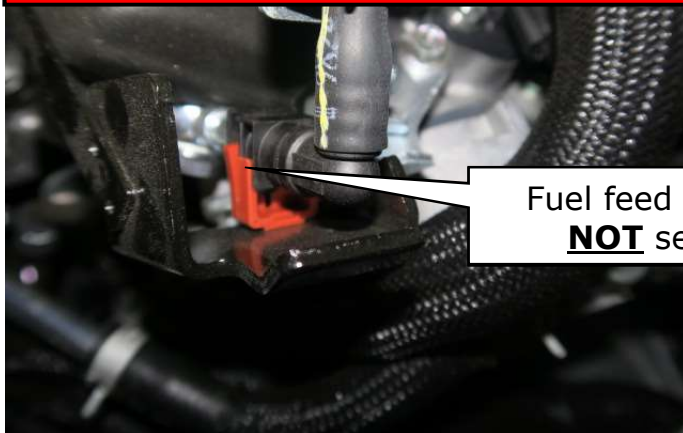
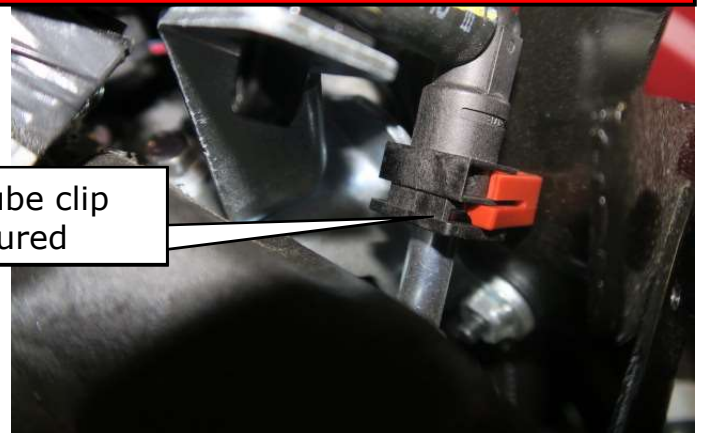
Nissan is conducting a dealer inventory quality action to inspect the fuel feed tube clip and, if necessary, secure it to the fuel line on **9,667** specific 2020 Sentra vehicles identified in Service Comm. Due to a production issue, a small number of fuel line clips may not have been properly set on the high-pressure fuel line and may need to be secured as a result. If the fuel feed tube clip is missing, or damaged, the fuel line will need to be replaced.

Fuel feed tube clip **NOT** secured

- Dealers must use the attached procedure to inspect and, if necessary, secure the fuel tube clip prior to retail delivery of the vehicle.
  - If the fuel feed tube clip is damaged or missing, dealers should replace the fuel line as per the instructions in the Electronic Service Manual (ESM).

4. Secure the fuel feed tube clip by pushing clip until a “click” sound is heard.

- Check that the clip is secured as shown above in Figure 3 and Figure 4
- End of inspection
- See Claims information on page 3
