Bulletin No.: PIP5528E

PIP5528E Information Assistance for HFV6 Re-Manufactured Engine Drivability Diagnosis Immediately Following Installation

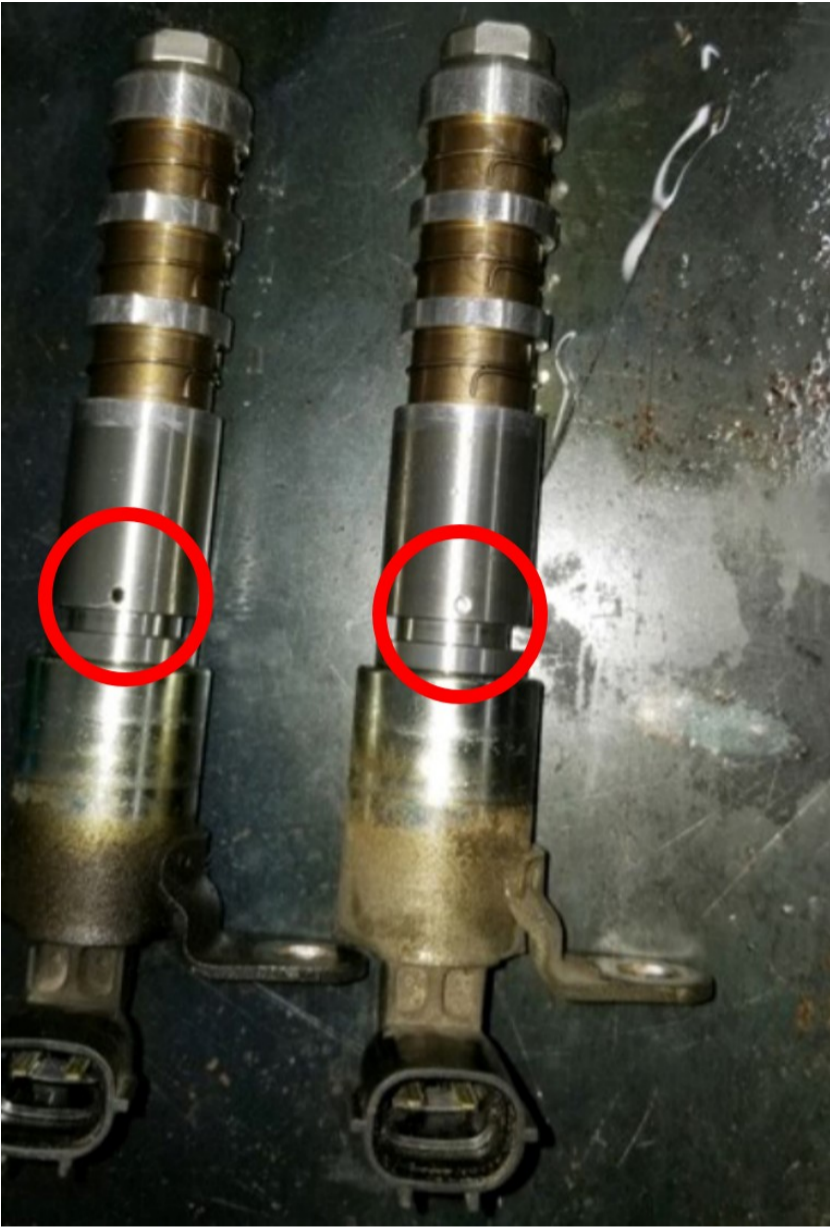
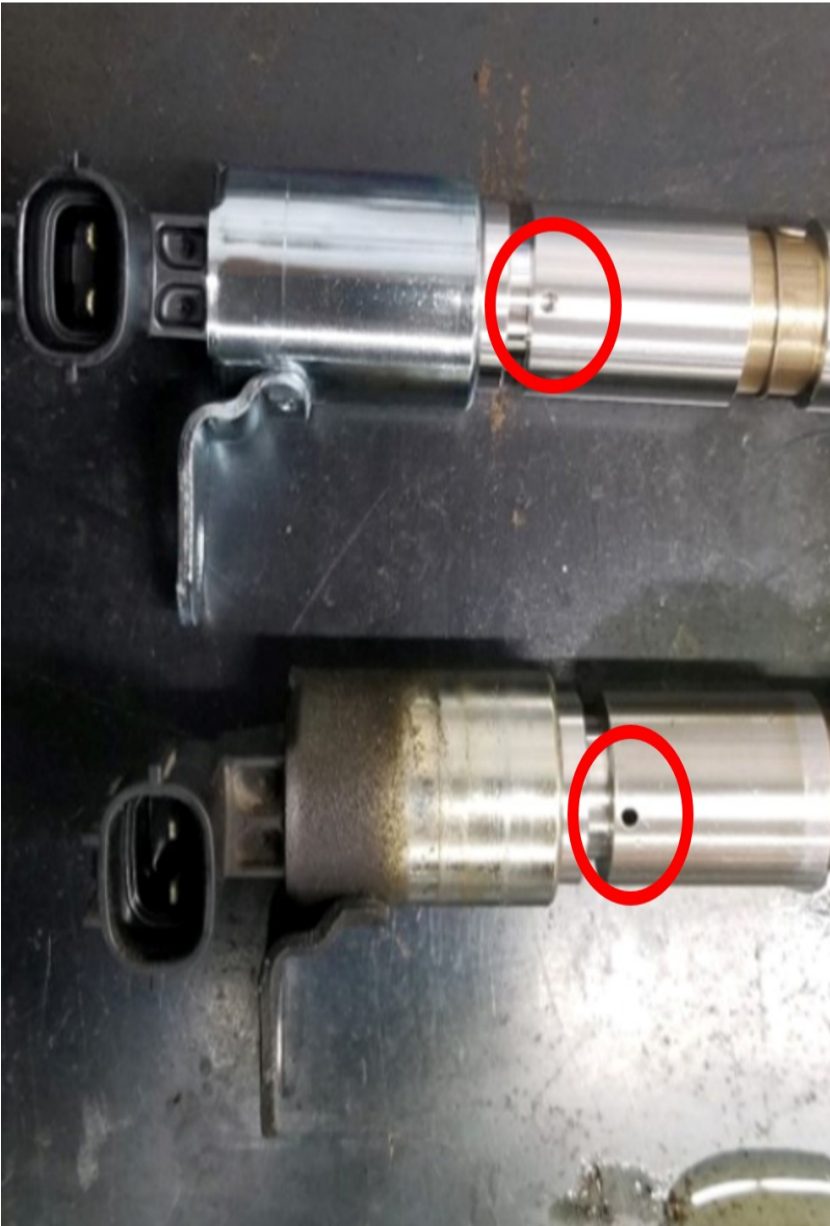
Comparison of good vs bad Camshaft Actuator Solenoids.

Involved Region or Country	North America
Condition	Some dealers may experience misfires, CEL / MIL, or other drivability concerns immediately after installing a GM re-manufactured HFV6 engine.
Cause	This condition may be caused by a component transferred over from the original engine that was not supplied with the replacement engine. Some of the things we have seen have been camshaft actuator solenoids (OCV's), fuel injectors and fuel, intake manifolds, and catalytic converters. Additionally this could be caused by a mistimed engine or an incorrect camshaft or actuator being installed in the incorrect location.

The stuck solenoid pintle is shown in each photo with the open hole visible in the body of the solenoid.

If a misfire or DTC concern is found immediately after engine installation, perform normal diagnostics.

NOTE: Make sure the misfire or DTC is not cause by ignition, fuel, or electrical components that were not part of the replacement engine assembly. See below

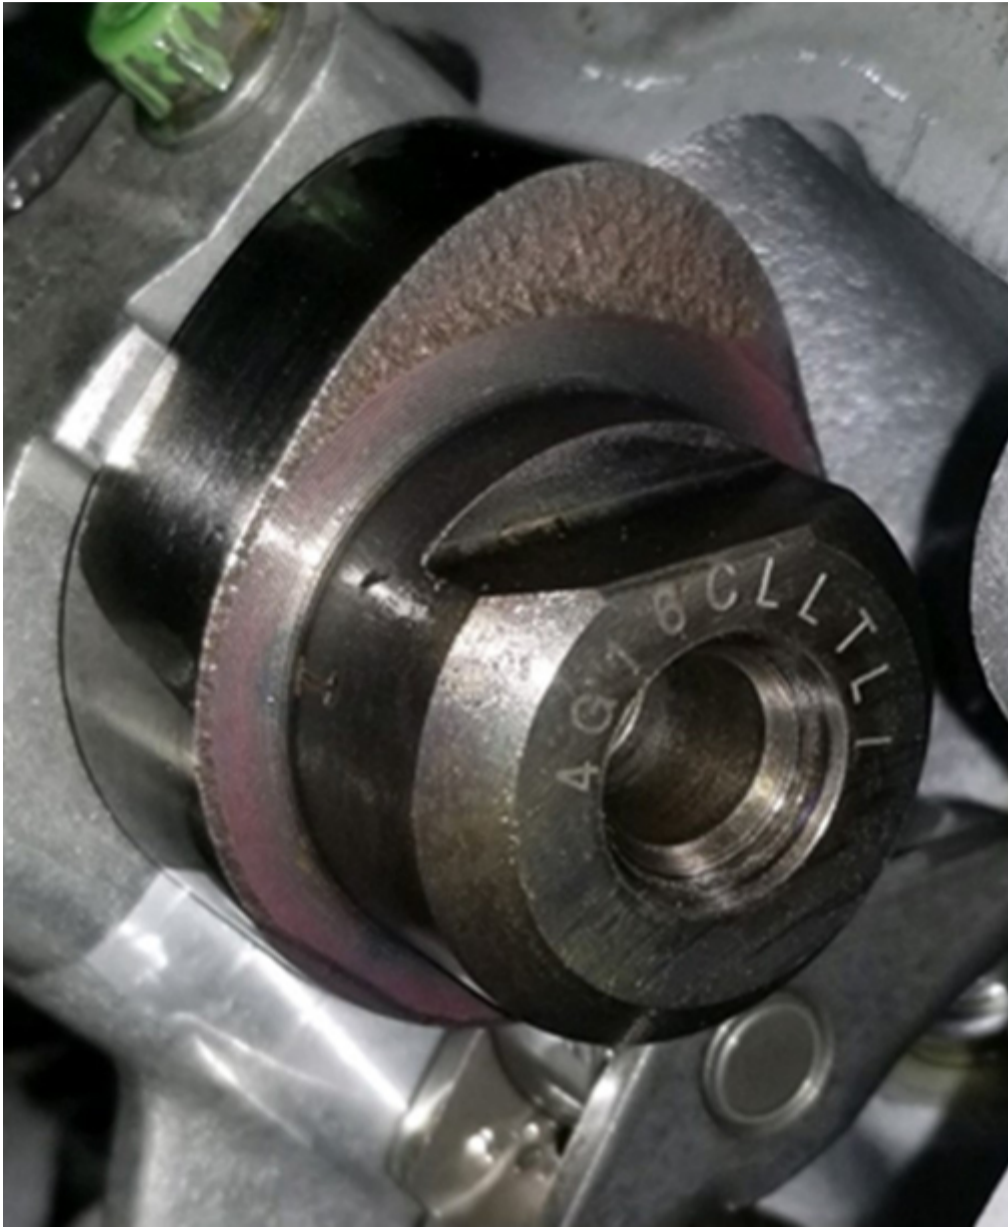
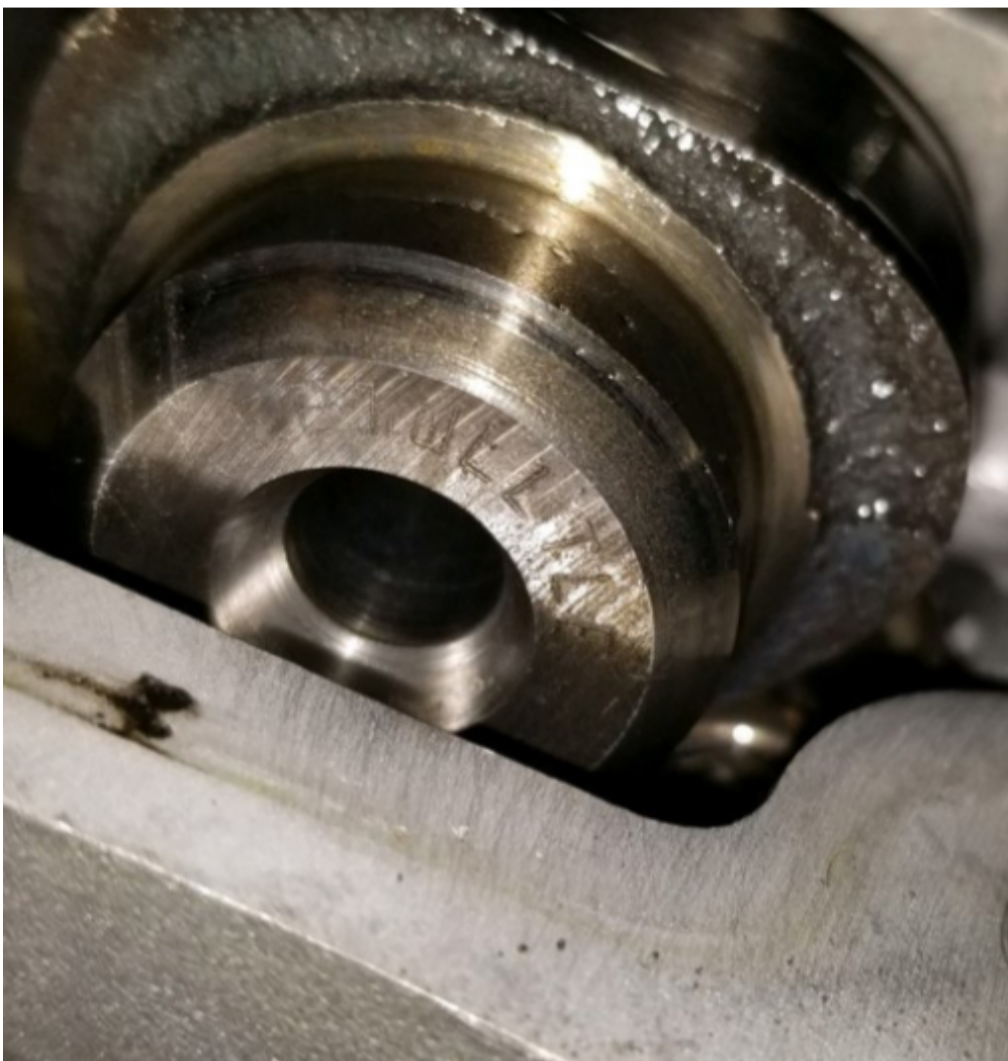
Also check to make sure the camshafts and actuators are correct and in the correct place. See Below Camshaft Identification on HFV6.

Note last 5 characters. Of these 5 characters, the first 3 designates the RPO of the engine, (L or R) designates the bank, and (I or E) designates intake or exhaust.

If normal diagnostics along with these enhanced diagnostics do not lead to the cause, prior to removing the timing cover or cylinder heads, call TAC and start a case for next step recommendation.
