Bulletin No.: PIT5751

### PIT5751 SES MIL DTC P0201/P0202/P0203/P0204/P0205/P0206/P0216 (Inspect Engine Harness 3.0L Diesel)

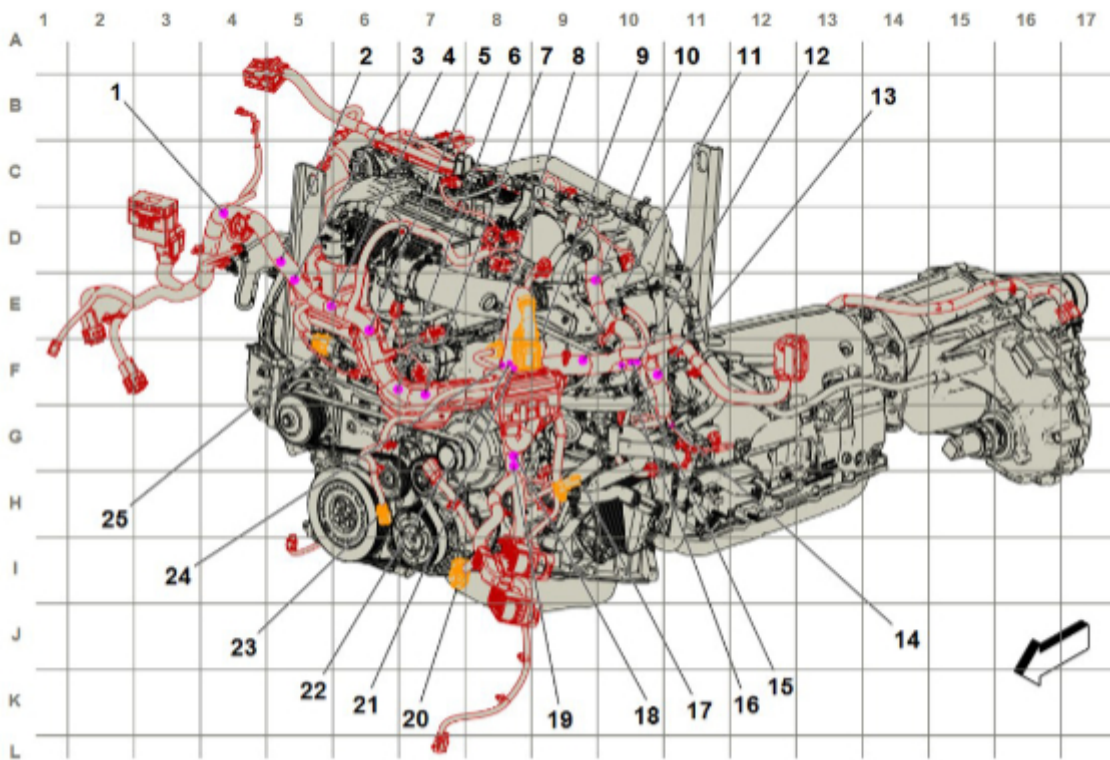
Involved Region or Country	North America
Condition	<p>Some customers may comment on any of the following concerns:</p> <ul style="list-style-type: none"><li>- Engine runs rough</li><li>- Misfires</li><li>- Low Power</li><li>- SES MIL</li><li>- DTC's: P0201, P0202, P0203, P0204, P0205, P0206, and/or P0216</li></ul>
Cause	<p>These concerns could be caused by the following:</p> <ul style="list-style-type: none"><li>- The engine harness getting pinched or shorted in grid coordinates H-7, shown below.</li><li>- Poor terminal contact at connector X160 callout 25, shown below.</li></ul>

In many cases, the ECM has been unnecessarily replaced for these concerns. Please thoroughly inspect the areas shown above and follow published SI diagnostics before any parts are replaced. If any concerns are found, then follow SI Wiring and Connector repair instructions to correct the concern.
