Preliminary Information

PIP5737 Diagnostic Tip: Inspect Engine Oil Dipstick Tube O-ring And Areas Above Lower Oil Pan Sealing Surface For Potential Engine oil Leaks

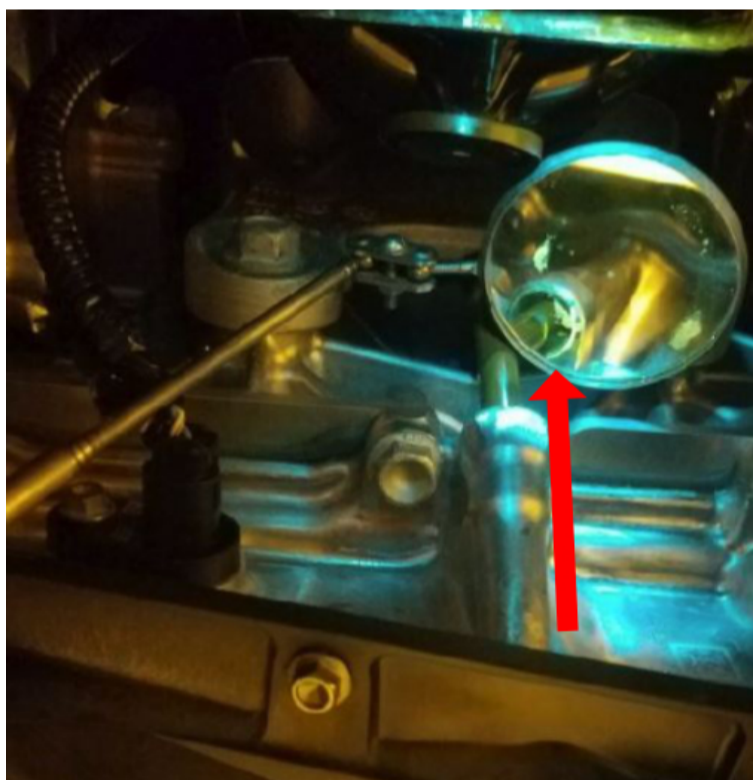
Picture below shows oil leak from dipstick tube O-ring (looking through inspection mirror)

When diagnosing engine oil leaks on the above listed vehicles it's important to inspect the dipstick tube O-ring and areas above the composite oil pan sealing surface for potential oil leaks before condemning the lower composite oil pan as root cause of engine oil leak.

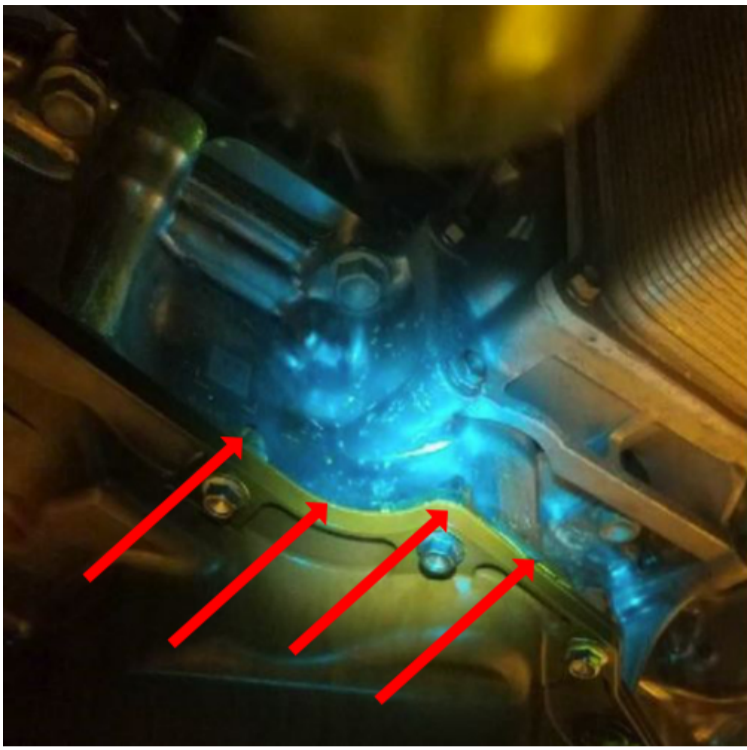
Picture below shows oil leak from composite oil pan sealing surface (shown with black light and tracer dye)

Note: The use of engine oil dye and trace powders are recommended to assist with isolating engine oil leak points. Be sure to clean suspected leak areas thoroughly before using trace powders.
