Preliminary Information

PIP5504F Diagnosing Fishbite Chuggle Misfire Feeling Or Shudder Vibration, With A Light Tip In

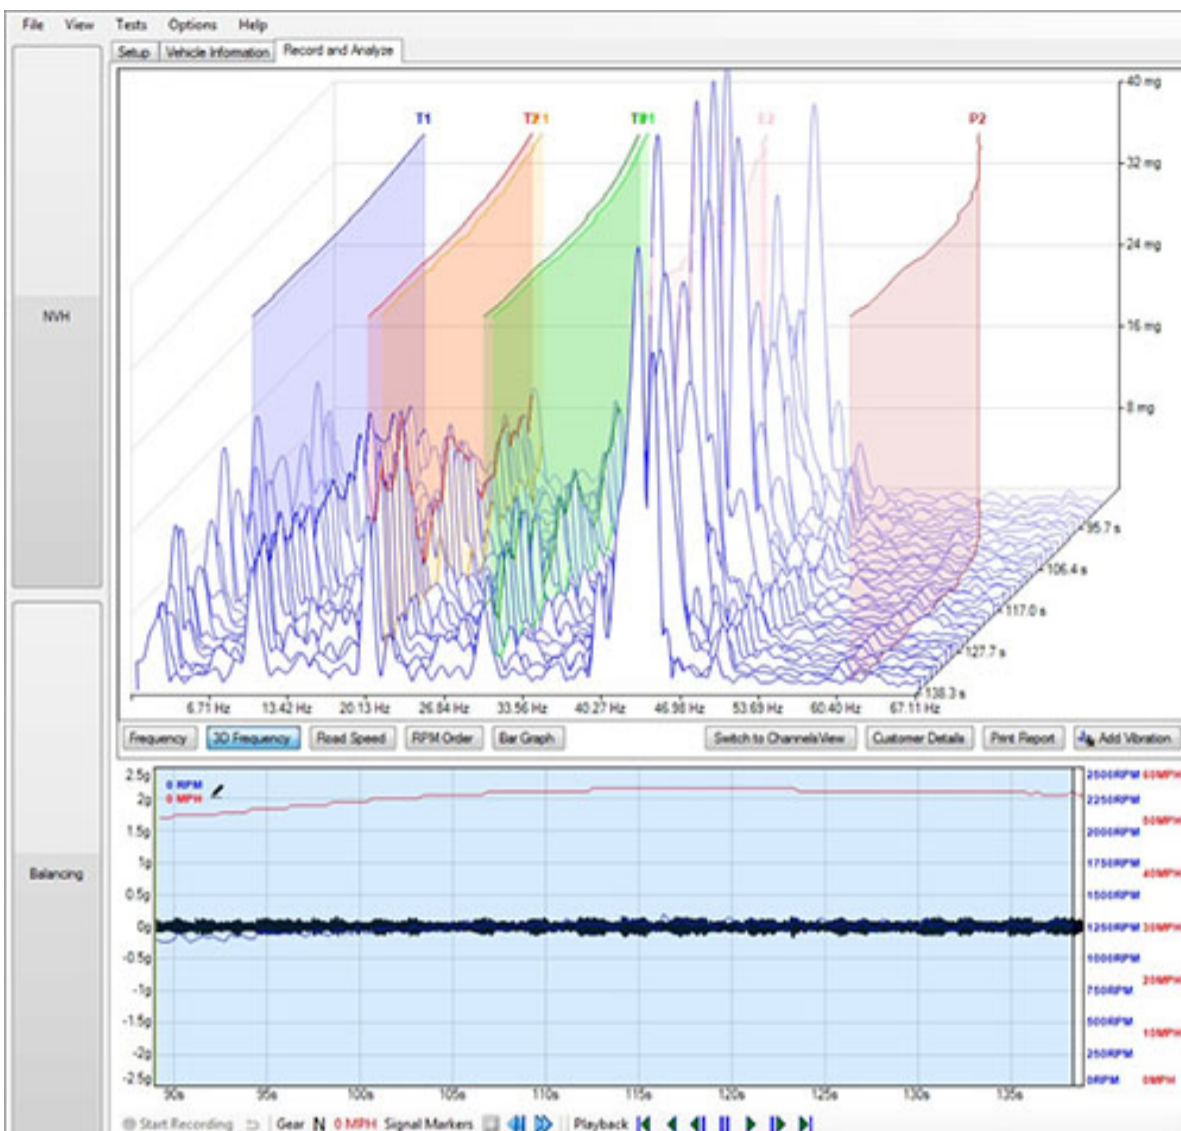
If TCC Shudder is present, a vibration peak will appear at approximately 43Hz +/-3Hz as shown in the picture above. If the vibration frequency follows engine, tire, or driveshaft speed, then it is NOT TCC Shudder.

TCC Shudder vibration frequency should stay constant per gear while vehicle and engine speeds change.

Vibrations identified as shudder should be further investigated using the "Torque Converter Diagnosis" in SI as a starting point.

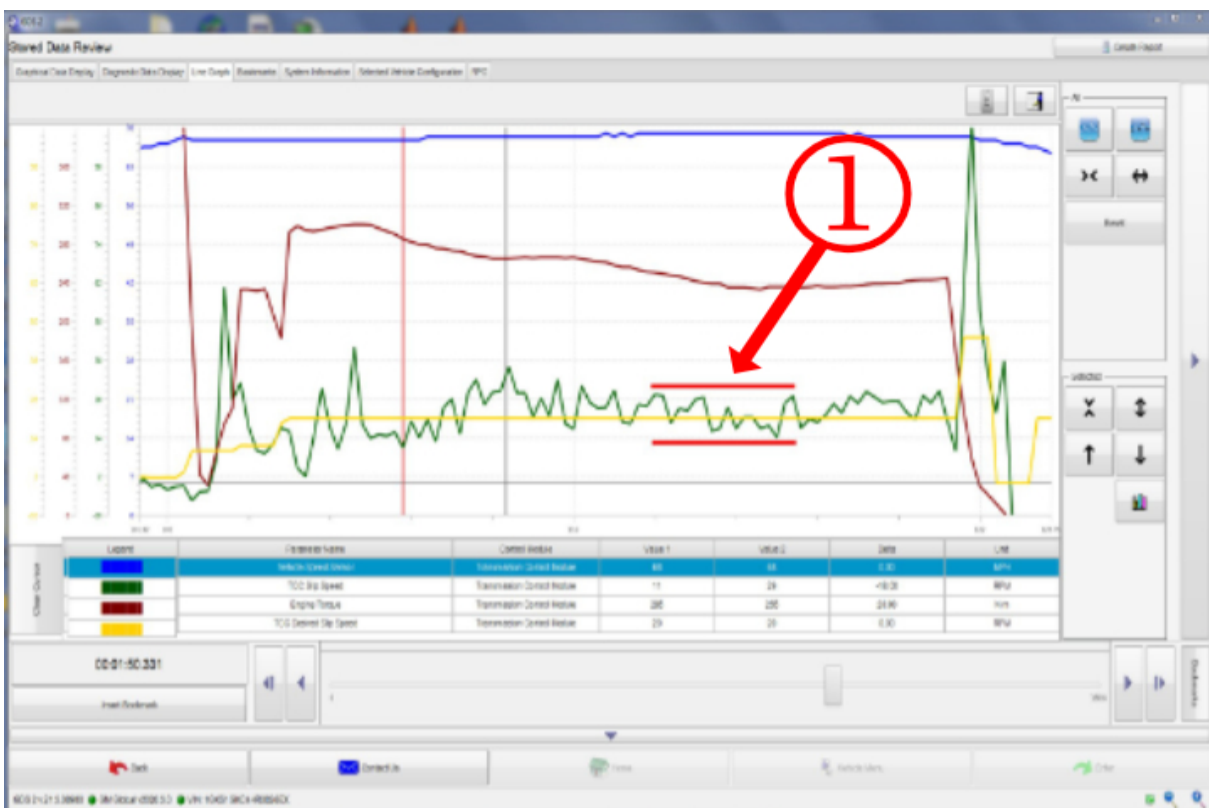
Callout 1

GDS2 data showing TCC slip peak to peak below 20 RPM is an example of normal TCC operation.

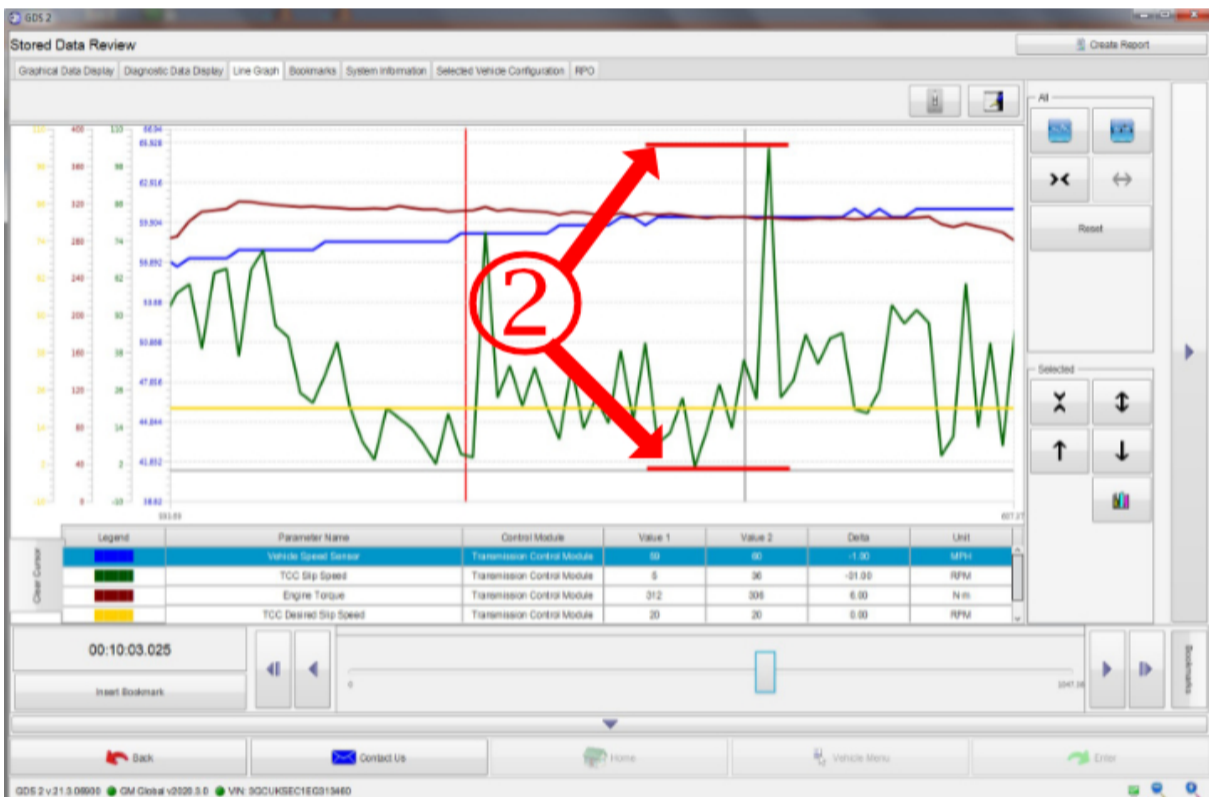
Callout 2

GDS2 data showing TCC slip peak to peak erratic near 0 RPM to over 100 RPM in a short time is an example of a damaged torque converter clutch.

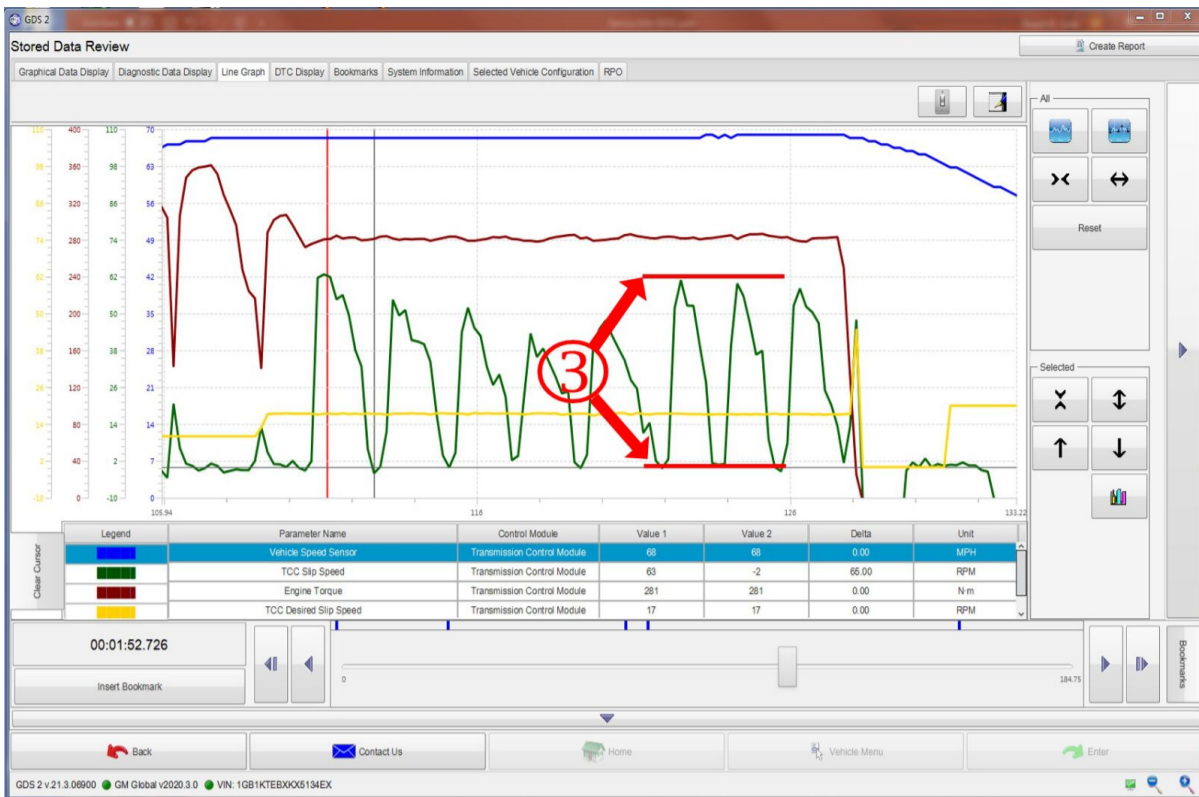
Callout 3

GDS2 data showing TCC slip peak to peak repeating near 60 RPM or less is an example of degraded fluid.
