GLOBAL SAFETY FIELD INVESTIGATIONS
DCS5451
URGENT - DISTRIBUTE IMMEDIATELY

Subject: N192278390 - Customer Satisfaction Program
Manual Service Disconnect Fuse Open

Models: 2019 Chevrolet Bolt EV

N192278390 Manual Service Disconnect Fuse Open

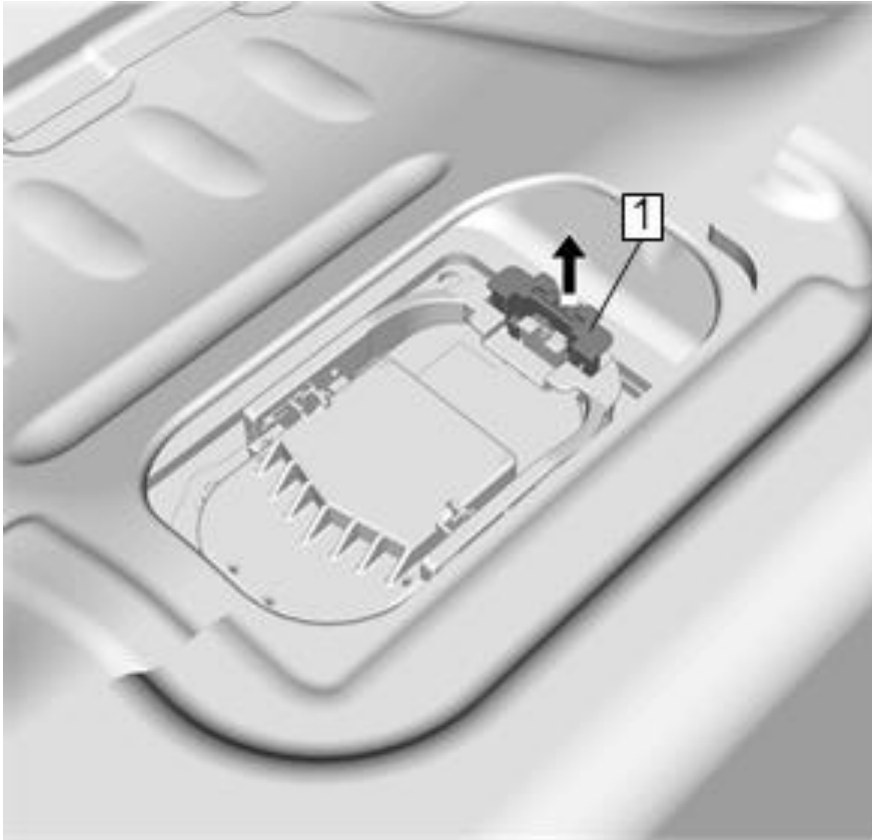
4564670

3. Lift the CPA lever (1).

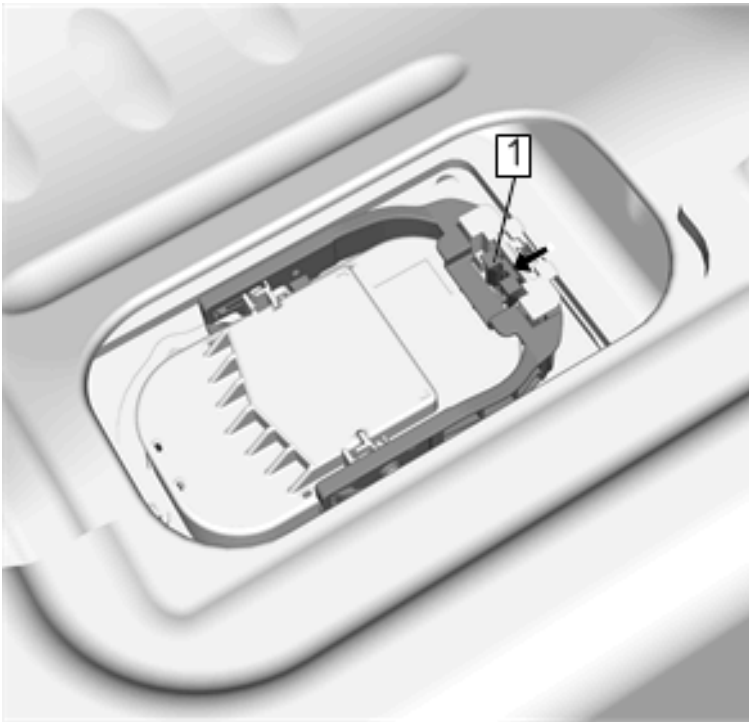
4564672

4. Push the lever button inward (1).

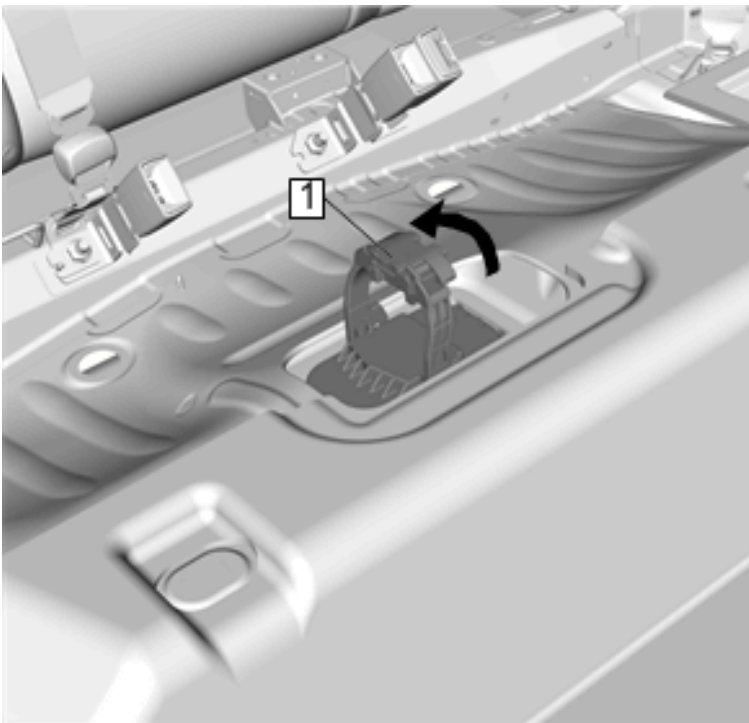
4564674

5. Lift the drive motor battery high voltage manual disconnect lever (1).

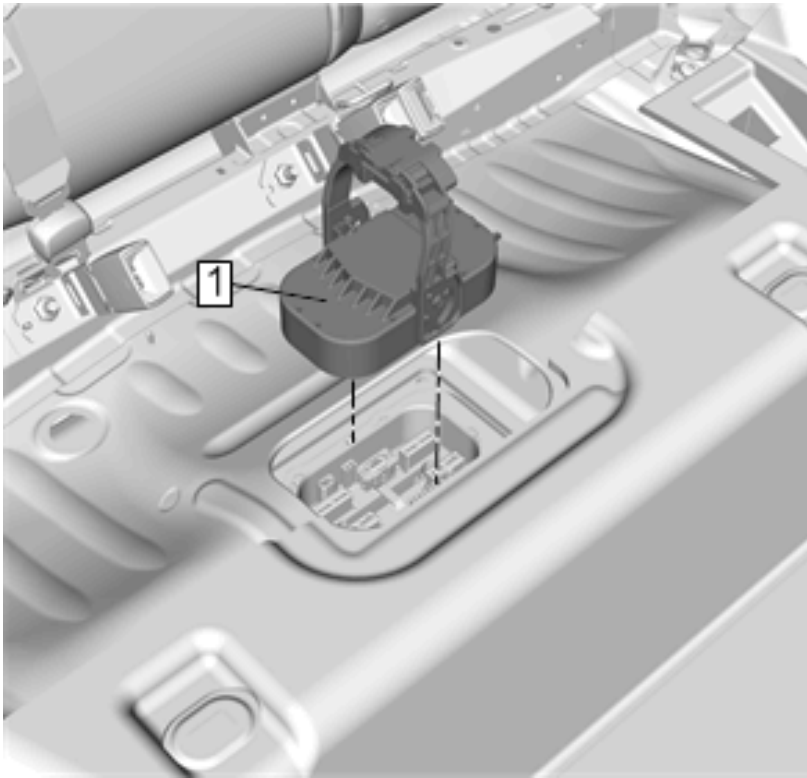
4564675

6. Remove the drive motor battery high voltage manual disconnect lever (1).

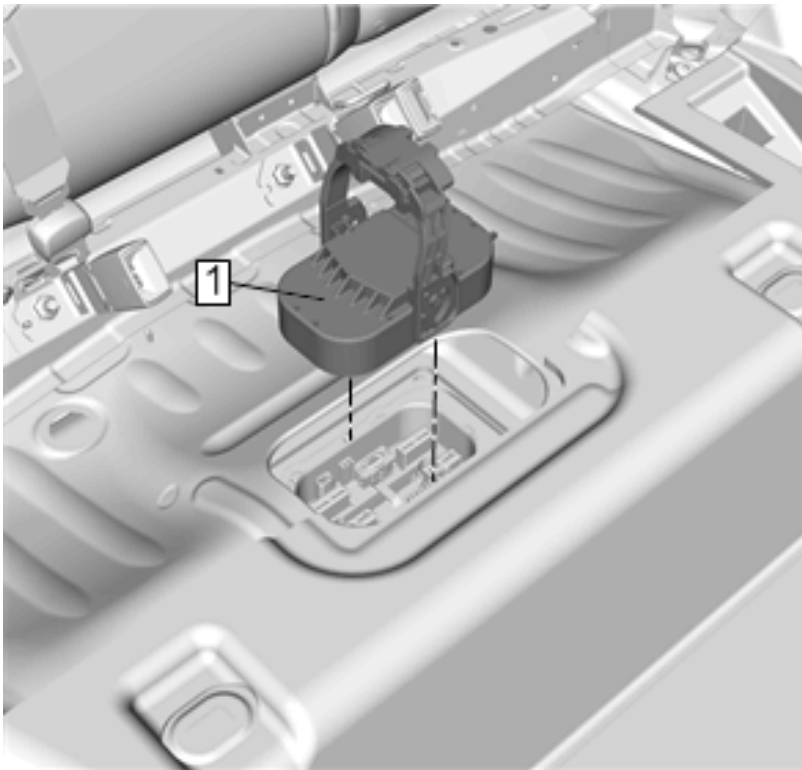
4564675

7. Install the drive motor battery high voltage manual disconnect lever (1).

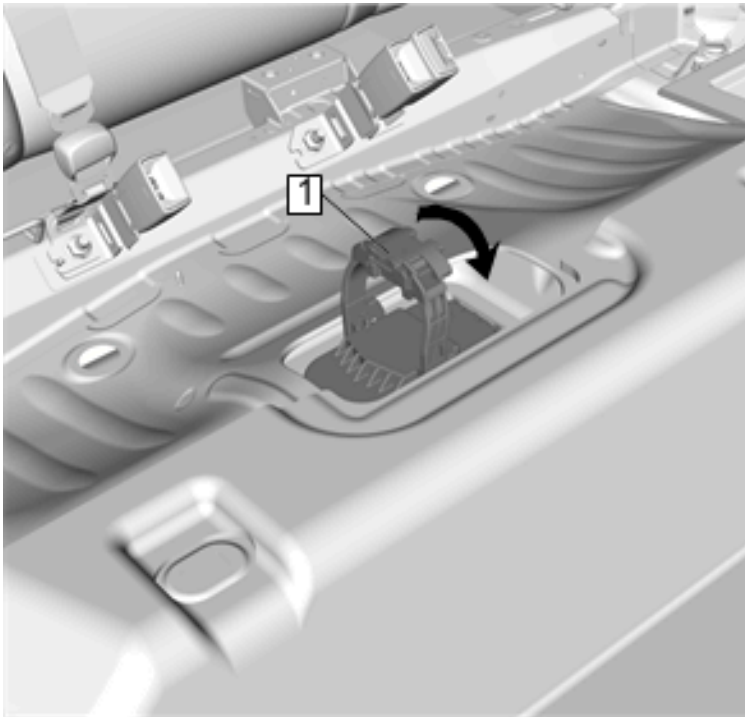
4564677

8. Engage the drive motor battery high voltage manual disconnect lever (1).

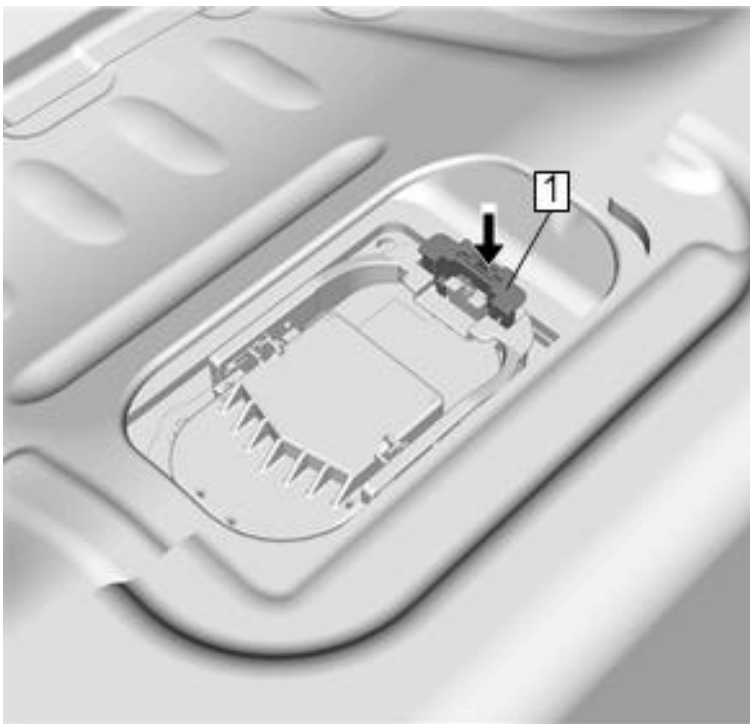
4564676

9. Push and engage the lever CPA (1).
