Technical Service Bulletin

91 Night vision system inoperative, DTC B201000 is stored in the night vision control module

91 20 91 2045020/5 August 4, 2020. Supersedes Technical Service Bulletin Group 91 number 19-12 dated November 13, 2019 for reasons listed below.

Model(s)	Year	VIN Range	Vehicle-Specific Equipment
Q7, SQ7	2017 - 2019	All	With night vision system
A6, A7, S6, S7, RS6, and RS7	2015 - 2018	All	With night vision system

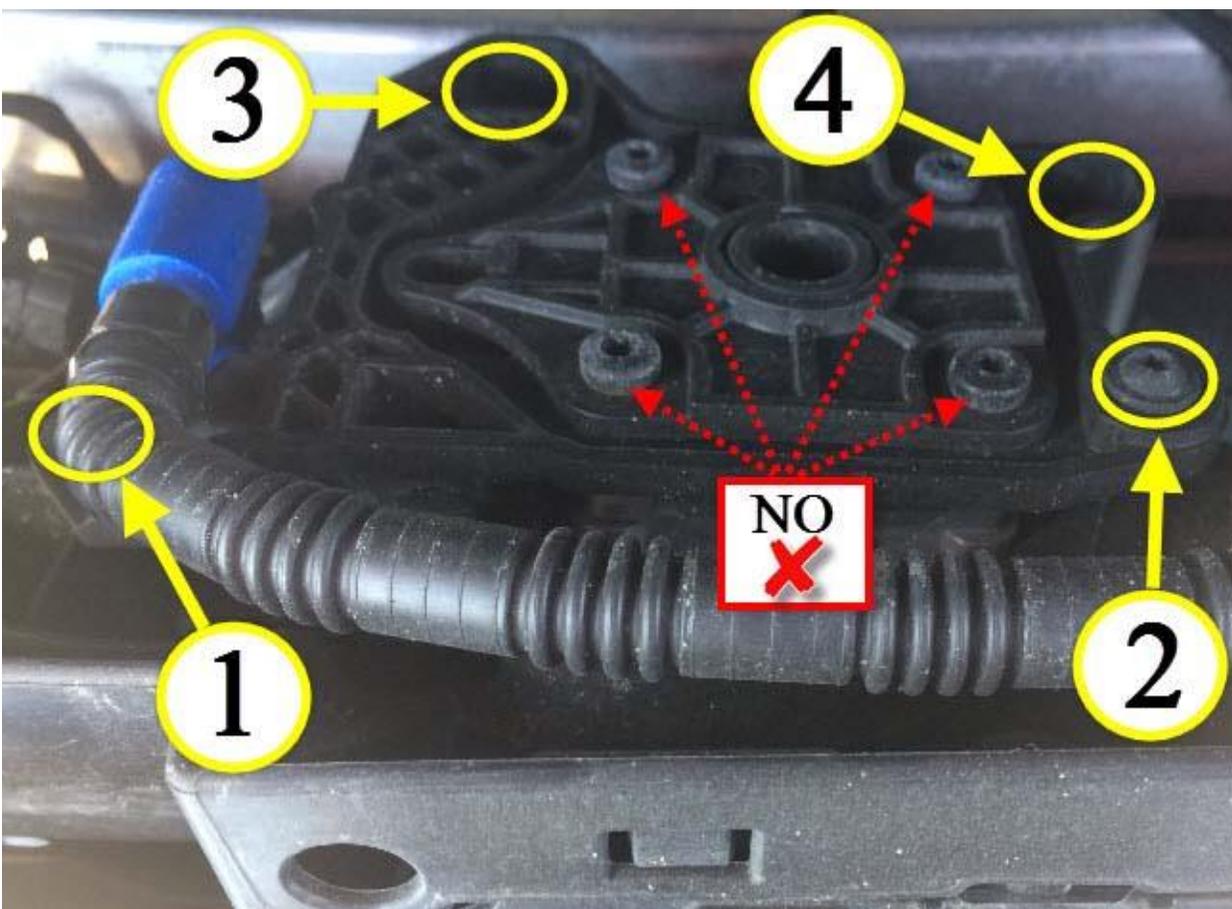
Figure 1. Night vision camera mounting bracket screw retainer locations 1, 2, 3, and 4. Loosen screws 1, 2, 3, and 4. Do not remove or loosen the four screws holding the camera to the bracket.

6. Loosen the night vision camera mounting bracket by loosening the four mounting screws that hold the mounting bracket to the radiator grille. Mounting screws are shown in the image below (Figure 1) by numbered arrows 1, 2, 3, and 4.

Tip: Do not remove or loosen the four screws that hold the camera onto the camera mounting bracket, these are shown in the image with red dotted arrows.

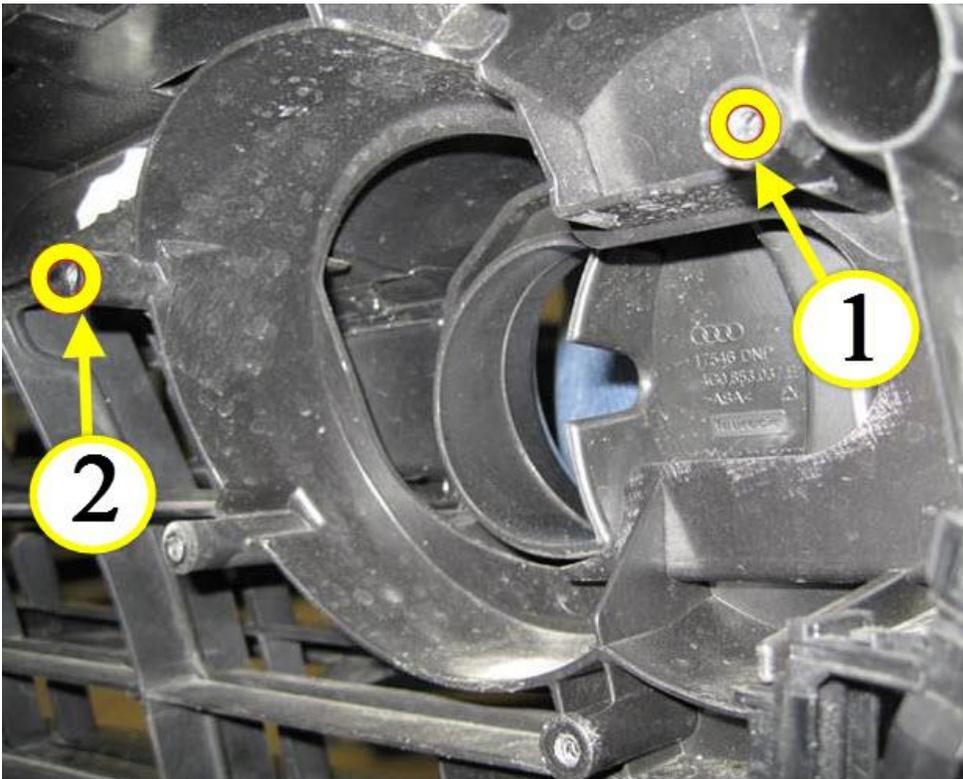
Figure 2. Radiator grille screw retainer locations with camera removed for reference. Spacers (N01152322) will be placed at locations 1 and 2.

7. Place a single spacer, part number N01152322, between each of the two upper mounting points that secure the night vision camera bracket to the radiator grille. These screws are shown in the above image as points 1 and 2 (Figure 1). The image below (Figure 2) references these points on the radiator grill as 1 and 2. The next image (Figure 3) shows the placement of the spacer on the camera as points 1 and 2, the camera has been removed for clarity.

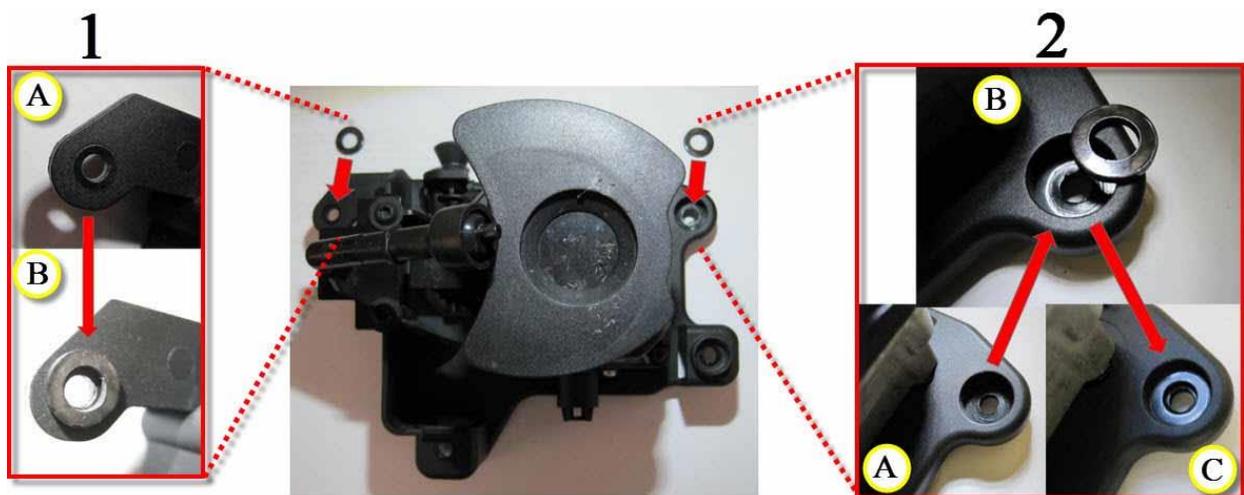
Figure 3. Additional photo showing the spacer placement with the camera removed for reference. Place a spacer on the grille facing side of the camera's upper mounting surface in positions 1 and 2.

8. After positioning the two spacers between the night vision cameras upper mount points and the radiator grille, torque all four screws to 2.5Nm.
9. Perform the calibration of the night vision system once again. Following the calibration, the new final pitch angles displayed by the tester should be between 0.3° and 1° less than the original values recorded. A final pitch value between +0.5° and +1.1° is acceptable.
10. If this is an RS 7 model, additional systems must also be calibrated due to the removal of the front bumper. Consult the Elsa repair manual for these procedures.
