STAR ONLINE PUBLICATION

Case Number: S2008000097

Symptom/Vehicle Issue: ESC Cluster Warning Lamp On, DTC B1783-01 Stop Lamp Control Circuit General Failure

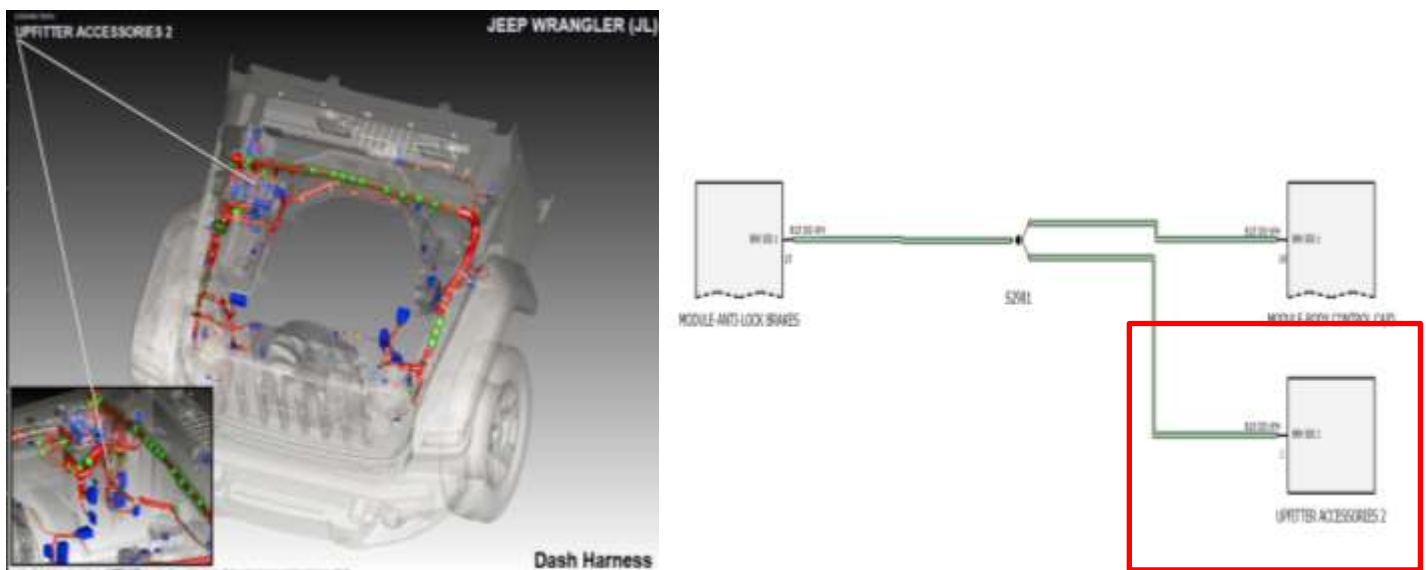
Fig 1

Customer Complaint/Technician Observation: Owner complains the ESC (Electronic Stability Control) warning lamp is on. Condition may have appeared after a recent service operation. Technician observed the lamp on with DTC B1783-01 Stop Lamp Control General Failure setting in the ABS module.

Repair Procedure: Inspect the up-fitter accessory 2 wiring take out for proper harness routing or signs of routing damage in the harness take out general location Fig 1, 2.
