STAR ONLINE PUBLICATION

Case Number: S2023000036

Release Date: 7/10/2020

Symptom/Vehicle Issue: Front Seat Lift Handle Binding

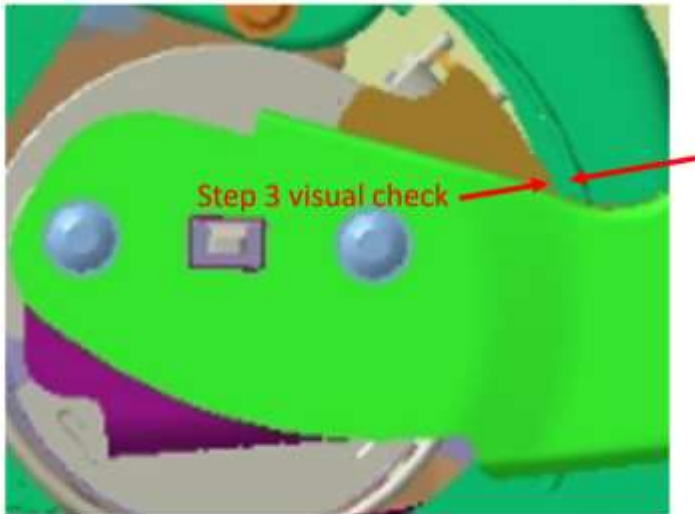
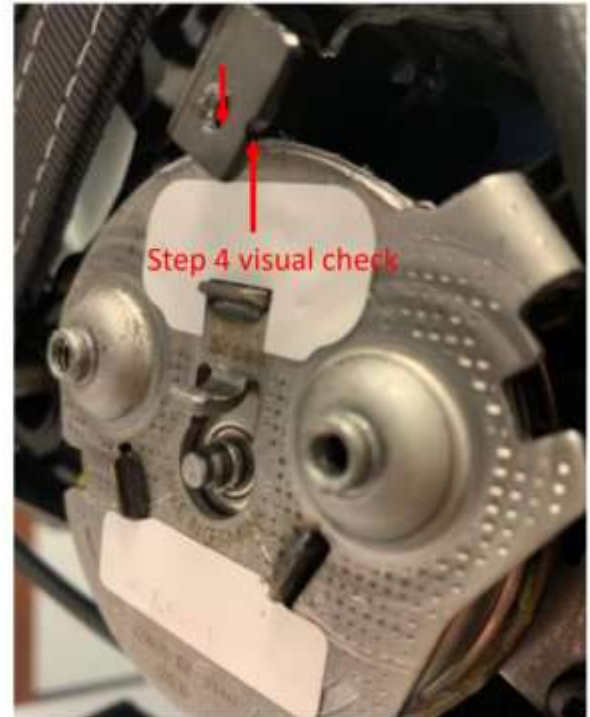
3. Visually confirm interference/binding between Lift-handle & Inner Ring rub-strip by cycling handle upward

4. Visually confirm interference/binding between Guide-wire bracket/screw & Lift-mechanism top edge by cycling handle upward

5. Remove 2 Lift Handle screws & Lift Handle
6. Remove 2 Inner Ring Plastic attachment screws and Inner Ring Plastic
7. Remove 1 guide wire attachment screw and 1 marriage bolt.
8. Remove bent guide wire.
