STAR ONLINE PUBLICATION

Case Number: S2008000112

Symptom/Vehicle Issue: MIL Lamp On Setting DTC's P0441, P0456, P0457, P0440

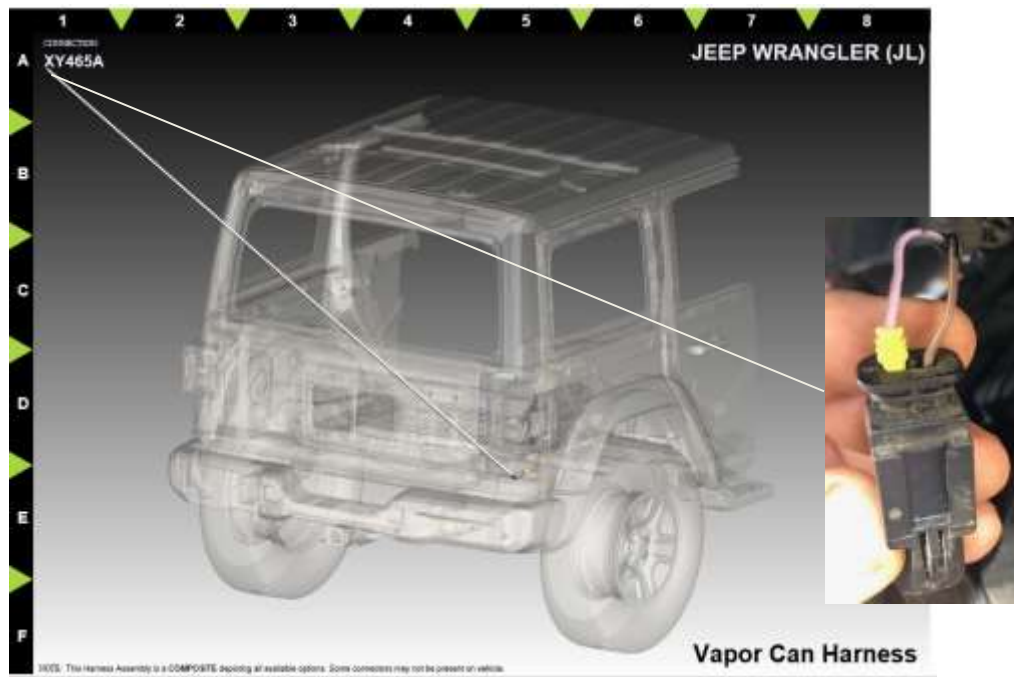
Customer Complaint/ Technician Observation: Owner complains intermittently the MIL (Malfunction Indicator Lamp) comes on in the cluster. Technician observed the stored DTC's relating to the emission control evaporative system, P0441 Evaporative System Performance, P0440 General Evaporative System Failure along with leak detected faults P0457 Loose Fuel Cap, P0456 Small Leak Detected.

Repair Procedure: Inspect connector XY465A for any signs of spread or pushed out terminals, secure the connector and terminals as needed, no parts required.
