Coolant temperature warning in IC DTCs P0A9300, P26CE22, U011564, U019F00 in various control modules

Topic number	LI20.00-P-071399
Version	1
Function group	20.00 General
Date	07-13-2020
Validity	All vehicles with M256 engine produced as of 07/2019 and up to 02/2020
Reason for change	
Reason for block

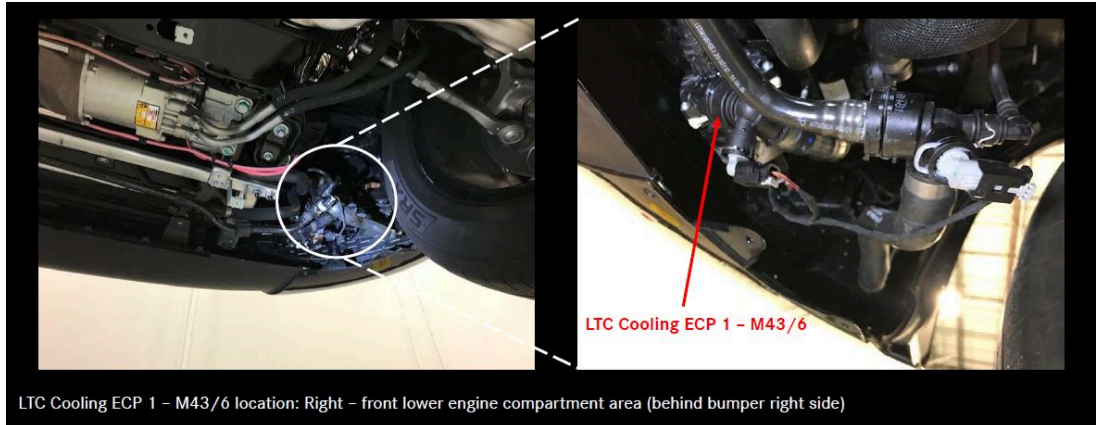
M256 LTC M43_6 coolant pump.JPG:

Attachments	
File	Description
M256 LTC M43_6 coolant pump.JPG	Location of the LTC coolant pump M43/6

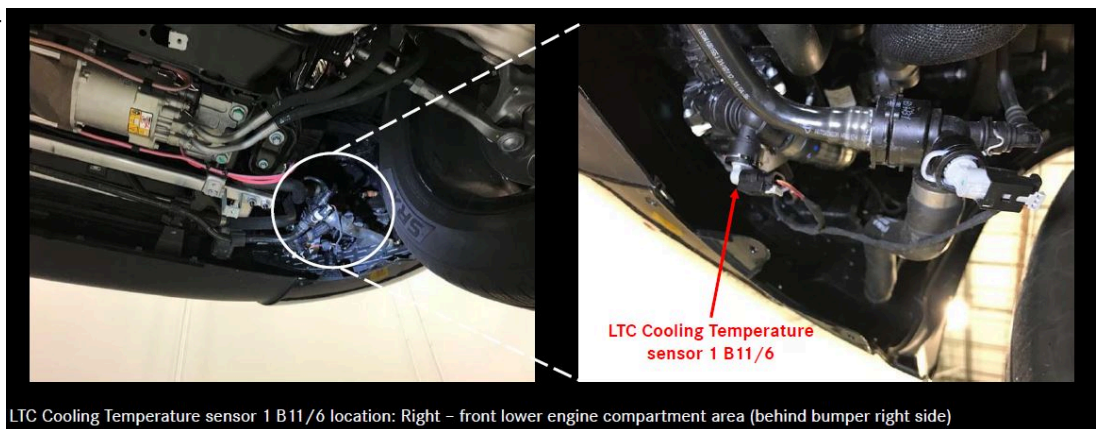
M256 LTC B11_6 temperature sensor NT1.JPG:

Low Temperature Cooling (LTC) circuits temperature sensors B11/6 and B11/7 might have swapped electrical connector connections

- a) locate temperature sensor B11/6 (NT1) - sensor close to the LTC coolant pump M43/6 refer to attachments for illustration. The NT1 sensor connector should have two wires attached (Red/Black + Brown/Yellow).

M256 LTC B11_6 temperature sensor NT1.JPG	Location of the LTC coolant temperature sensor B11/6 (NT1)
---	--

- b) disconnect the B11/6 (NT1) connector from the temperature sensor
- c) if the disconnection results in triggering the fault code P00E112 in the engine control module - ME (MRG1), the connection to the NT1 temperature sensor is correct. If disconnecting NT1 sensor results in DTC P0C4500 in the CP-C_NG control module the connection to the NT1 temperature sensor is incorrect.

5. if connections to NT1 and NT2 are found to be incorrect, ensure correct connections by swapping connectors and try to duplicate the original symptom. If no problem found, release the vehicle. Otherwise if symptom still exists or original symptom occurs with correct NT1 and NT2 connections, open a PTSS and all information, findings and illustrations.
