# Technical Service Bulletin

## 39 Four-wheel drive malfunction message, DTC C05ED00 is stored in the all-wheel drive control module

39 20 35 2051558/4 August 21, 2020. Supersedes Technical Service Bulletin Group 39 number 20-32 dated June 17, 2020 for reasons listed below.

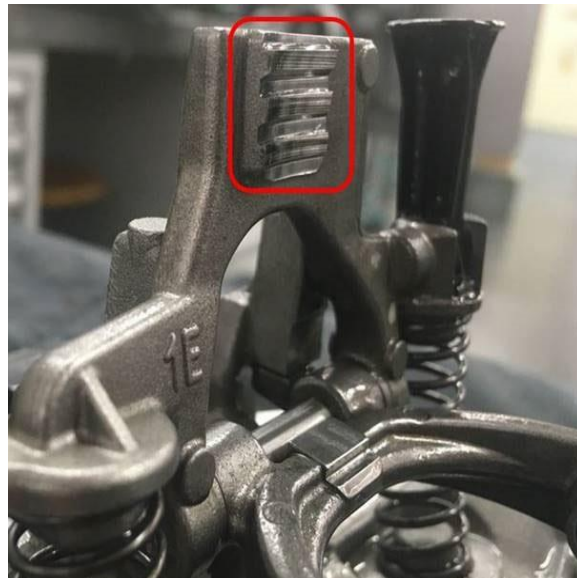
- **DTC C05ED00** (4WD/AWD Clutch "B" Stuck Engaged) with symptom code 29725.

Quattro Ultra shift fork inside the rear differential is worn/faulty (Figure 1).

**Figure 1.** Worn/faulty shift fork.

Improved material in production

- If the result of the test plan leads to a repair, follow the Guided Fault Finding repair advice and this TSB does not apply.
  - If the result of the test plan finds no defect, perform a short test drive. If the same DTC returns after the test drive with the same symptom, the shift fork inside the rear differential is at fault and must be replaced. Perform the repair as follows. Do **not** replace the complete differential.
1. Drain the oil of the rear differential according to the repair manual.
  2. Remove the rear differential per the repair manual.

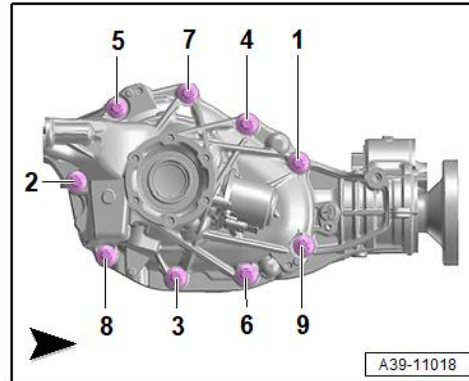
**Figure 2.** Case bolts.

- Loosen the case bolts -1 to 9- and separate the housing halves saving the bolts as they will be reused for reassembly (Figure 2). Use care to not damage the sealing surfaces.

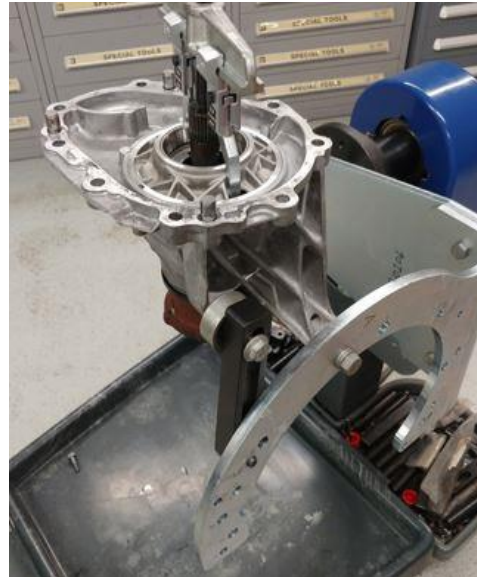
**Figure 3.** Mounted side carrier.

- Mount the side carrier as shown below (Figure 3) to the VAS6095 using T40206, T40206/1A, one long slotted arm from the VAS6095, 3350/2 (Figure 4 and Figure 5), three M10 flat washers 2mm thick each (Figure 5), one M10 x 1.5 x70 bolt (Figure 4 and Figure 5), and one M12 x 1.5 x 38 bolt (Figure 4).

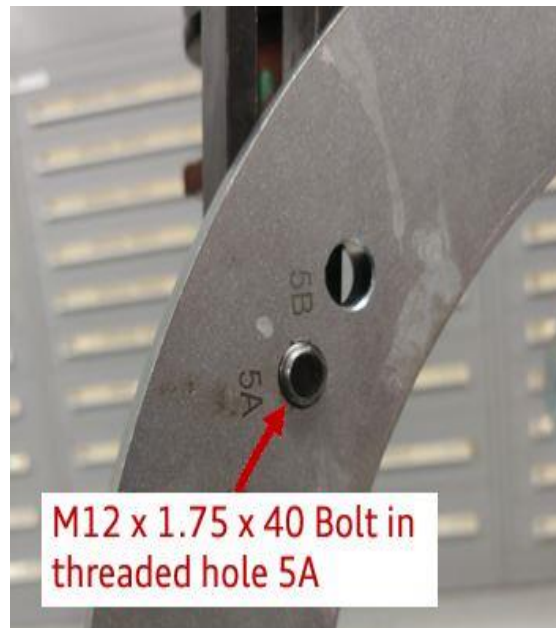
**Figure 7.** Mounting.

- 5a. The passenger side differential mount attaches to the T40206/1A at hole #6 and the long slotted arm of the VAS6095 attaches to threaded hole 5A using one of the M12 x 1.75 x 40 bolts from the VAS6095 engine/transmission stand (Figure 7). Alternately the long slotted arm of the VAS6095 can attach to threaded hole 5B with any M12 bolt and a nut (bolt must be 50mm or longer).

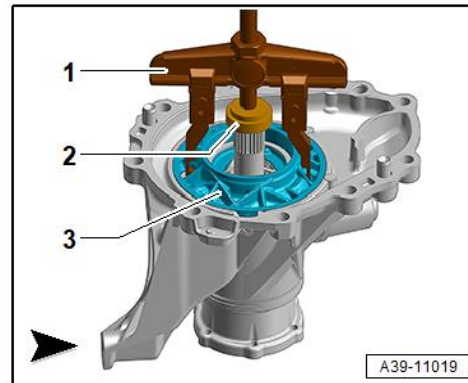
**Figure 8.** Puller arrangement.

6. Pull out the gear carrier (Figure 8, position 3) using the VAS 251001 with VAS 251 001/2 (Figure 8, position 1) and thrust piece 30 – 555 (Figure 8, position 2).

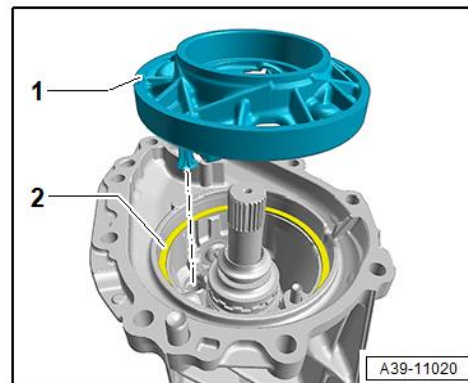
**Figure 9.** Gear carrier and shim removal.

7. Remove the gear carrier (Figure 9, position 1 and Figure 10). During this step, guide the shift fork out of the clutch module (engagement collar), then remove the shim (Figure 9, position 2).

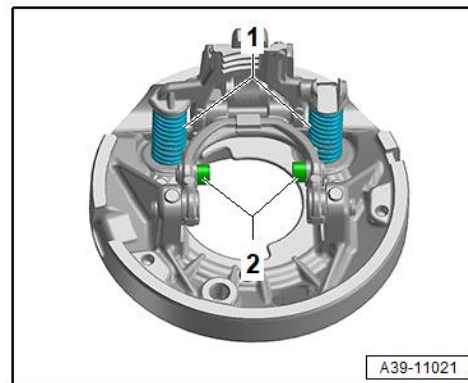
**Figure 11.** Shift fork assembly.

8. Remove the springs and save them for reinstallation (Figure 11, position 1).  
Remove the roller sleeves (Figure 11, position 2).

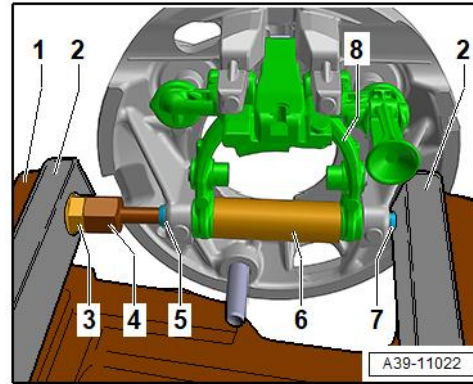
**Figure 12.** Pin removal.

9. Install an M8 flange nut (Figure 12, position 3) onto the T10172/9 (Figure 12, position 4).

Tension the gear carrier in the vise as shown (Figure 12, position 1) using the plastic or brass soft jaws (Figure 12, 2). You may need a 2<sup>nd</sup> technician to assist you in holding the carrier.

Position the sleeve provided in the repair kit Part # 0B0 598 082 (Figure 12, position 6) between the shift fork (Figure 12, position 8).

Press out the bearing pin (Figure 12, position 5) until the thrust piece stops (Figure 12, position 4).

The bearing pin (Figure 12, position 5) remains in the shift fork (Figure 12, position 8) together with the sleeve (Figure 12, position 6).

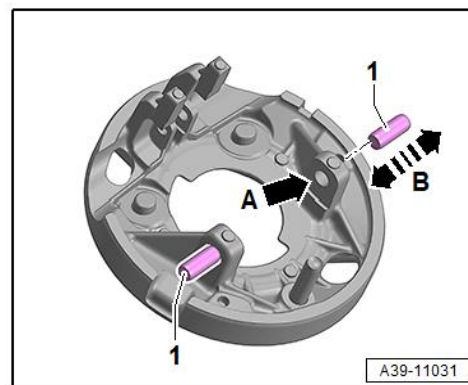
**Figure 13.** Pin checking.

10. Insert the pins (Figure 13, position 1) into the holes of the gear carrier.

The pins have to be easy to move in and out of the holes

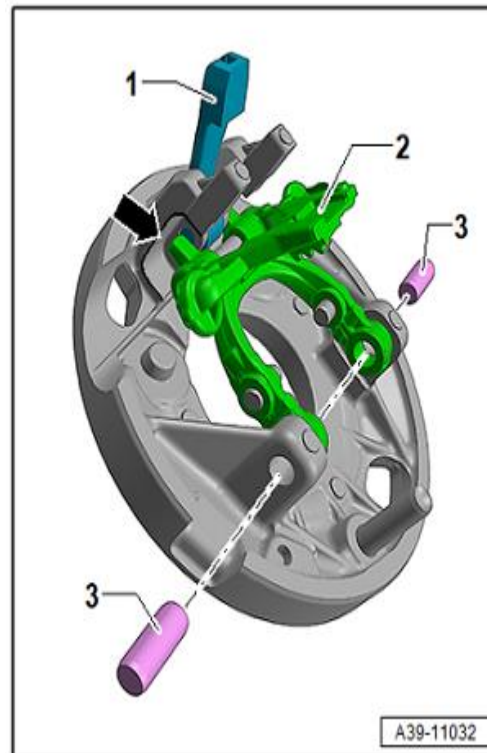
**Figure 14.** Installing a new shift fork.

11. Insert the new shift fork from the repair kit (Figure 14, position 2) into the gear carrier, and in doing so pay attention to the right installation position.

Flap the latch (Figure 14, position 1) outward for installation.

Insert the shift fork (Figure 14, position 2) into the recess of the gear carrier -arrow-.

Partially insert the new pins provided in the repair kit (Figure 14, position 3), to secure the shift fork for the next step (Figure 14, position 2).

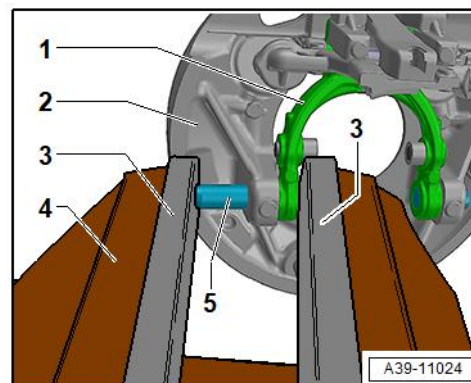
**Figure 15.** Pressing a pin with a vise.

- Tension the gear carrier (Figure 15, position 2) and pin -5- as shown into the vise (Figure 15, position 4).
- Push in the pin (Figure 15, position 5) so far that it is flush with the inner side of the shift fork (Figure 15, position 1).
- Repeat the procedure on the other side.
- Check if the shift fork (Figure 15, position 1) can be swiveled with ease.

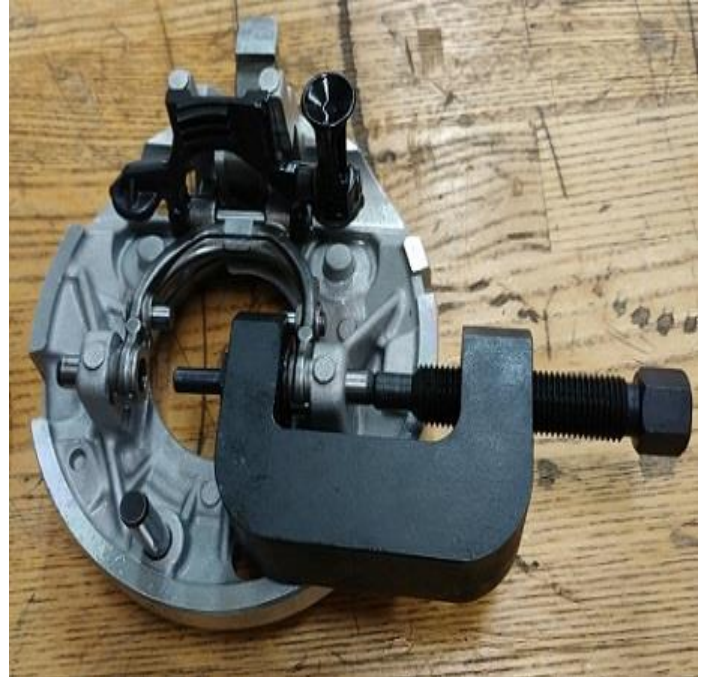
**Figure 18.** Pin pressing with the 582277.

- 12c Set up the 582277 stud remover to press in the pin (Figure 18). The spindle might “walk” off-center and if it does loosen the spindle and center it again and continue pressing. You can also mount the body of the 582277 stud remover in a vise to steady it while pressing the pins. Press in one pin and then repeat on the opposite side.

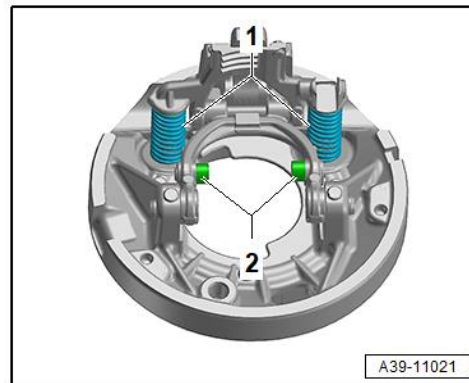
**Figure 19.** Bushing and spring installation.

13. Apply a small amount of assembly grease to the pins for the bushing and install the new bushings from the repair kit (Figure 19, position 2).

Reinstall the springs (Figure 19, position 1).

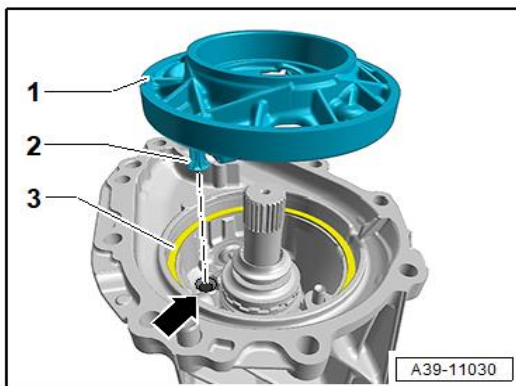
**Figure 20.** Shim and carrier installation.

14. Insert the shim (Figure 20, position 3).

Insert the gear carrier (Figure 20, position 1) into the housing together with the coupling sleeve. Pay attention that the shock absorber (Figure 20, position 2), and the centering pin are correctly positioned to the housing (Figure 20, arrow).

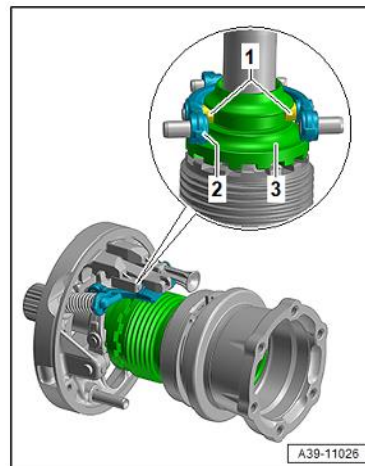
**Figure 21.** Detail of coupling installation.

If the coupling sleeve (Figure 21, position 3) is easily removed from the shaft, remove it and insert it into the gear carrier (Figure 21). Pay attention that the sleeves (Figure 21, position 1) engage into the groove of the coupling sleeve (Figure 21, position 3).

If the coupling sleeve (Figure 21, position 3) is difficult to remove from the shaft you can raise it up the shaft and install it into the clutch module and install the gear carrier paying attention to the steps above.

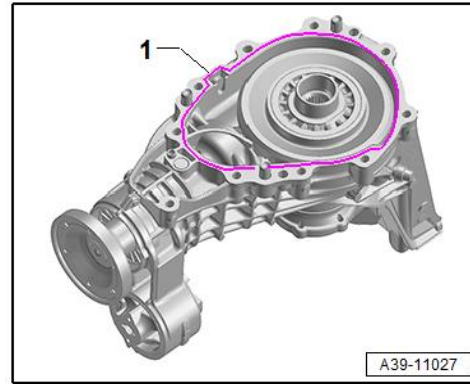
**Figure 23.** Sealant application.

Apply the sealant (D 176 501 A1) onto the housing halves for the differential as shown (Figure 23).

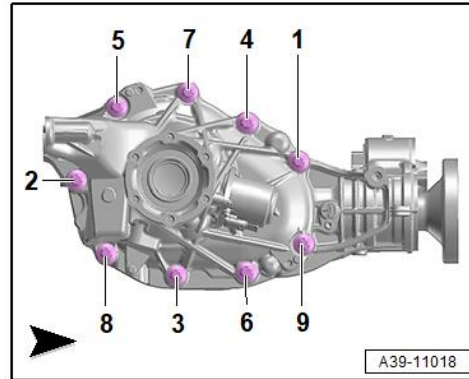
**Figure 25.** Tightening sequence.

18. Install and torque the case bolts as follows and in the sequence shown (Figure 25):

- Install all the way by hand.
- Torque the bolts in sequence to 30 Nm.
- Turn each bolt an additional 45° in sequence.
