ARTICLE: SLI-15-07-01

DATE: July 01, 2015

SUBJECT: SLINGSHOT - REPROGRAMMING (REFLASH) PROCEDURE

MODELS: 2015 SLINGSHOT

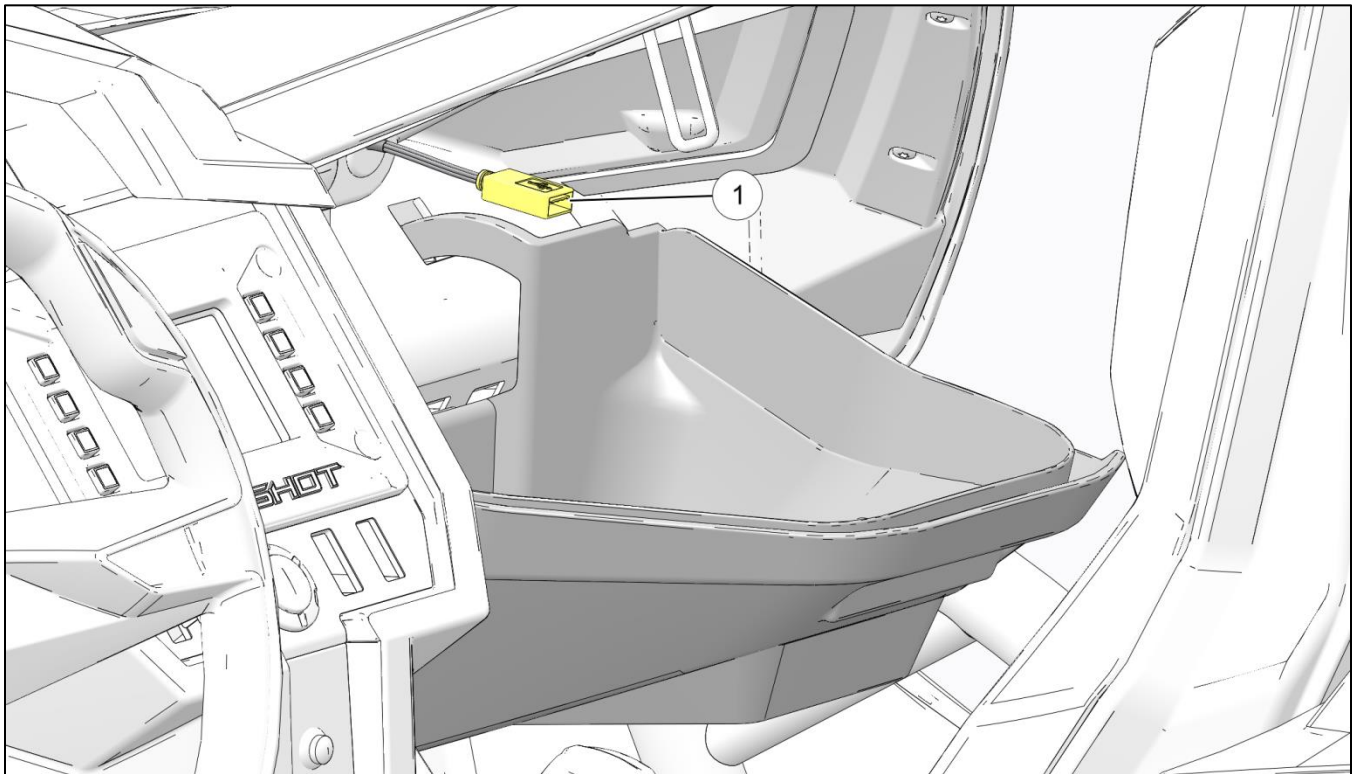
The Slingshot Division of Polaris Industries has determined the reprogramming (reflash) procedure may be negatively affected if performed with a device connected to the USB connector.

It is important to disconnect all devices from the USB connector ① prior to performing an ECU, Stability Control, Instrument Cluster or Audio System reprogramming (reflash) procedure.
