ARTICLE: T-17-01-01

DATE: February 23, 2017

## SUBJECT: SLINGSHOT – T-16-06 Proper Swingarm Installation

### MODELS: 2015-2017 SLINGSHOT MODELS

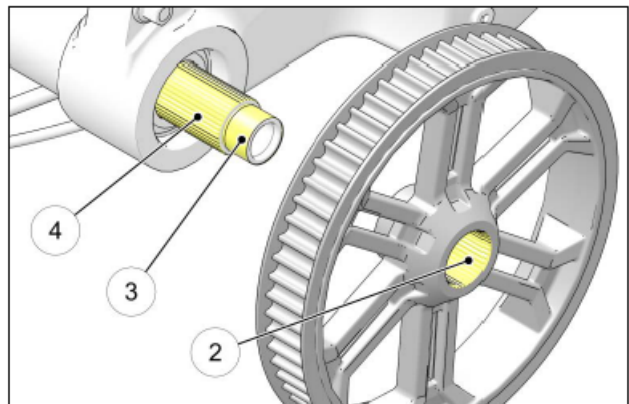
Slingshot has had a small but concerning number of post bulletin repair contacts due to failure to properly assemble the rear axle, sprocket and nuts. Improper installation may result in a rear axle assembly with insufficient clamp load. When proper clamp load is not achieved, the vehicle may experience erratic or incorrect rear wheel speed sensor readings. Symptoms include a reduction in deceleration during engine braking and a feeling of cruise control being engaged or the ABS solenoid being activated during light to moderate braking. This may occur when the axle splines or sprocket splines are not properly cleaned to remove corrosion or Loctite® prior to reassembly.

Removal of all Loctite material is a labor intensive process and may take up to 10 minutes or more to complete. It is critical that these surfaces are clean and no residual Loctite material or corrosion is present.

1. Thoroughly clean pivot shaft, pivot nut and all bushings removed from the original swingarm with contact cleaner.
2. Remove all Loctite residue. Using degreaser and a wire brush, thoroughly clean axle splines ④, threads ③ and the sprocket splines ② before installation.
