Service Bulletin

Bulletin No.: 19-NA-249

Subject: Radio Favorites Grayed Out or Unavailable at Times

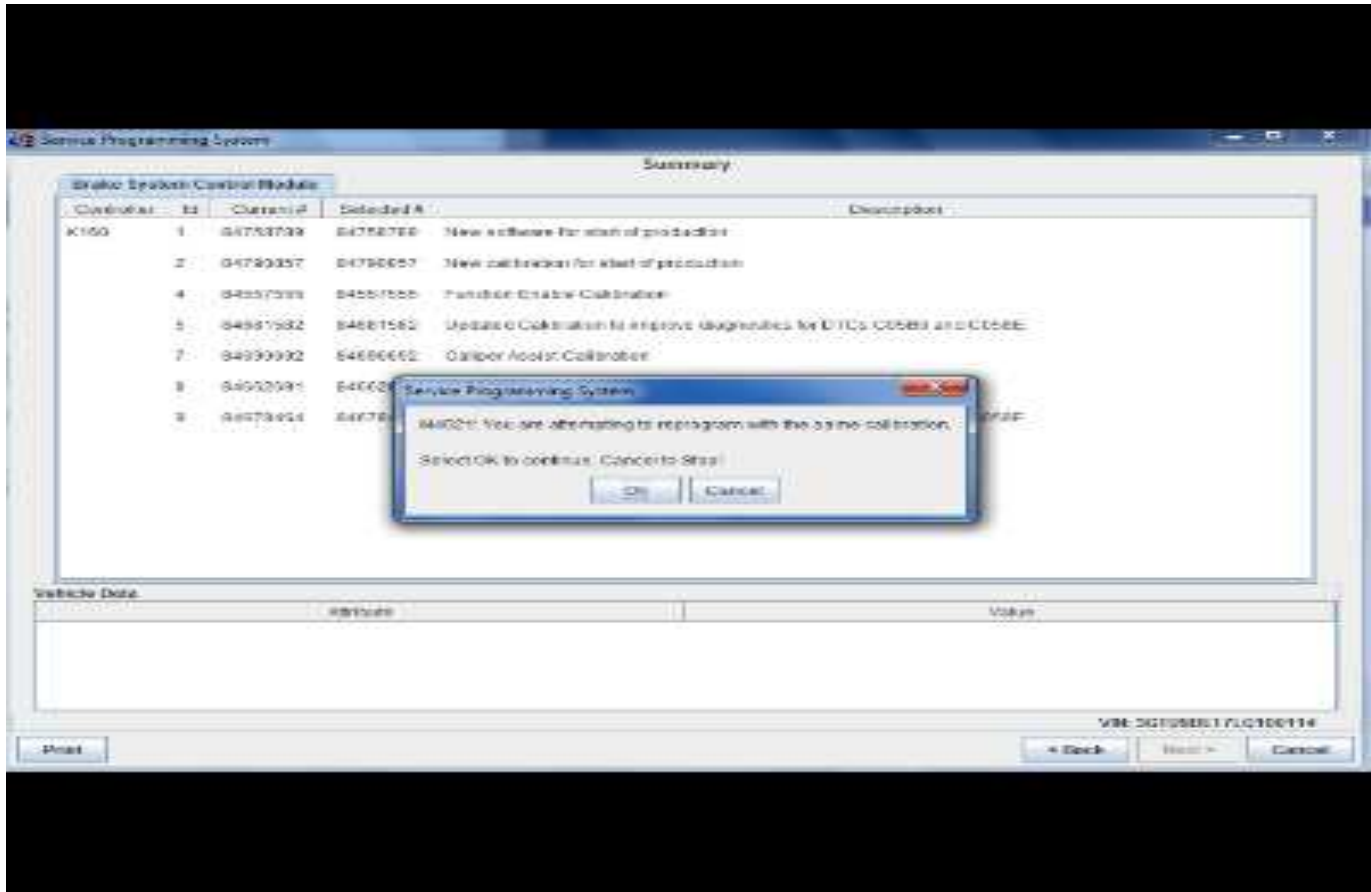
5431207

Important: TIS2WEB screen shown. Techline Connect screen is similar and will be included soon.

Important: If the Same Calibration/Software Warning is noted on the SPS screen, select OK and follow screen instructions. After a successful programming event, the WCC is located in the Service Programming System dialogue box of the SPS Summary screen. No further action is required. Refer to the Warranty Information section of this bulletin.

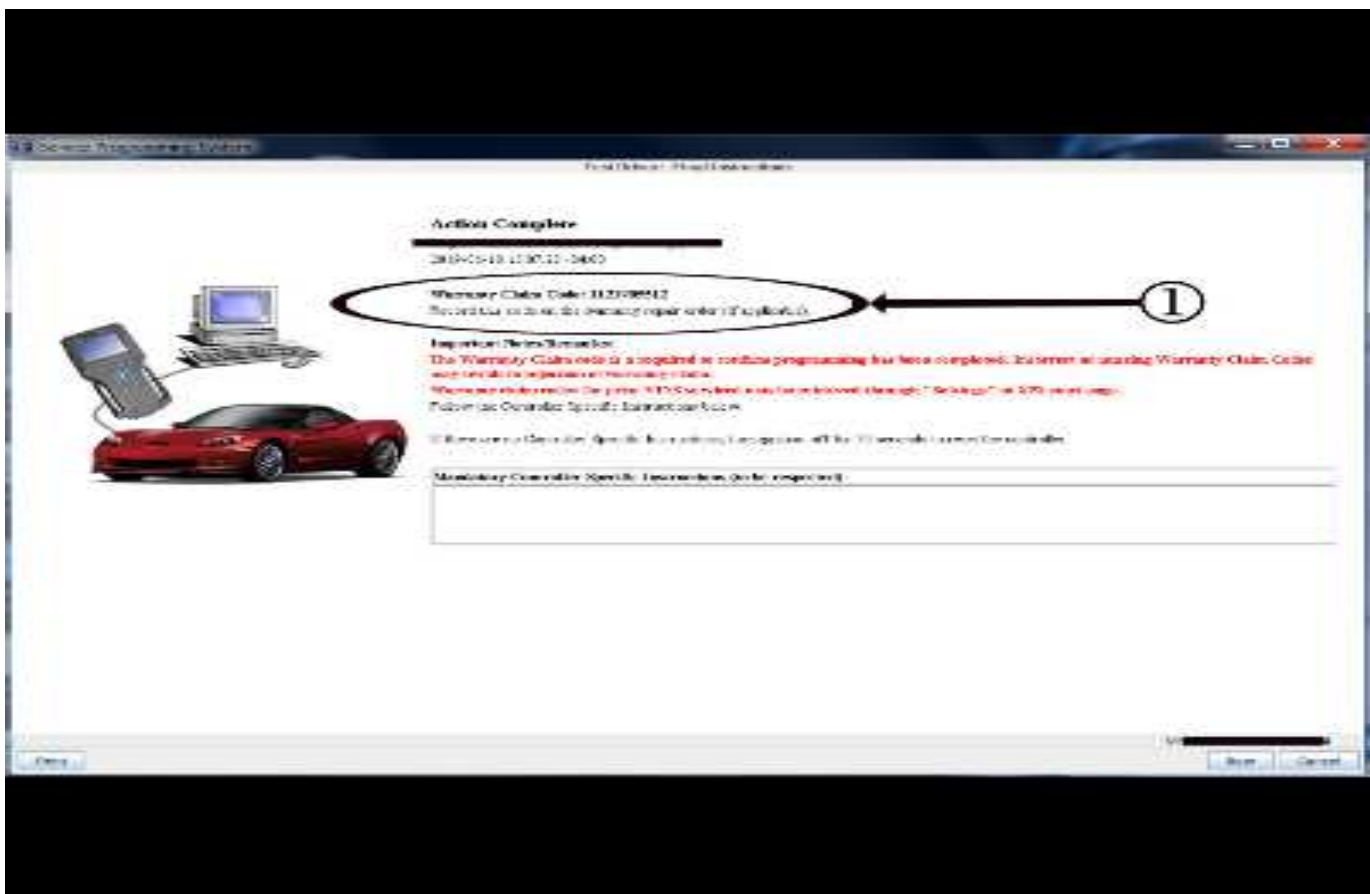
5431209

Important: TIS2WEB screen shown. Techline Connect screen is similar and will be included soon.

Note: To avoid warranty transaction rejections, you **MUST** record the warranty claim code provided on the SPS Warranty Claim Code (WCC) screen on the job card. Refer to callout 1 above for the location of the WCC on the SPS screen.

4. Record SPS Warranty Claim Code on job card for warranty transaction submission.
5. Favorites that were grayed out prior to the installation of 22.10, or greater, may need to be manually tuned and stored again to return their functionality.
