# Service Bulletin

Bulletin No.: 20-NA-130

**Subject:** Information on Message Illuminated in DIC, DTC B094C (39) Set

Brand:	Model:	Model Year:		VIN:		Engine:	Transmission:
		from	to	from	to		
Chevrolet	Bolt EV	2019	2020	—	—	All	All

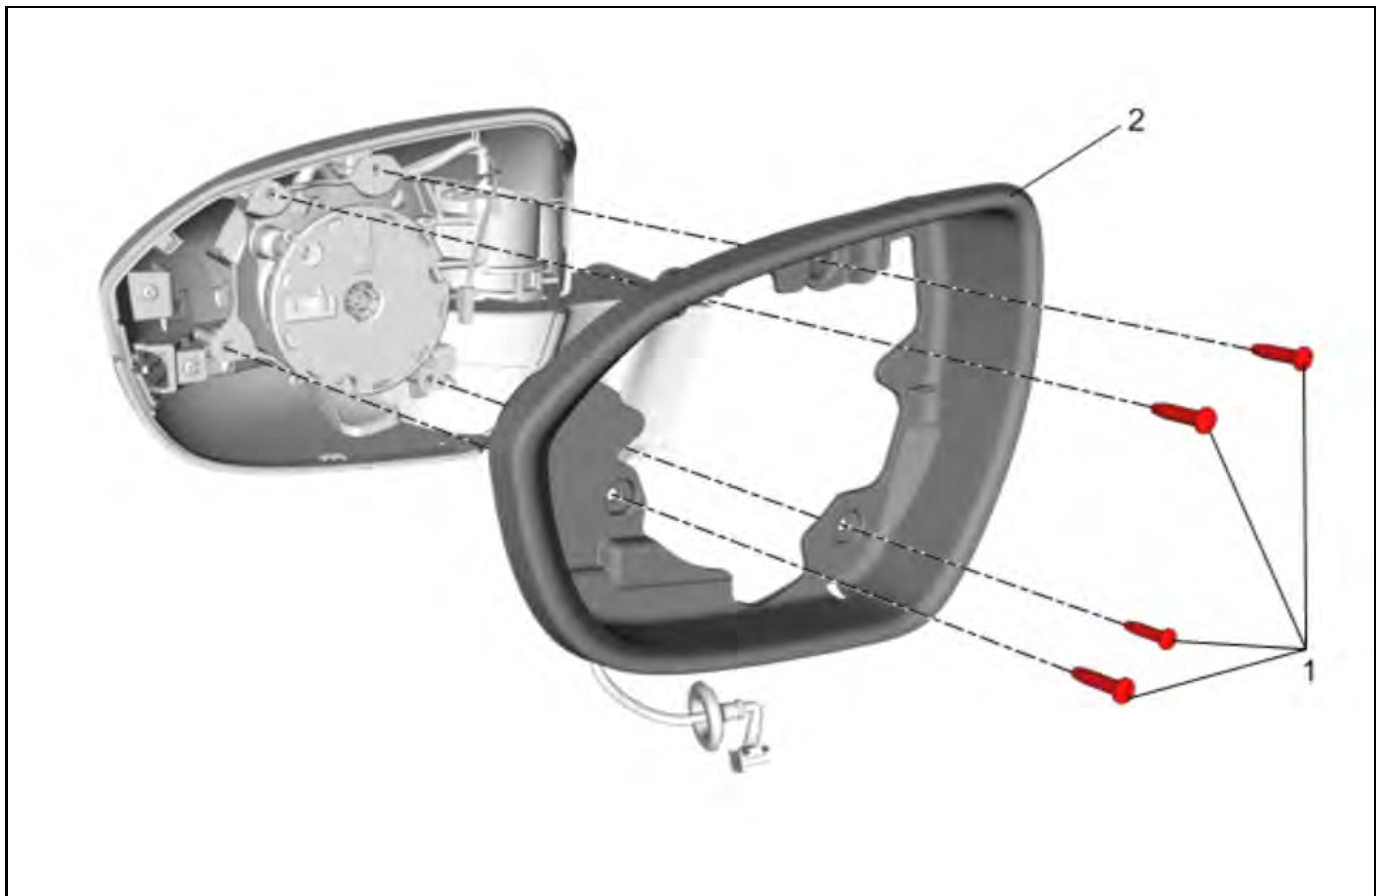
4533897

1. Remove the right outside rearview mirror housing bezel (2). Refer to *Outside Rearview Mirror Housing Bezel Replacement* in SI.

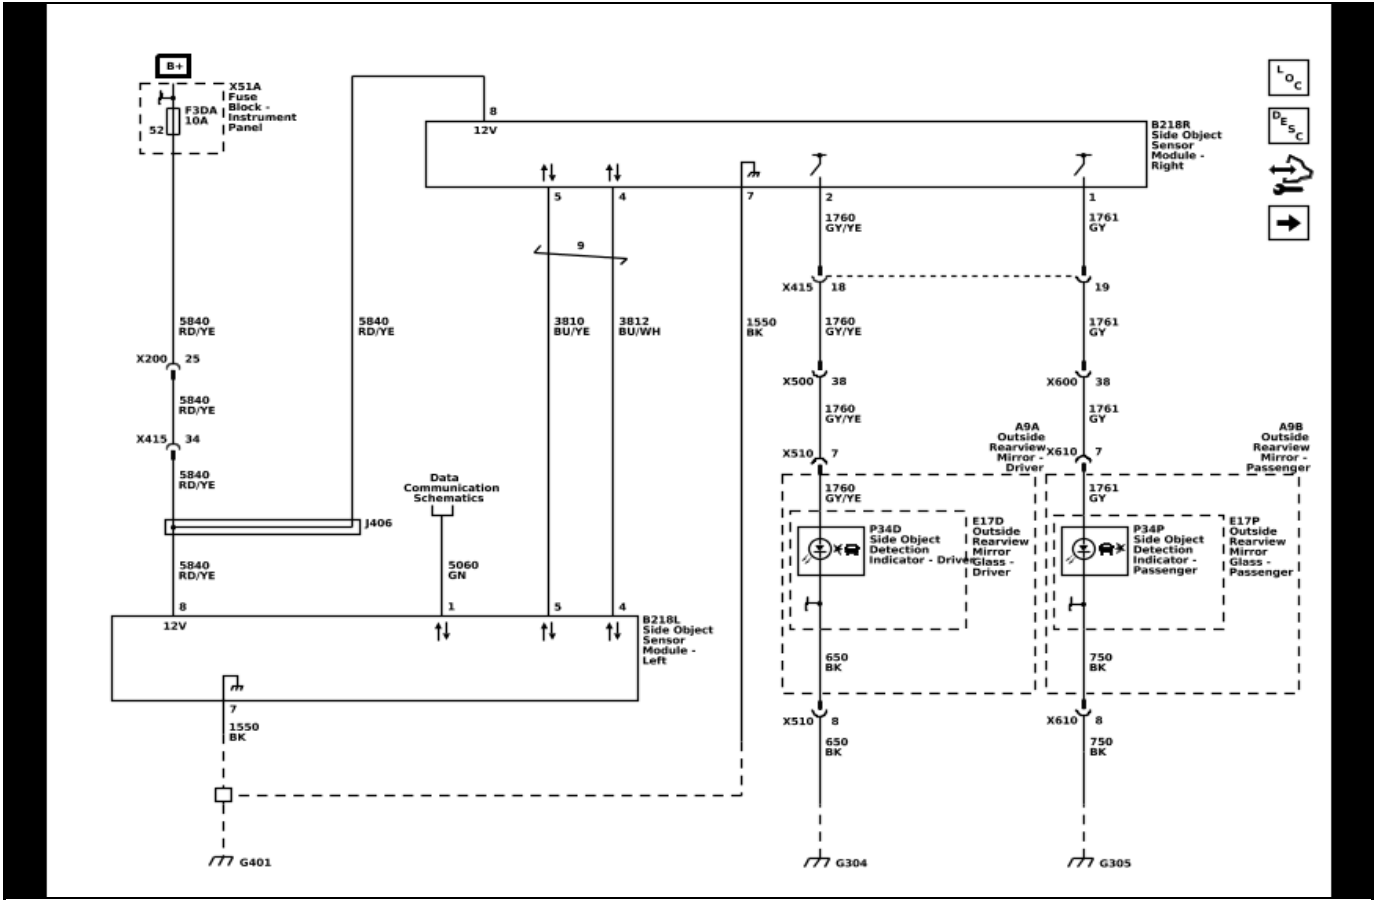
4811651

2. Inspect the LED circuit in the mirror for corrosion. Refer to Rear Cross Traffic Alert (UFG) and Side Object Detection (UKC) (Document ID #4817118) in SI.
  - If any corrosion IS found, it will be necessary to replace the mirror assembly. Refer to *Outside Rearview Mirror Replacement* in SI.
  - If NO corrosion is found, reinstall the mirror and follow the DTC B094C diagnostics referenced in SI.
